**Project: Pier A Structural Repairs Project – Phase II  
General Contractor Services –  
Request for Proposals (“RFP”)**

**Addendum #4  
# of Pages: 112**

## **Pier A Underwater Inspection for Phase 2 to 5 Supportive Maintenances**

**PIER A & ADJACENT BULKHEAD,  
BREAKWATER AND LOW-LEVEL  
PLATFORMS  
ROUTINE CONDITION INSPECTION**

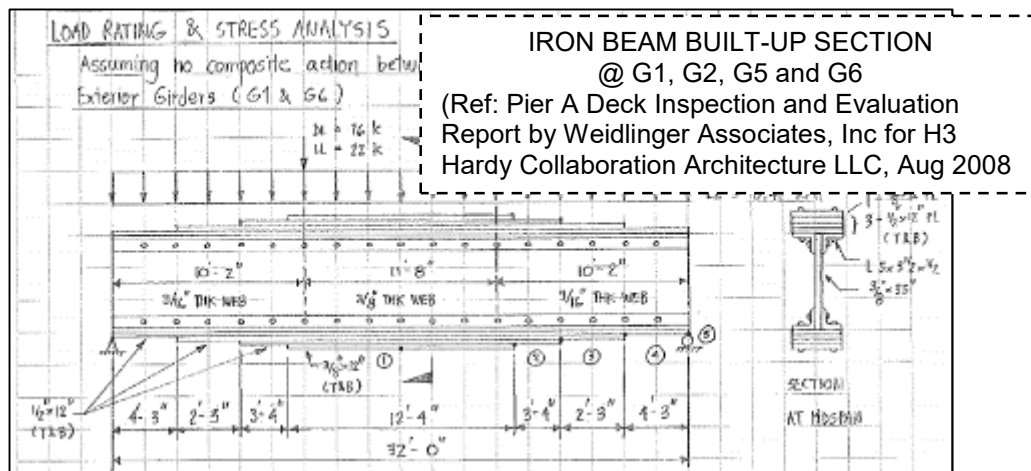
Figure 2\_ Inner Iron Girders section

The iron girders consists of built-up plate girders encased in concrete, which is part of the jack arch deck. The bottoms of iron girder flanges are exposed to the air and tidal water and are in poor condition. This corrosion has caused adjacent concrete spalls and cracks. The corresponding top girder flanges are encased in concrete and can not be inspected. The inner girders, G3 & G4 have additional plates on the bottom of the flange. Please see the below sketches extracted from 2008 deck evaluation report. Our recommendation for maintenance of the iron girder bottom flanges is to remove the corrosion and rusted surfaces with sandblasting and then painting with an appropriate marine coating. Please see appendix E2 for detail of defected area photographs - 85 to 90.

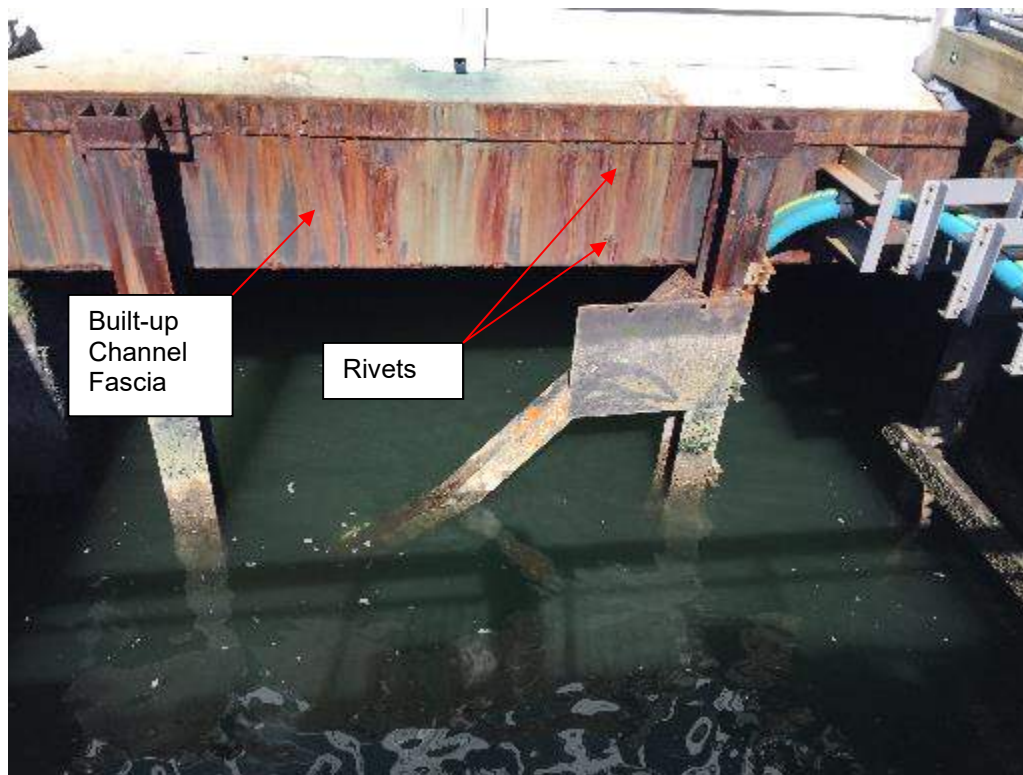
**Figure 4\_ Inner Iron Girders section**

The paint on the pier perimeter fascia channel is peeling off, rusted and in fair condition. The channel is built-up with 3/8"x36" plates and two L3 1/2 x L3 1/2 x 1/2 " angles. They are connected to the adjacent concrete block with two rivets at equal spacing. This corrosion is purely ascetic and not a structural issue. The recommendation is to clean and repaint the surface.

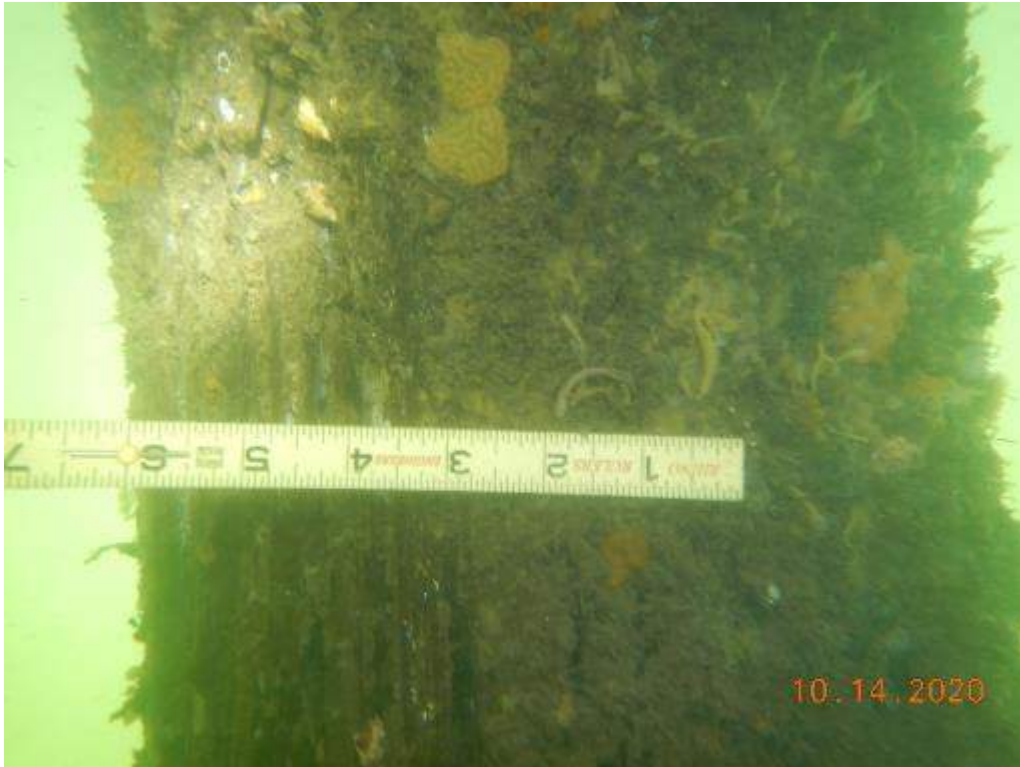
**Photograph 1. Pile 10% section loss and Marine Borer found from water surface to mudline at Grid 23J**

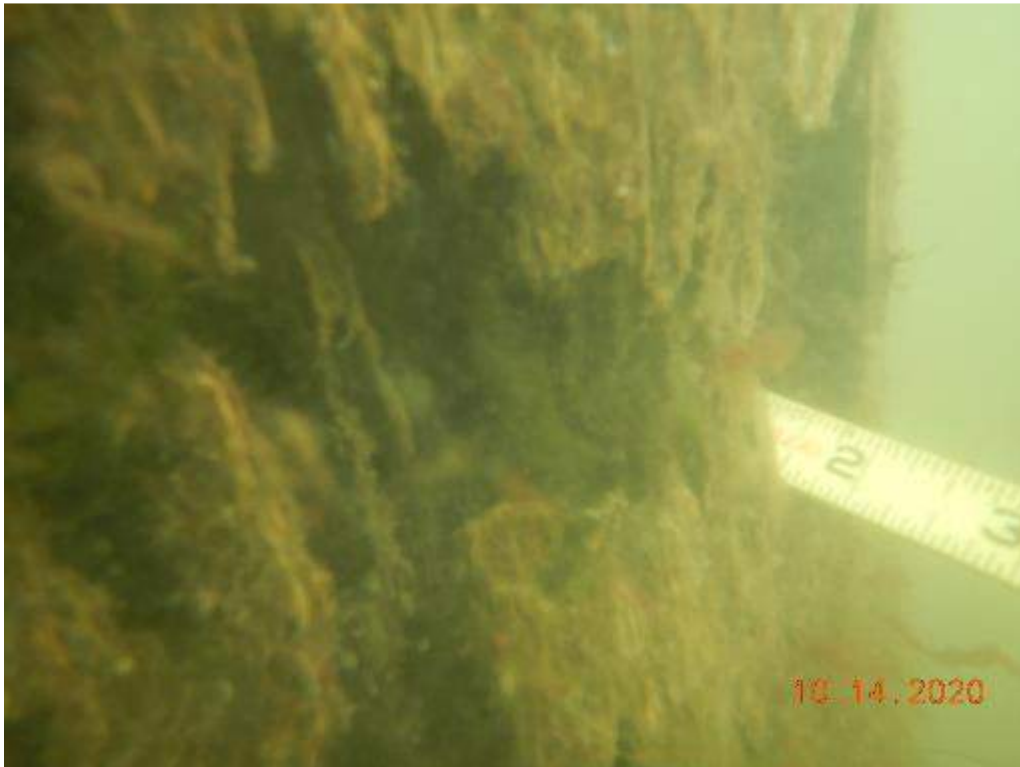
**Photograph 2. Pile section loss and Marine Borer found from water surface to mudline at Grid 28**

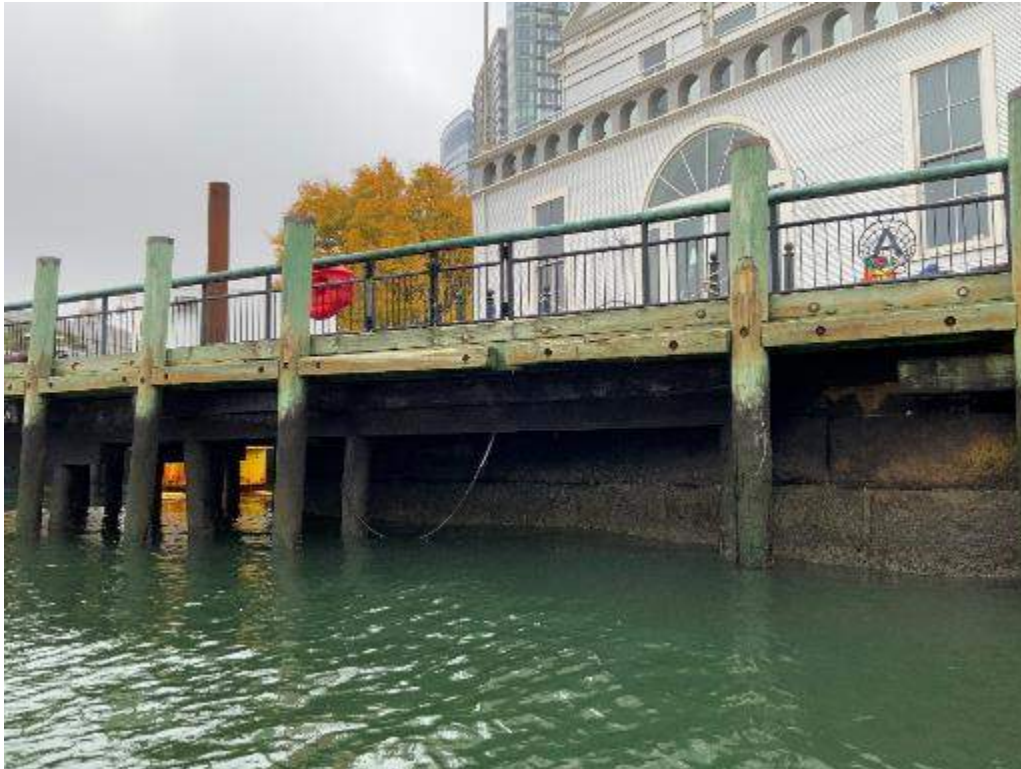
**Photograph 3. Fender Pile was missed in Grid 7 between Grid F & G**

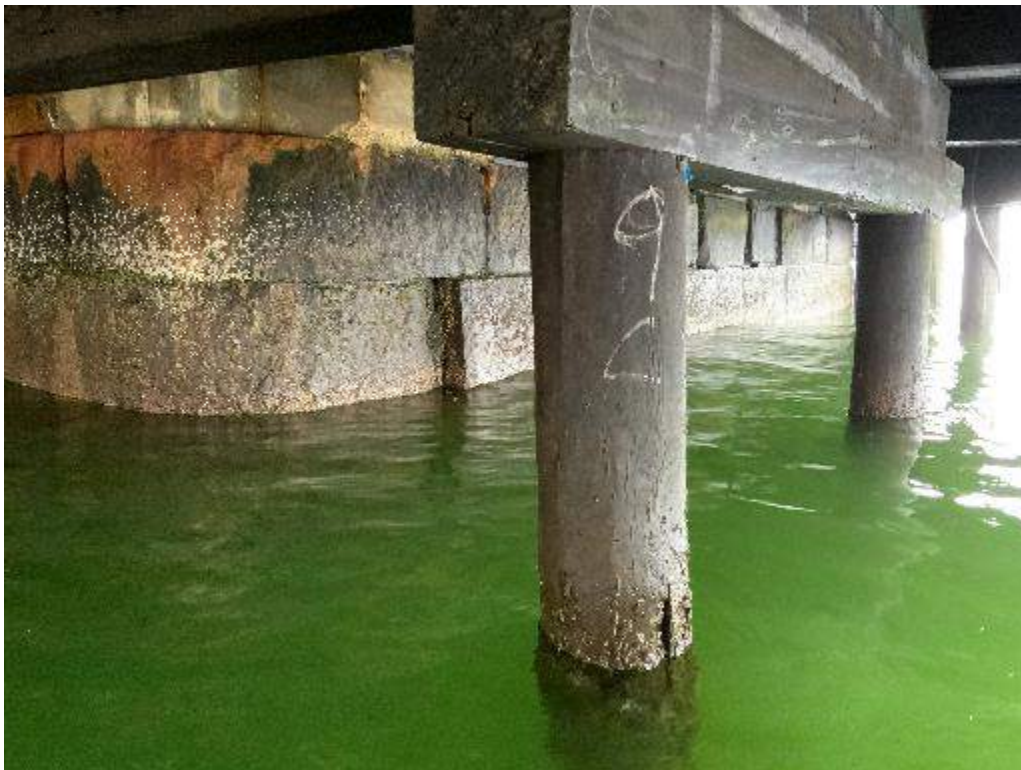
**Photograph 4. Pile Abrasion at Grid - 9C**

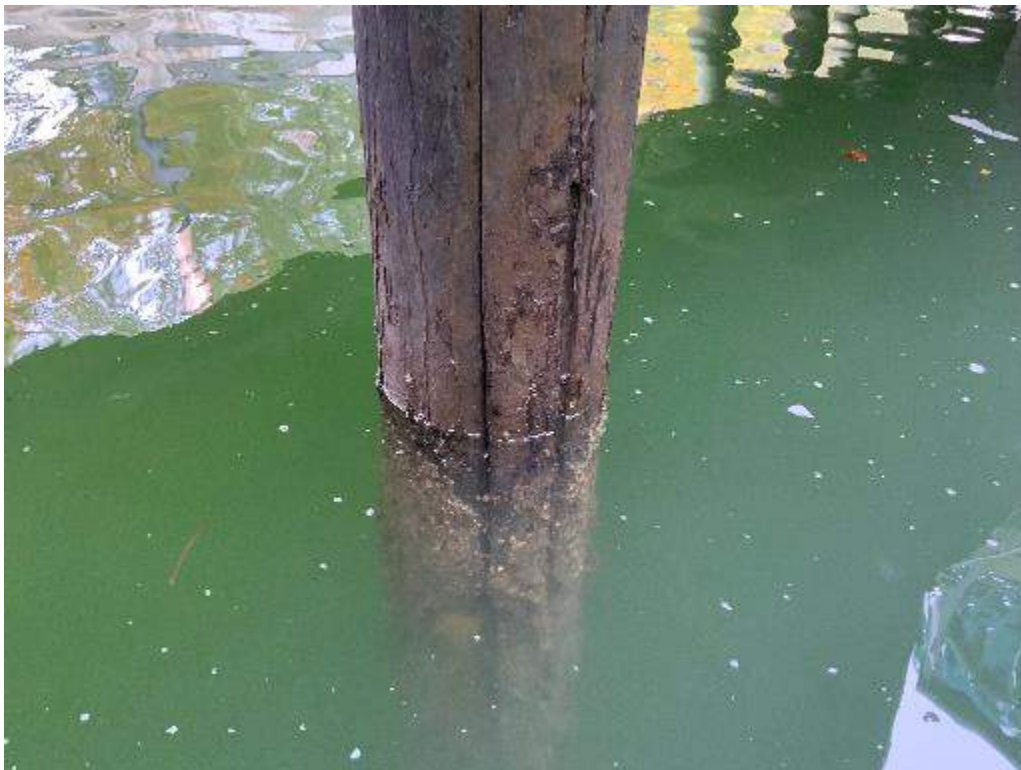
**Photograph 6. Pile Shimming at Grid – 17B**

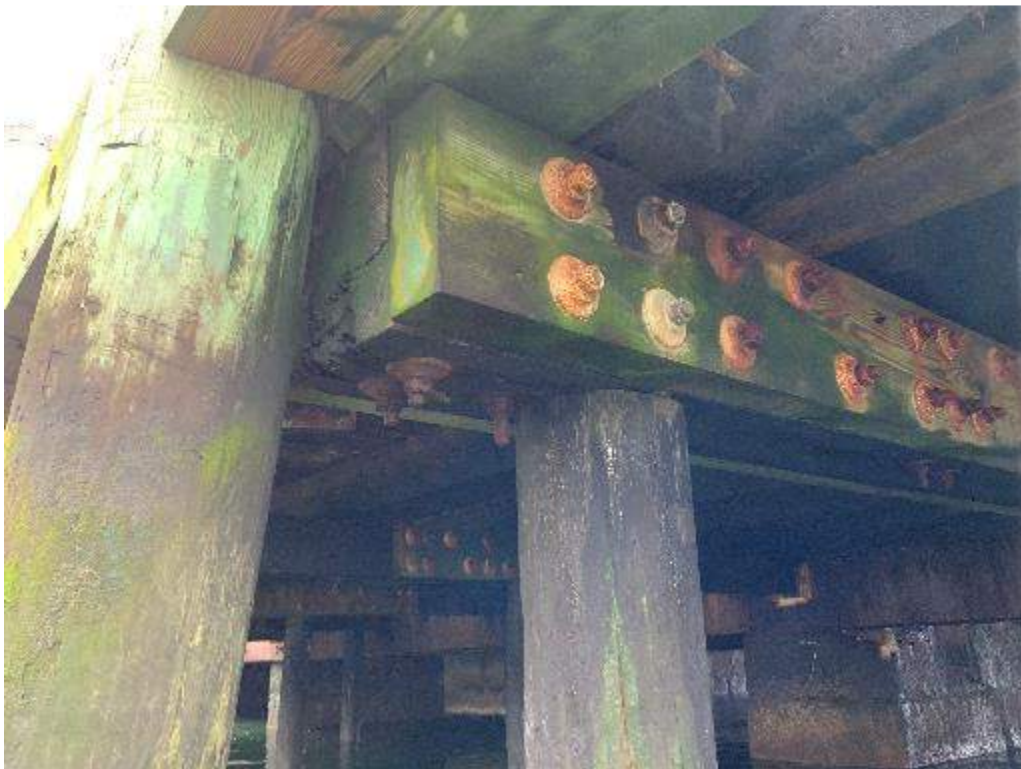
**Photograph 8. Repaired Pile Cap with Corroded Bolts at Grid - 12A**

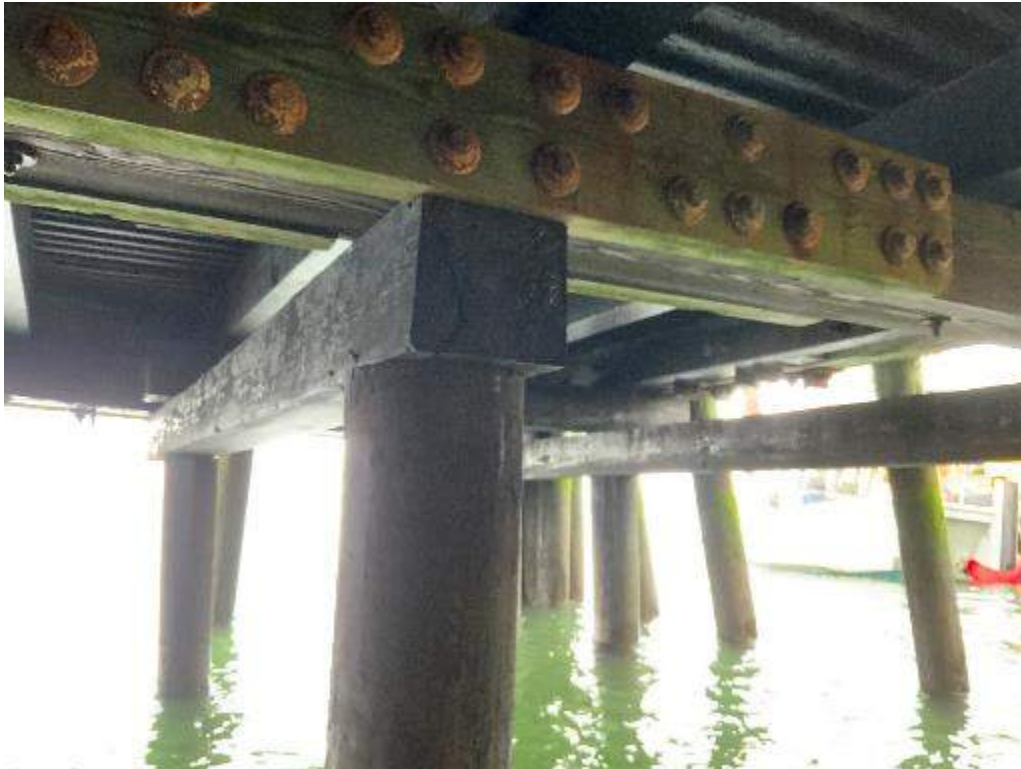
**Photograph 9. Repaired Pile Cap with Rusty Bolts at Grid – B (Between Grid 18 & 19)**

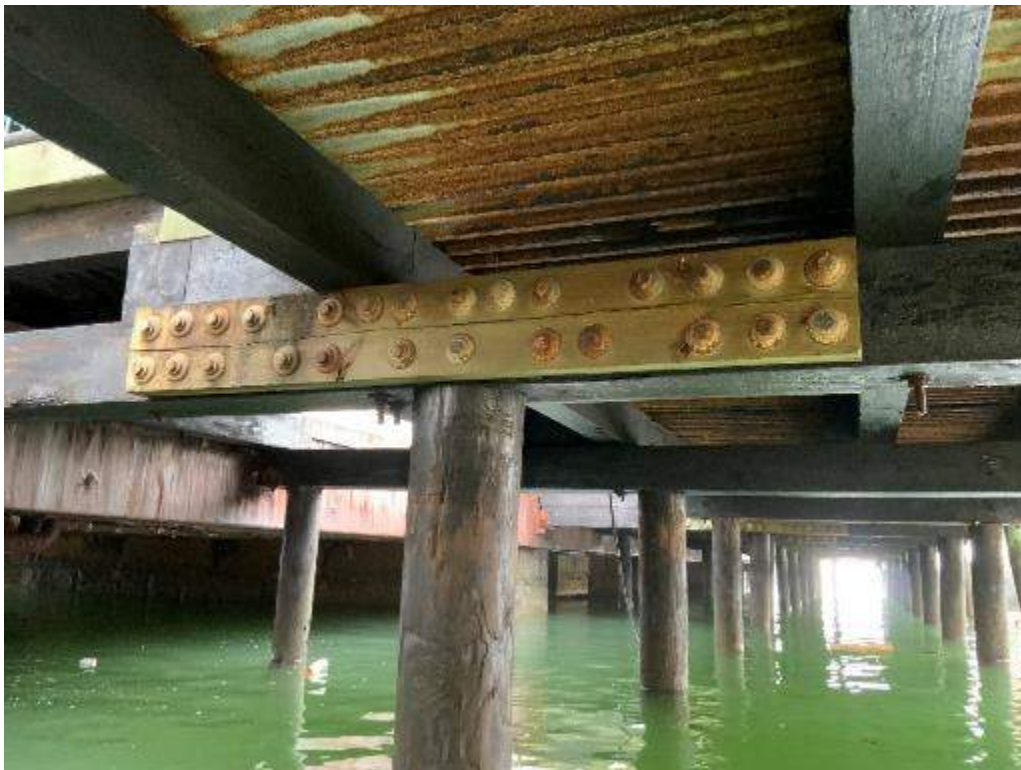
**Photograph 10. Pile Cap with Rusty Bolts at Grid – 19B**

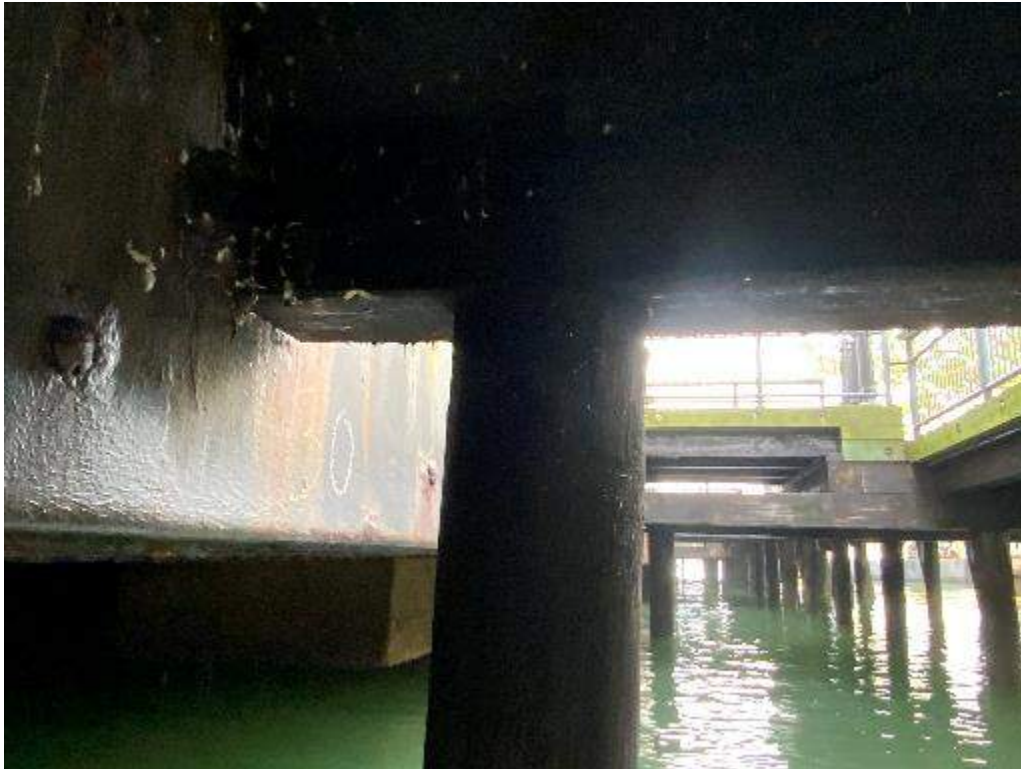
**Photograph 11. Pile Cap Bearing Loss at Grid – 19B**

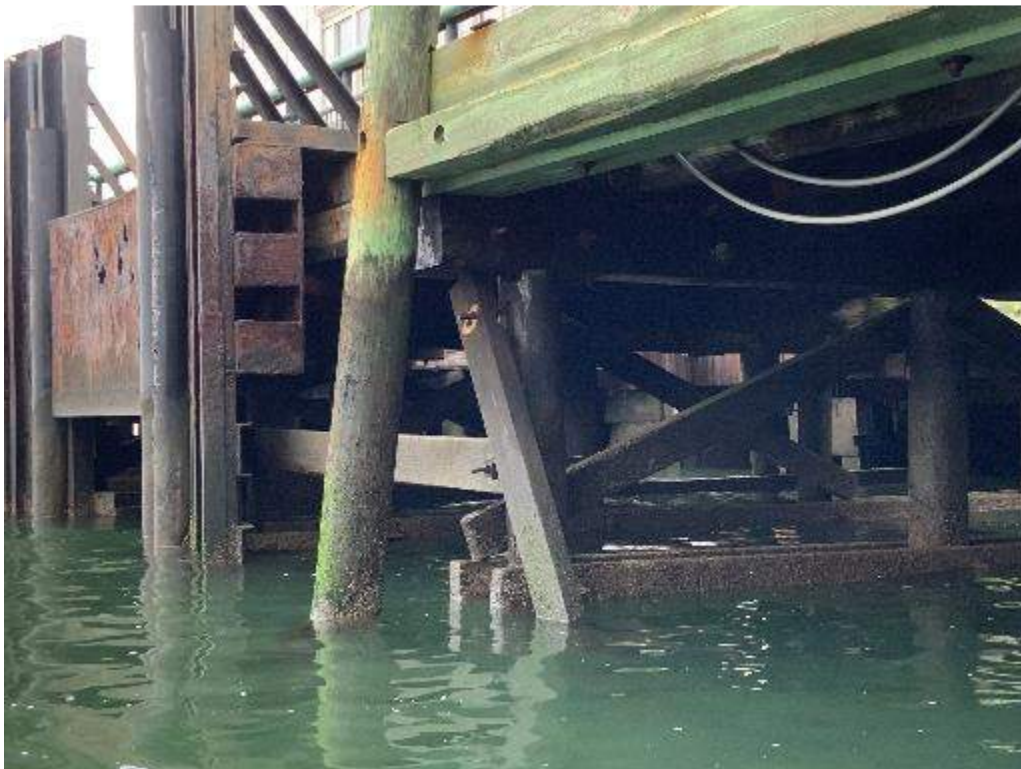
**Photograph 12. Timber Bracing connection loose at Grid – 19L**

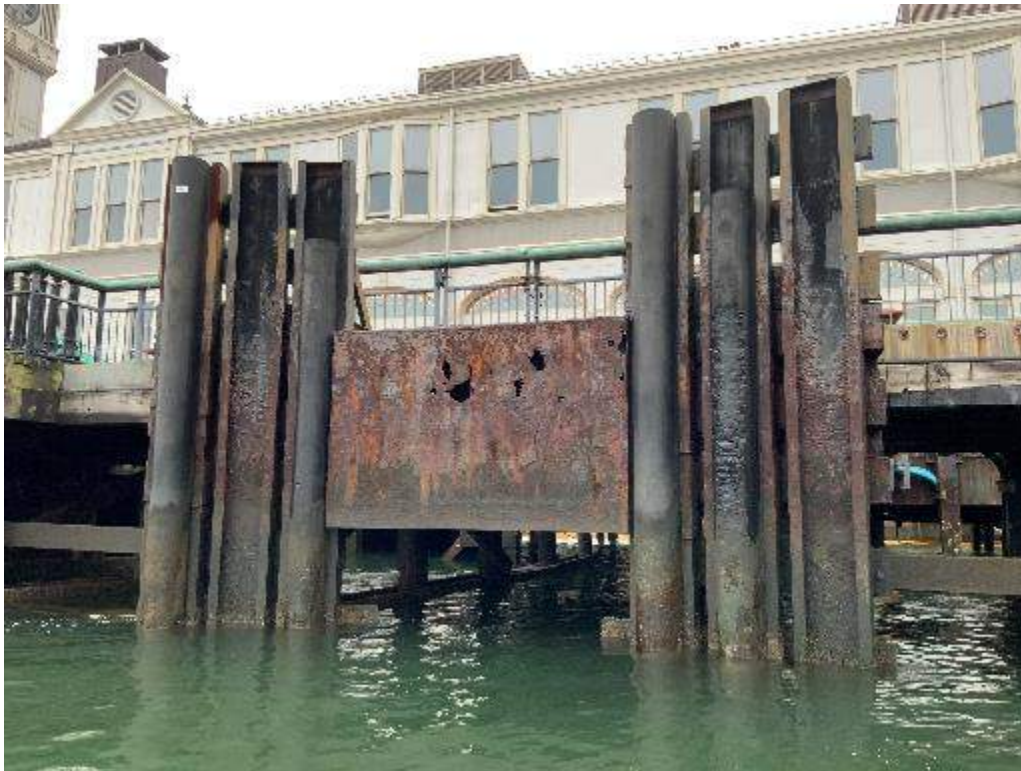
**Photograph 13. Deteriorating Fender Panel and Lost Fenders**

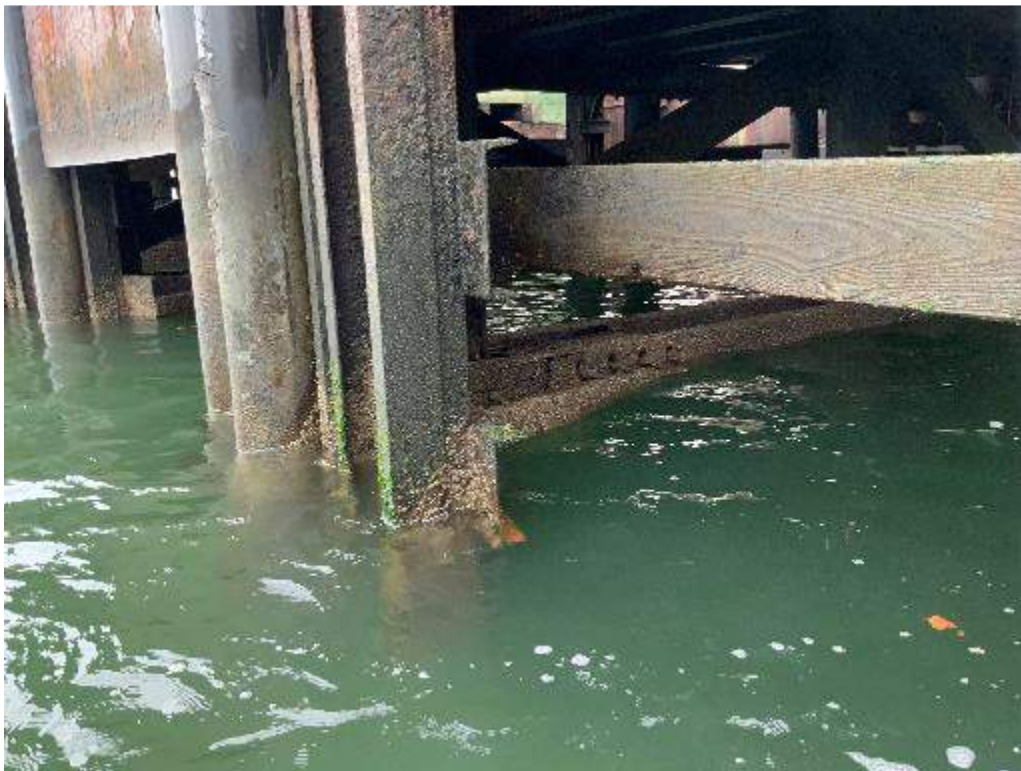
**Photograph 14. Deteriorating Fender Support Bracings**

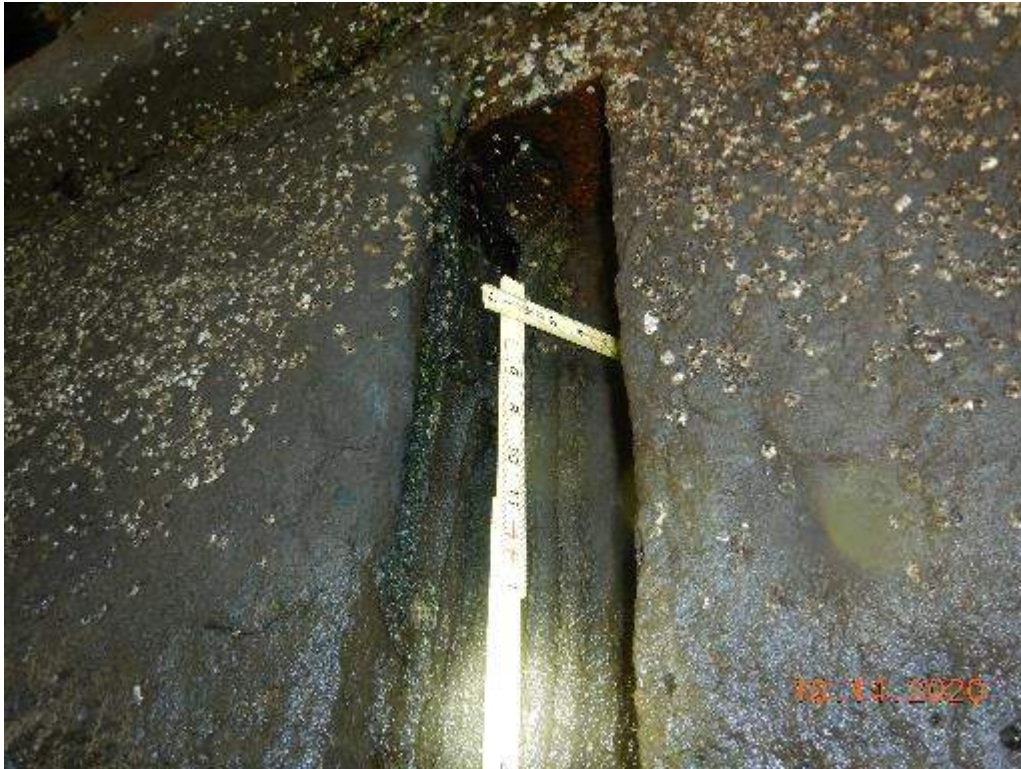
**Photograph 15. Pier-3 Mechanical cut on Pier Stem**

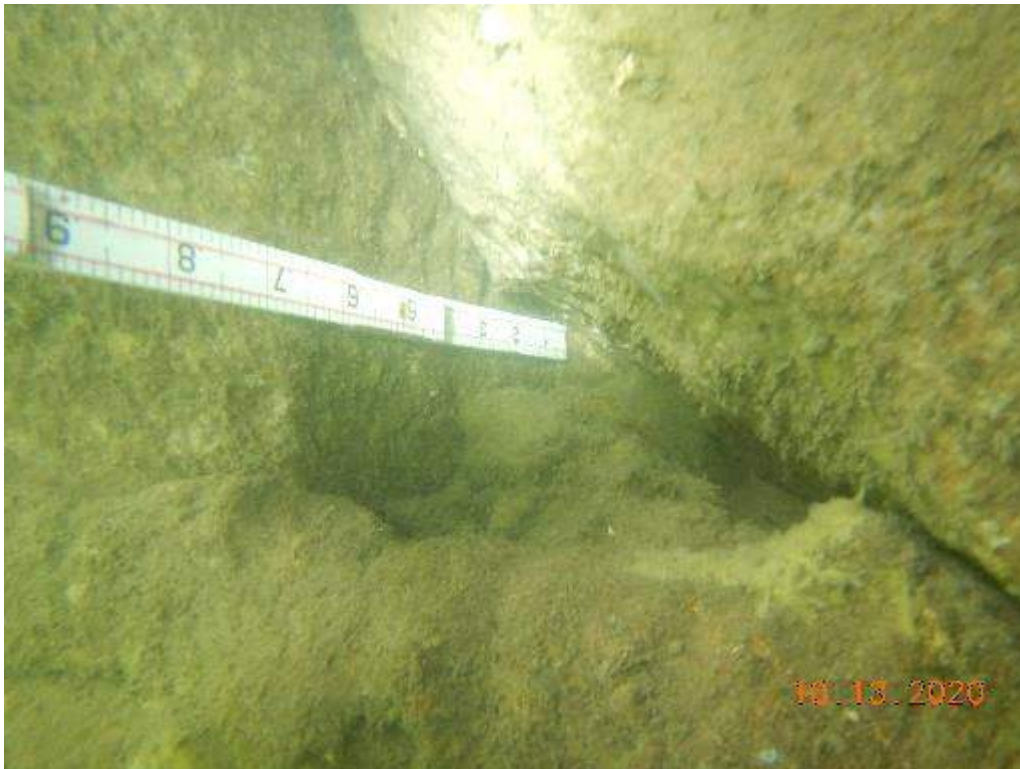
**Photograph 22. Bulkhead Joint Loss ~ 10 Ft (1'D x 0.2'H) under North Apron**

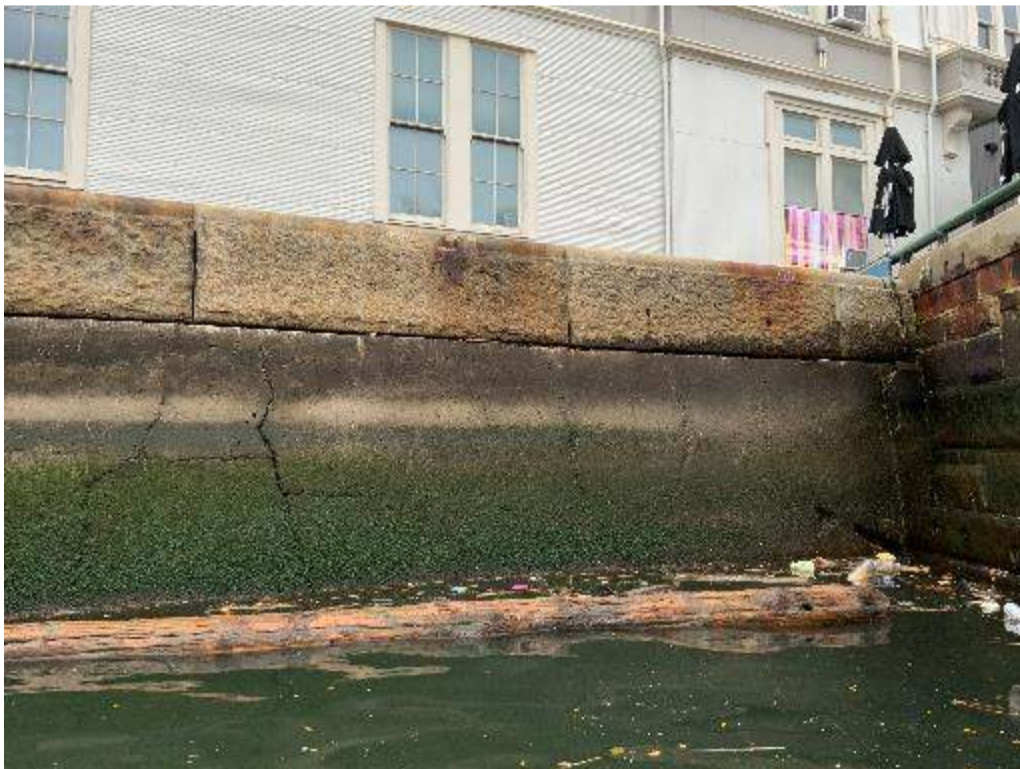
Photograph 36. Breakwater wall concrete crack, South Surface, North Breakwater

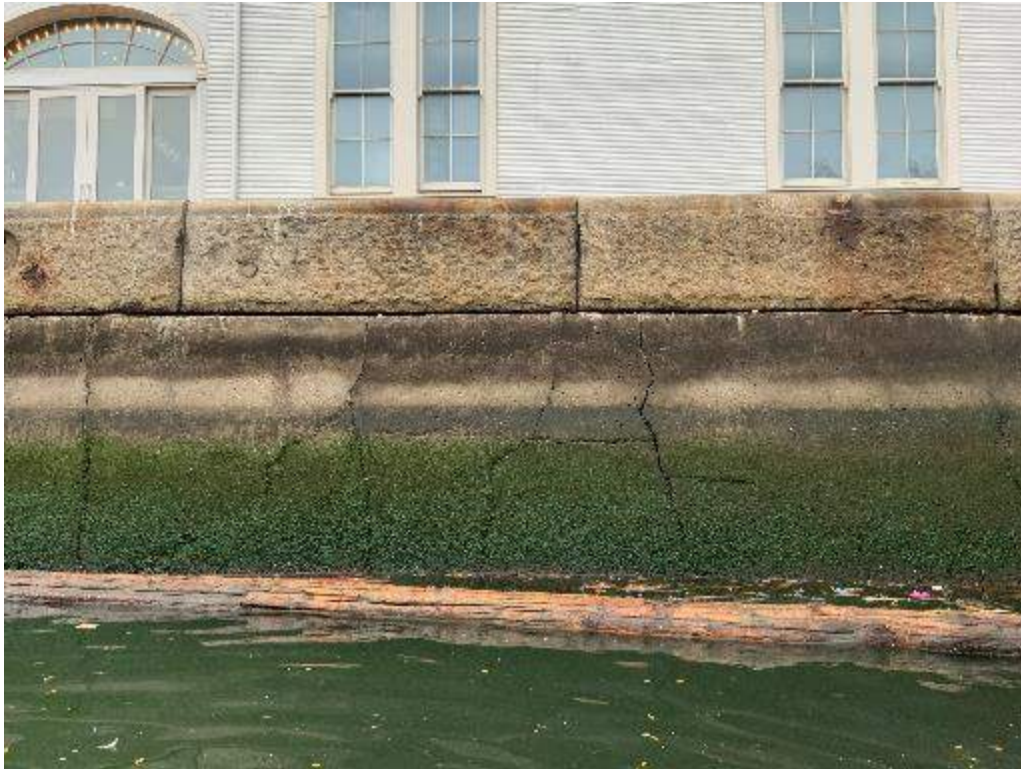
**Photograph 37. Concrete crack lines on South Surface, North Breakwater**

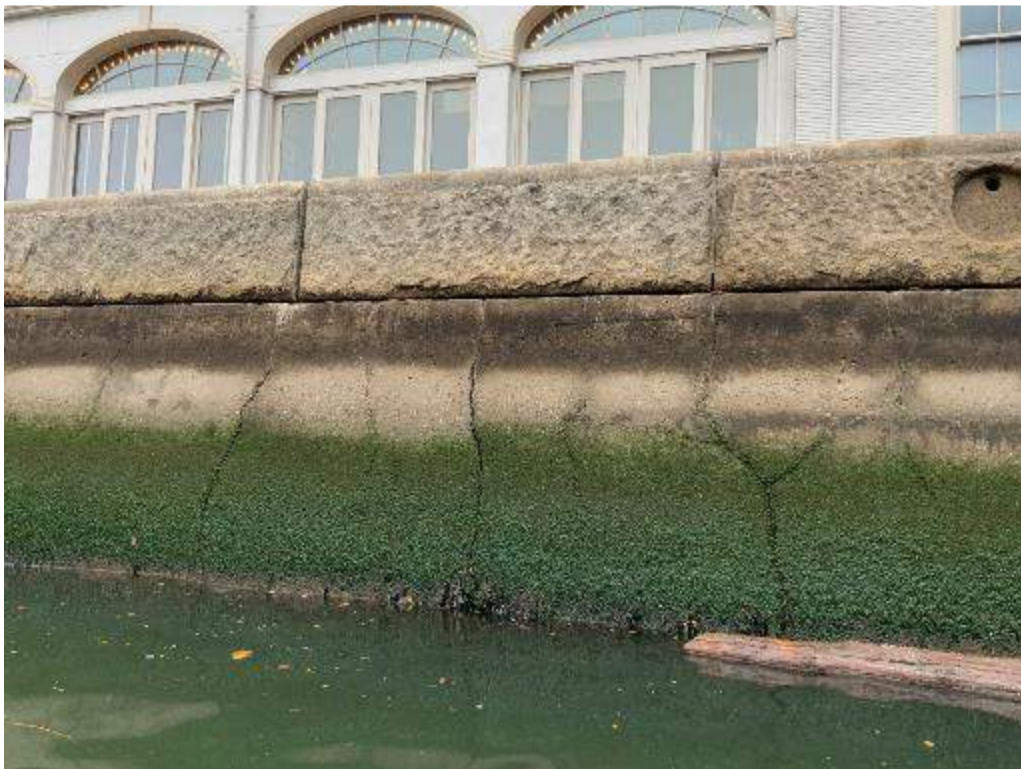
**Photograph 38. Concrete crack lines on South Surface, North Breakwater**

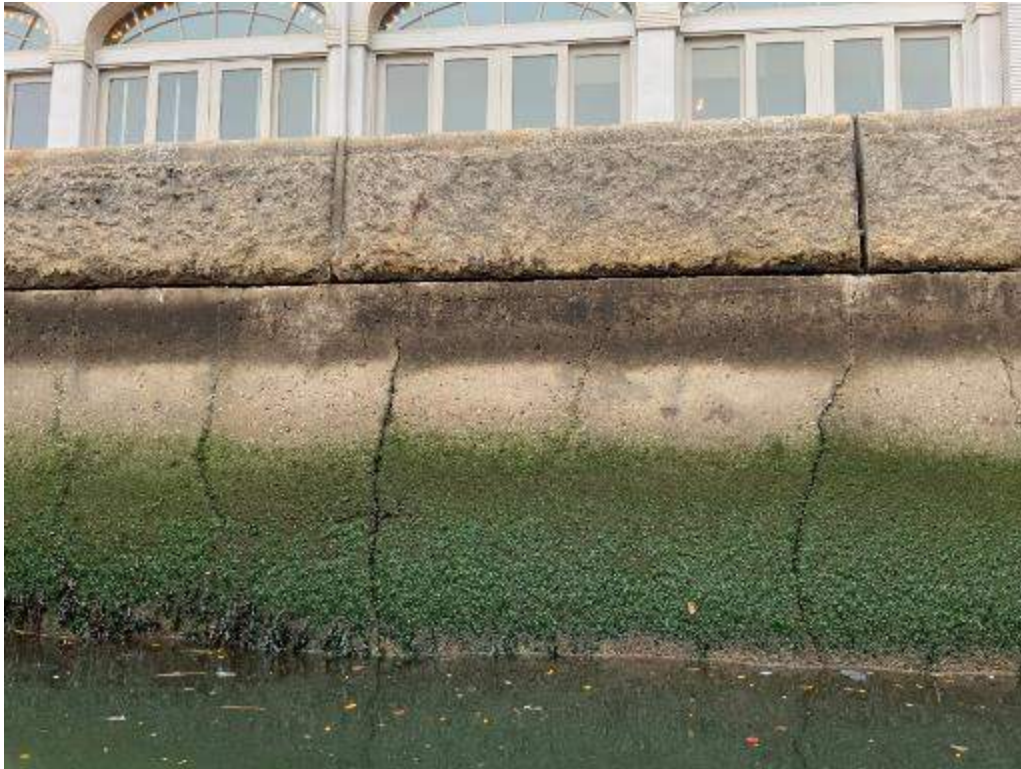
**Photograph 39. Concrete crack lines on South Surface, North Breakwater**

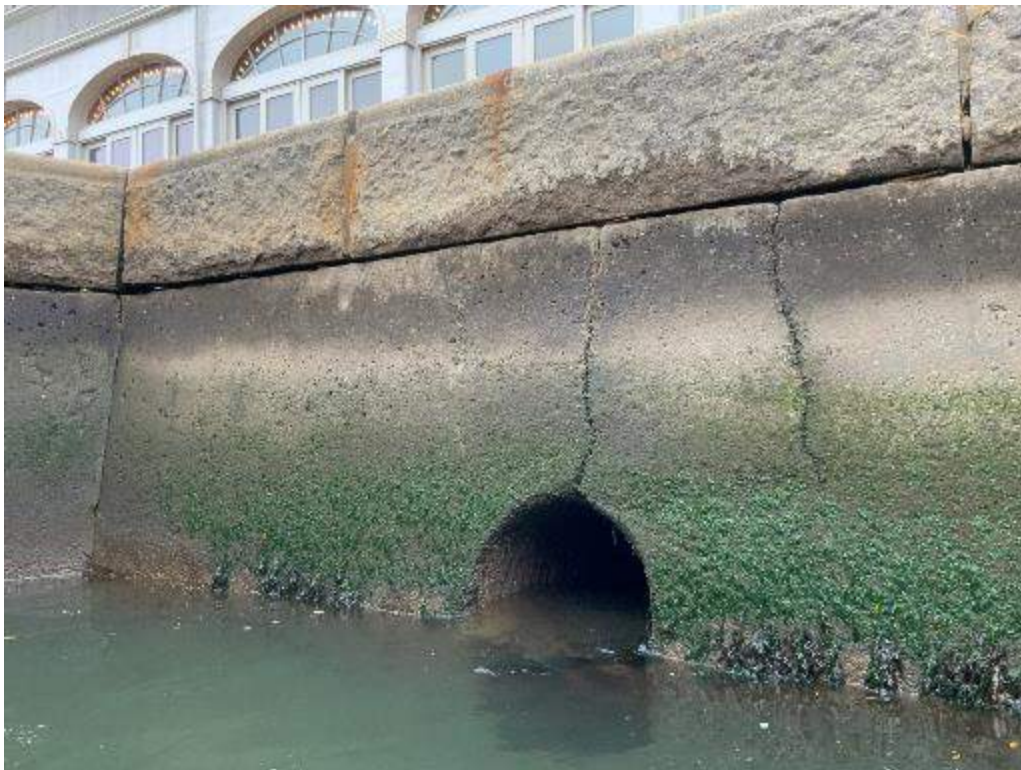
**Photograph 40. Concrete crack lines on South Surface, North Breakwater**

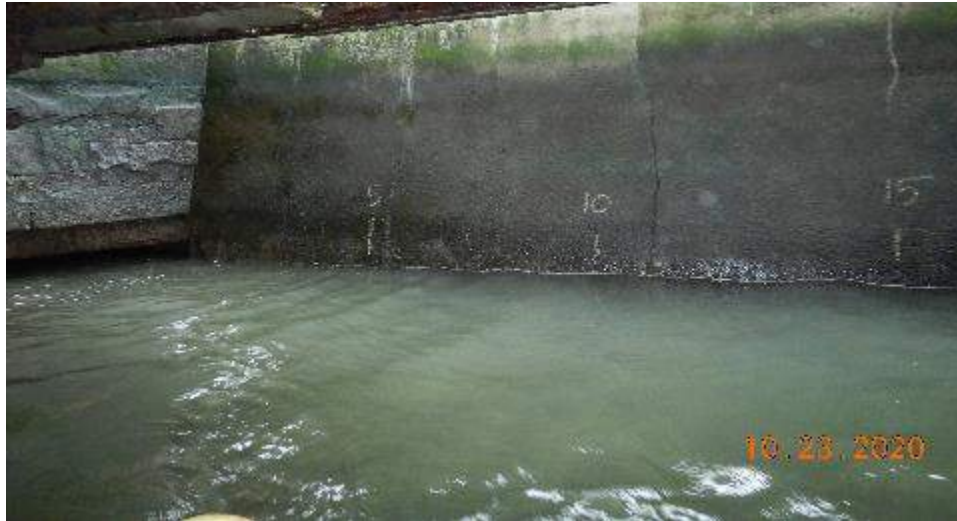
Photograph 41. Concrete crack lines on North Surface, North Breakwater

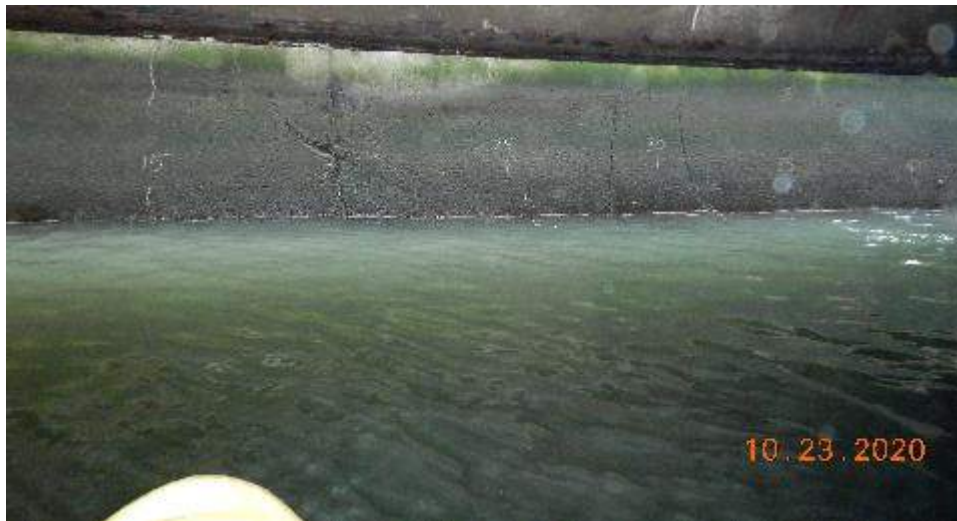
Photograph 42. Concrete crack lines on North Surface, North Breakwater

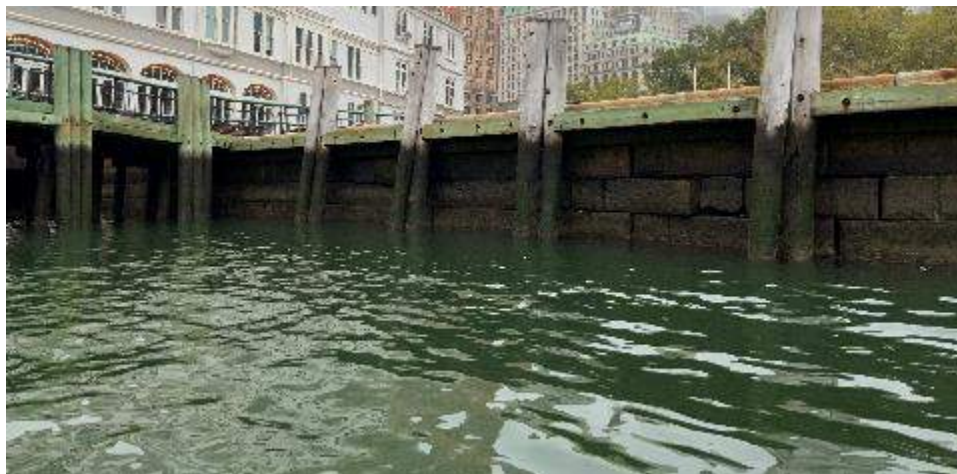
Photograph 43. Voids between Blocks Wall on West Surface, West Breakwater

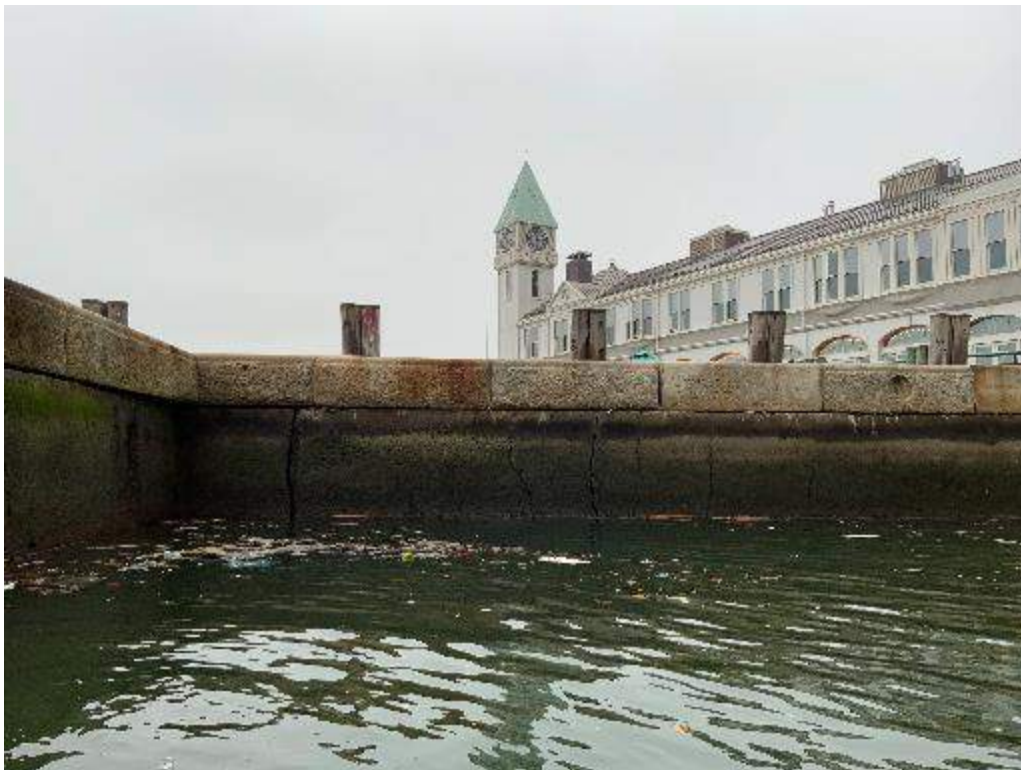
**Photograph 45. Concrete crack lines on East Surface, West Breakwater**

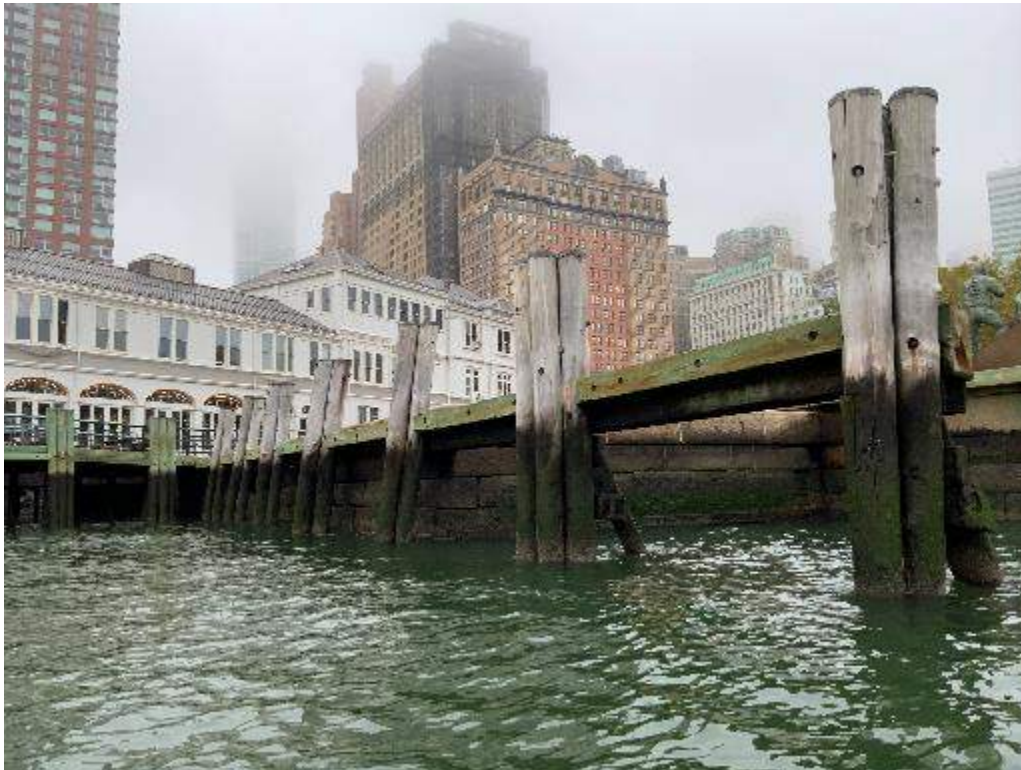
**Photograph 46. Fender Piles near West Breakwater (Routine inspection required)**

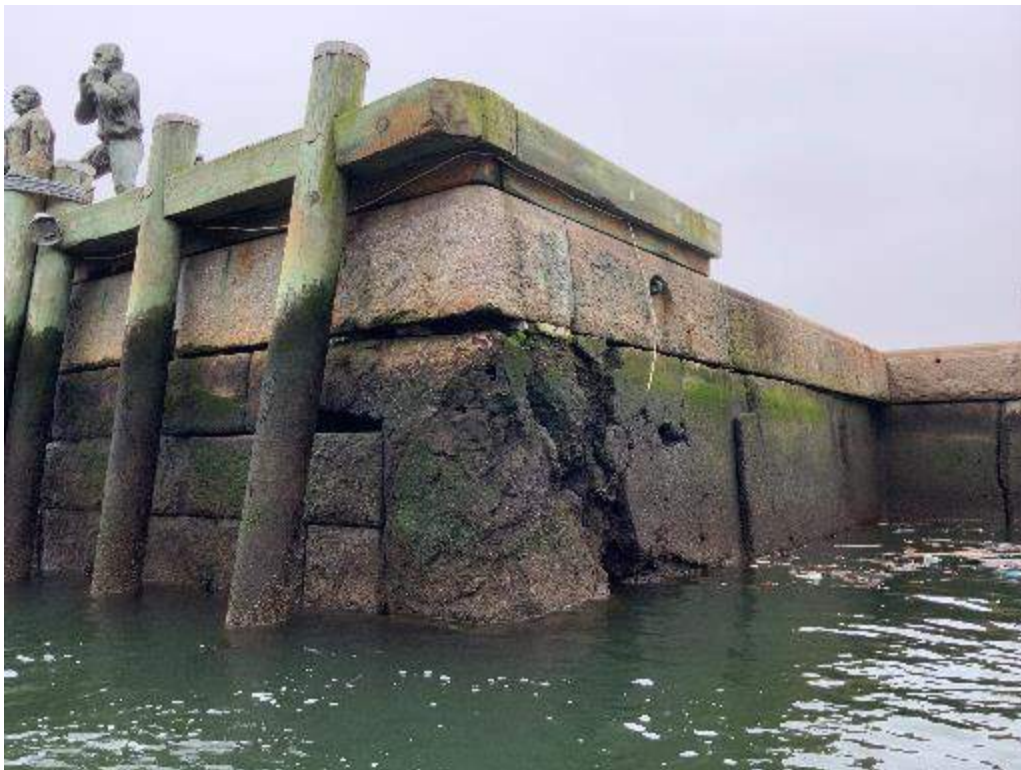
**Photograph 49. Concrete Spalling at North East Corner, Memorial Breakwater**

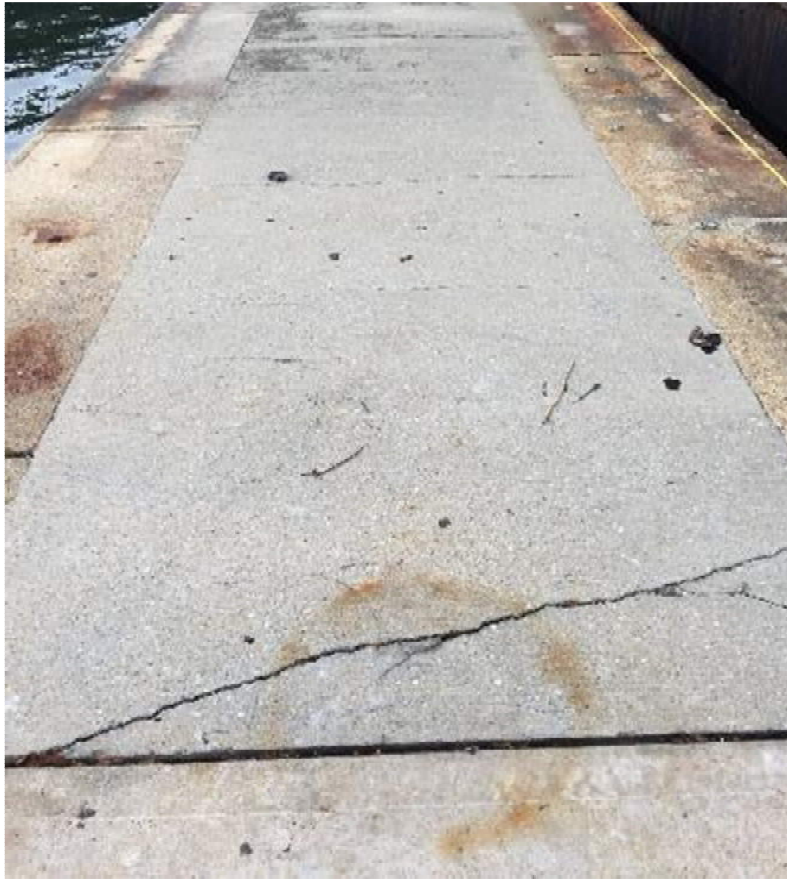
**Photograph 50. Concrete crack lines on Walkway Slab every 5-10 ft, North Breakwater**

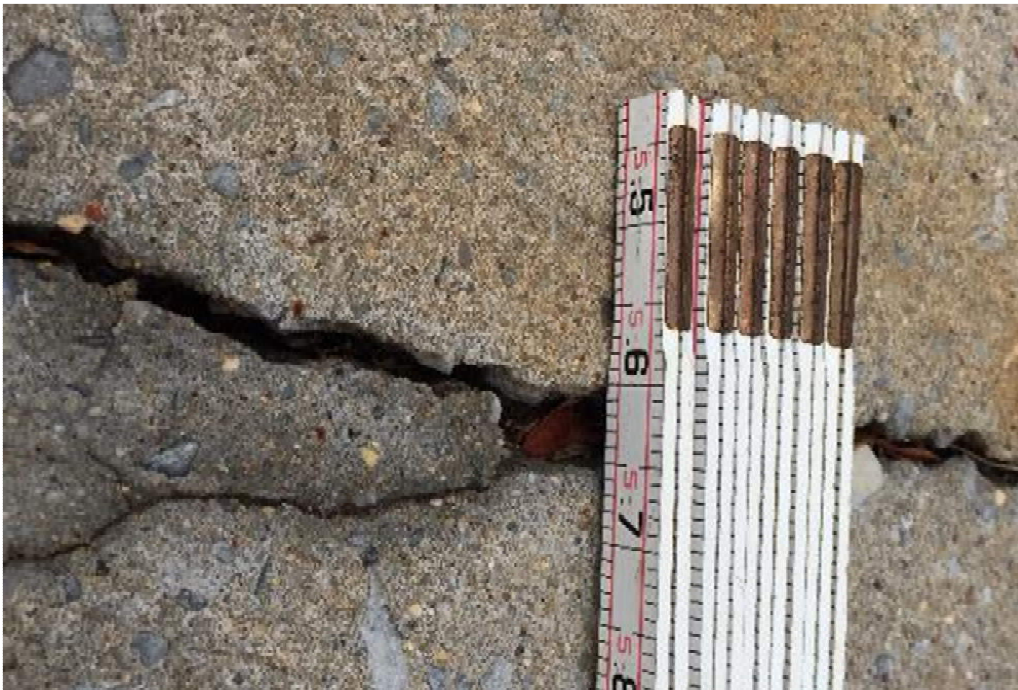
**Photograph 51. 0.6" Crack Width on Walkway Slab, North Breakwater**
