**Project: Pier A Structural Repairs Project – Phase II  
General Contractor Services –  
Request for Proposals (“RFP”)**

**Addendum #4  
# of Pages: 112**

## **Pier A Underwater Inspection for Phase 2 to 5 Supportive Maintenances**

**PIER A & ADJACENT BULKHEAD,  
BREAKWATER AND LOW-LEVEL  
PLATFORMS  
ROUTINE CONDITION INSPECTION**

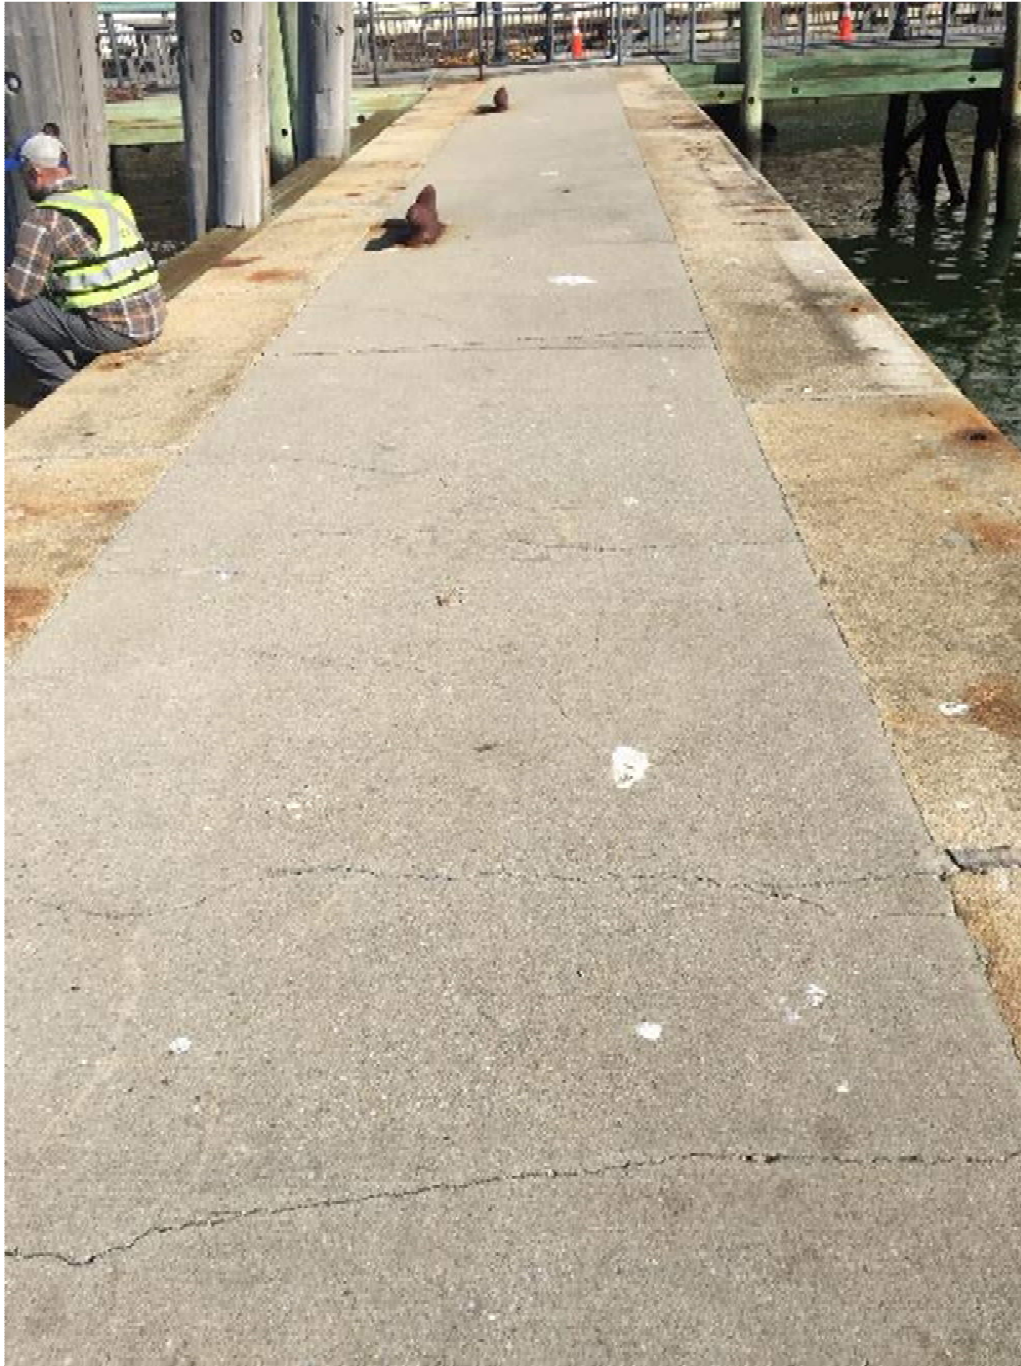
**Photograph 52. Concrete crack lines on Walkway Slab every 5-10 ft, West Breakwater**

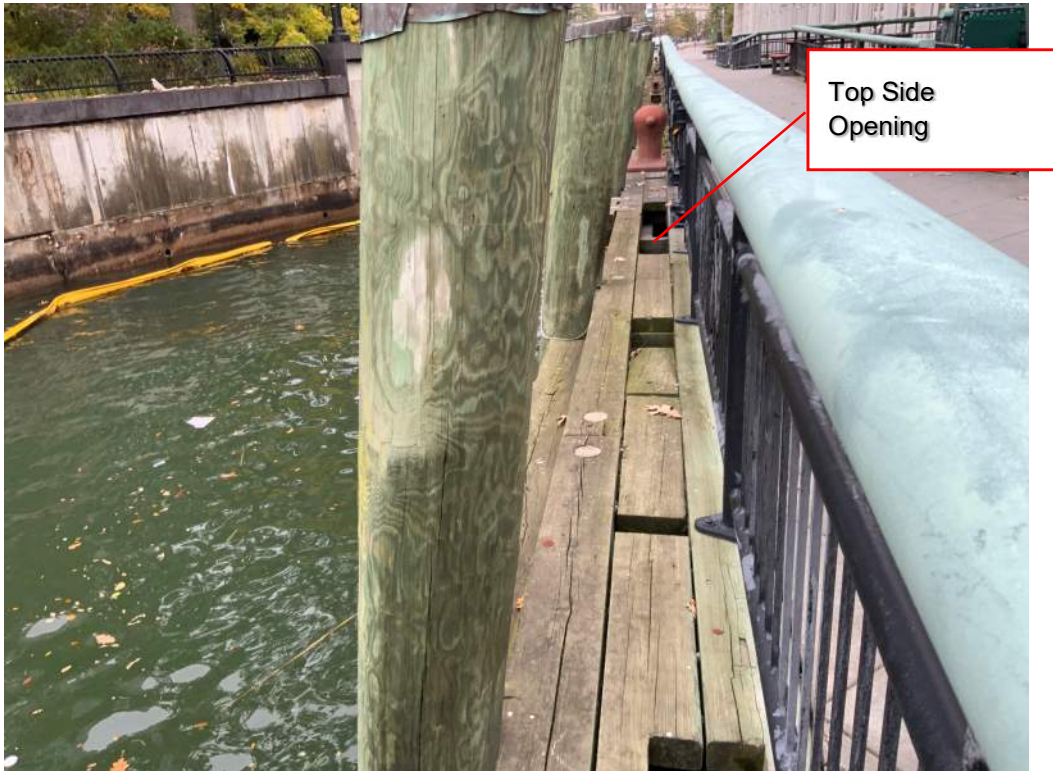
**Photograph 53. Top Side Openings in Pier-A North Apron**

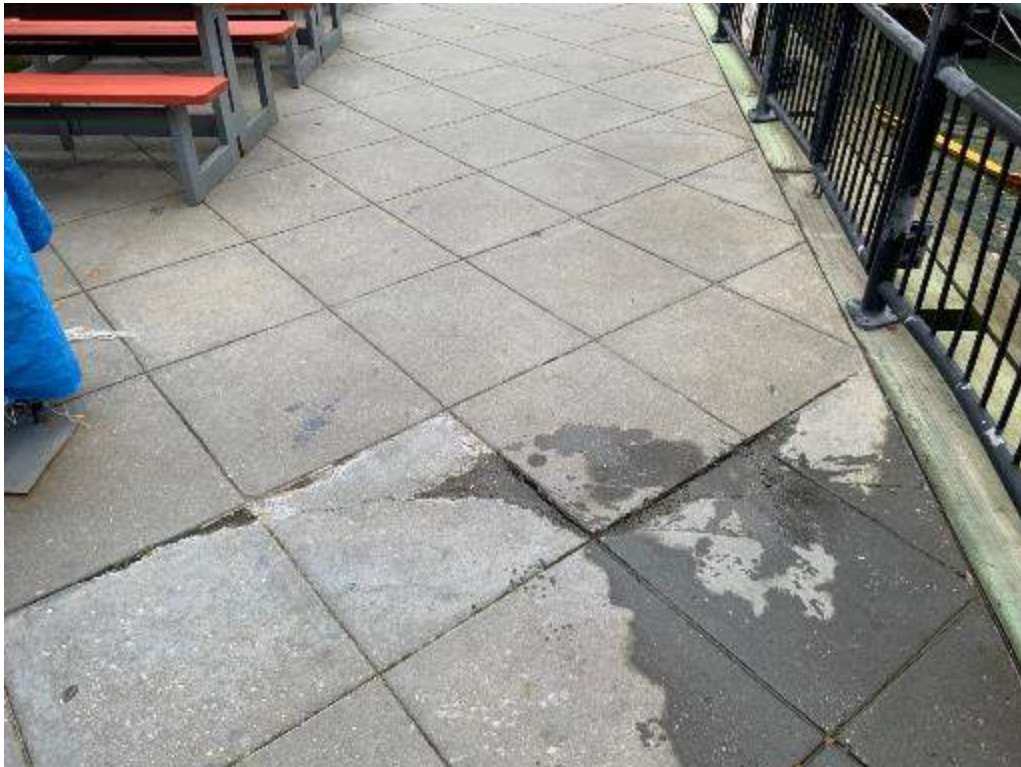
**Photograph 54. Concrete spall on walkway pavement**

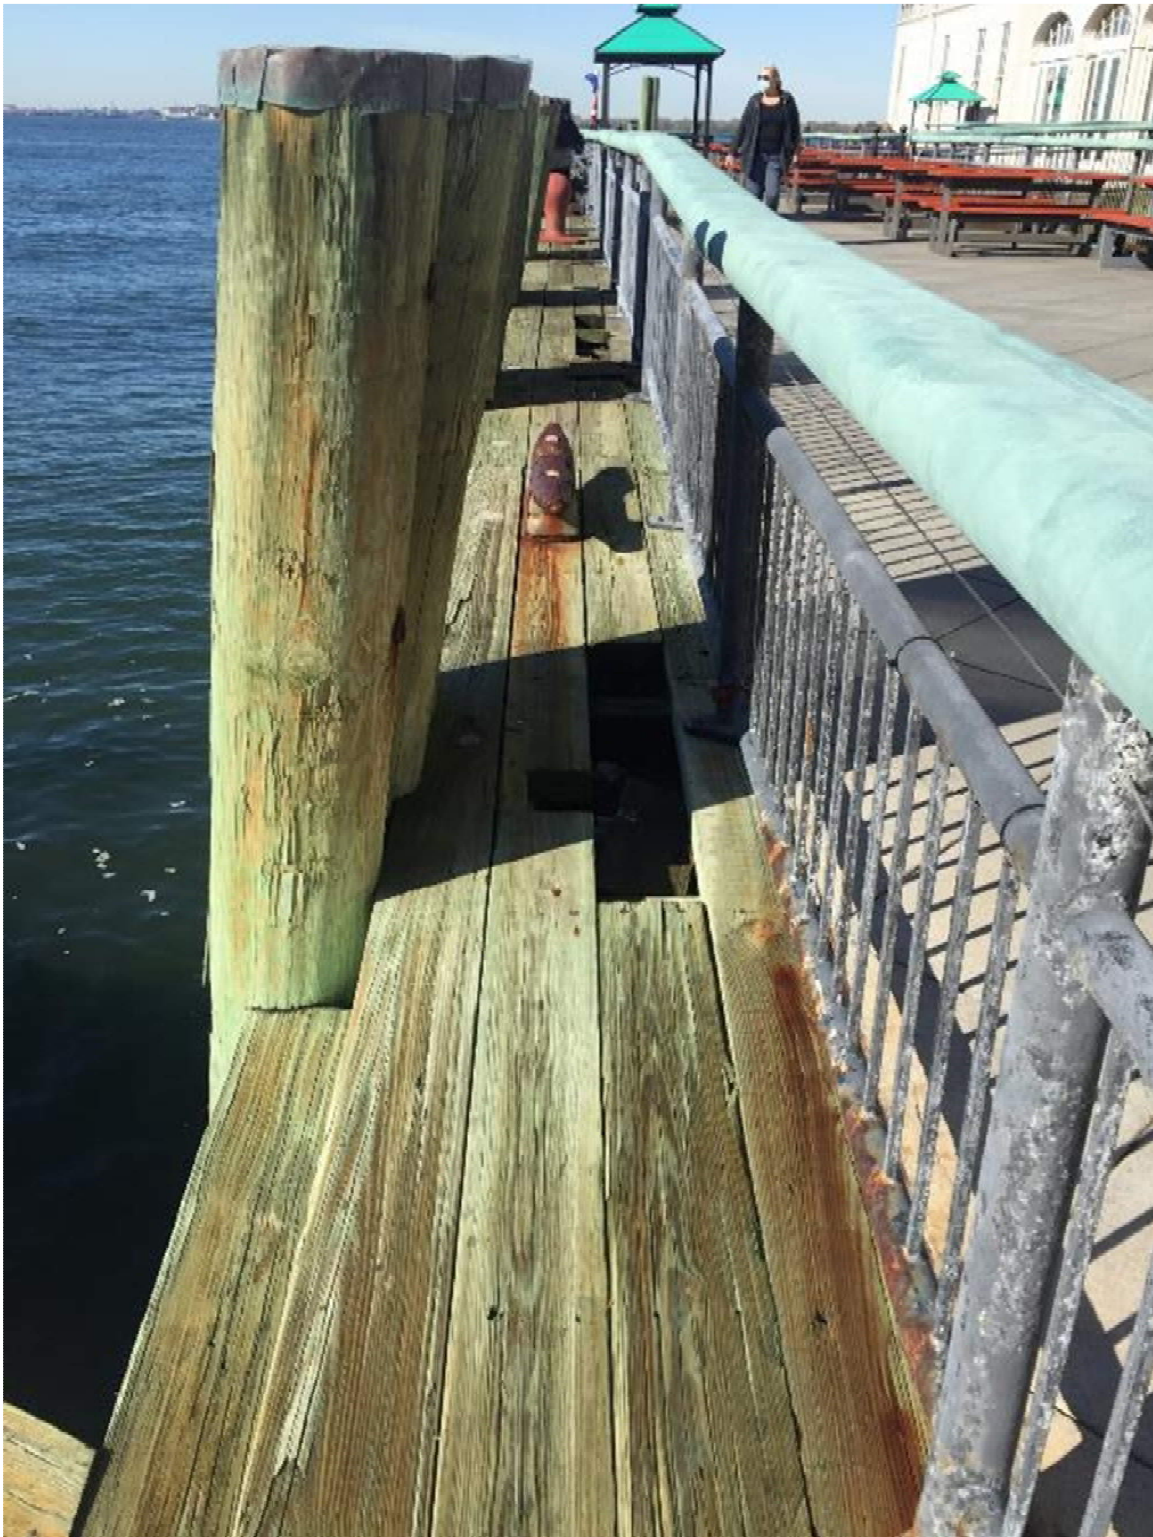
Photograph 55. Top Side Openings in Pier-A South Apron

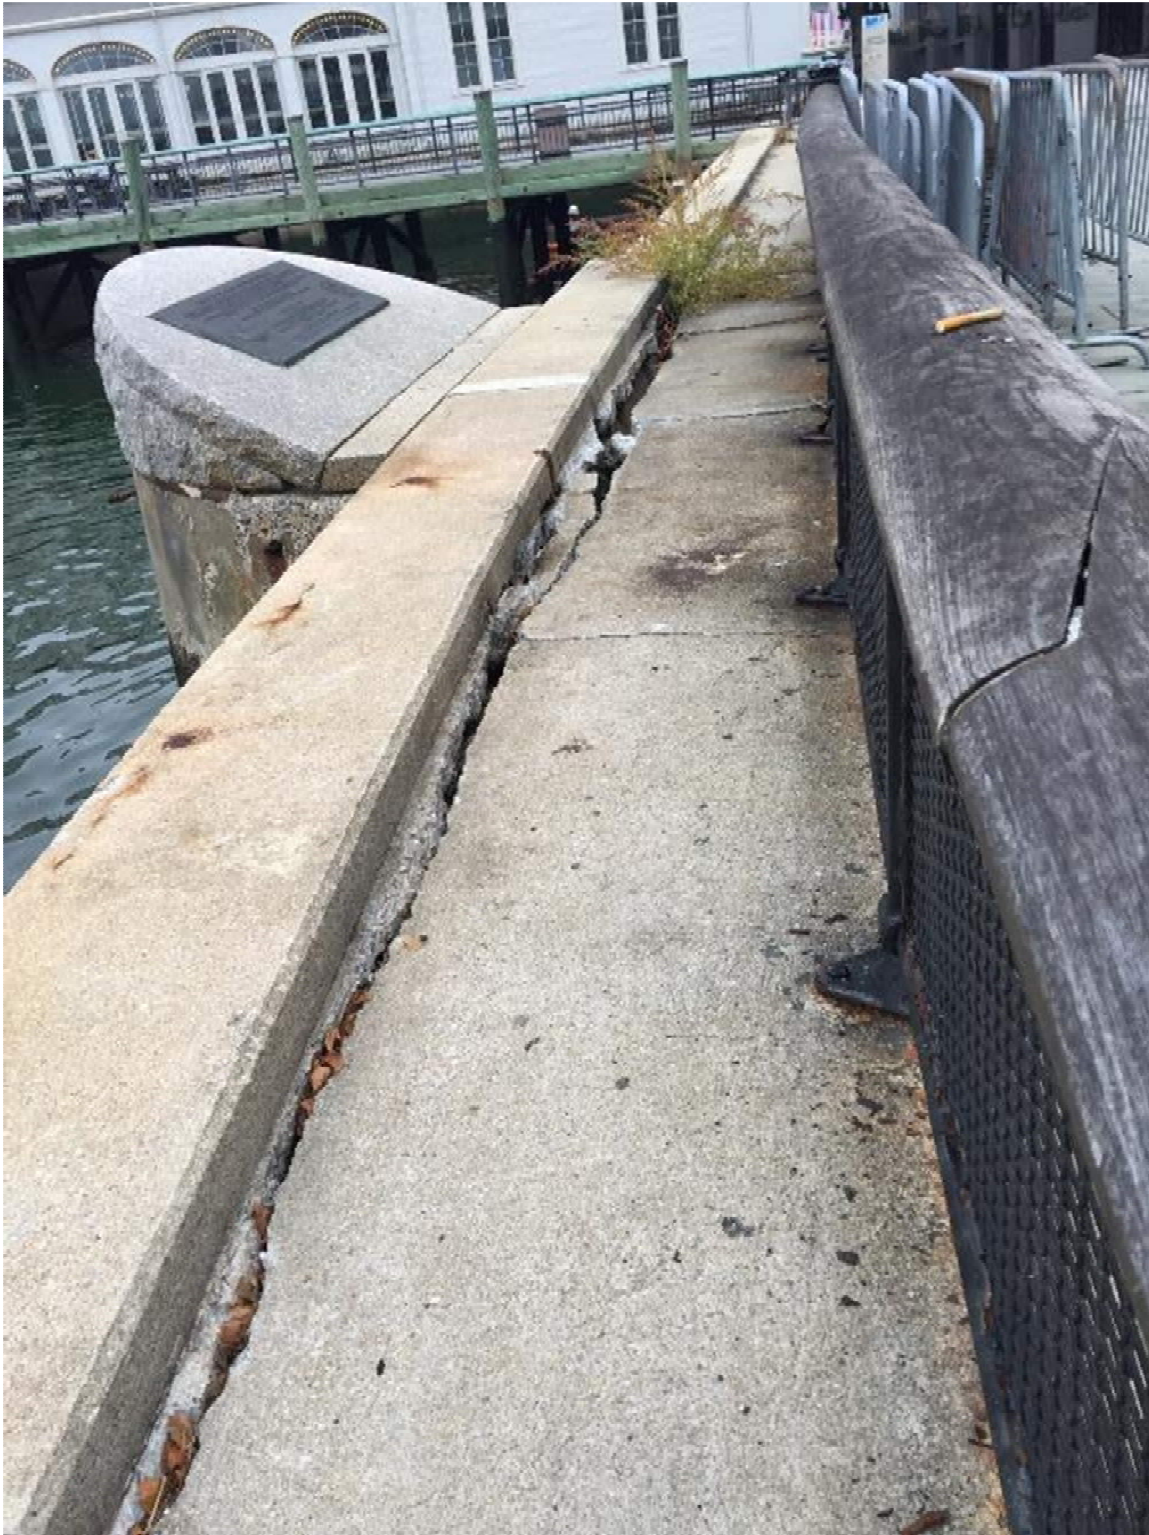
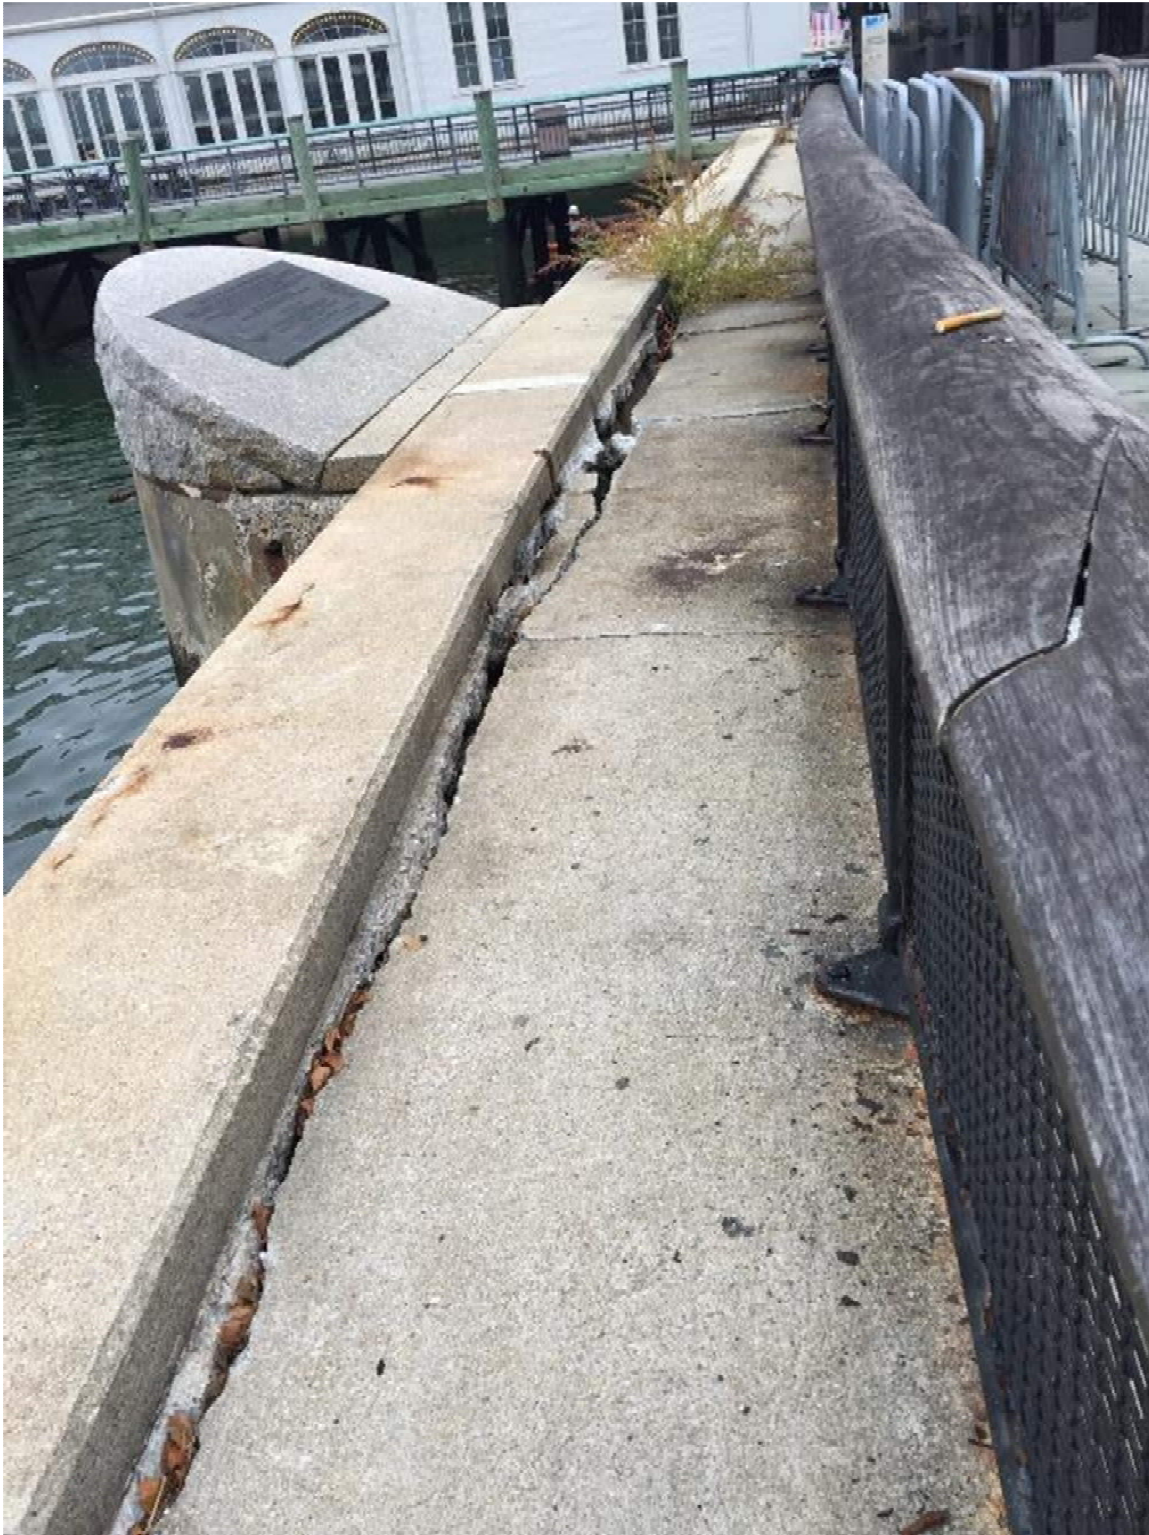
Photograph 66. Seawall concrete cap displacement outside of project limit

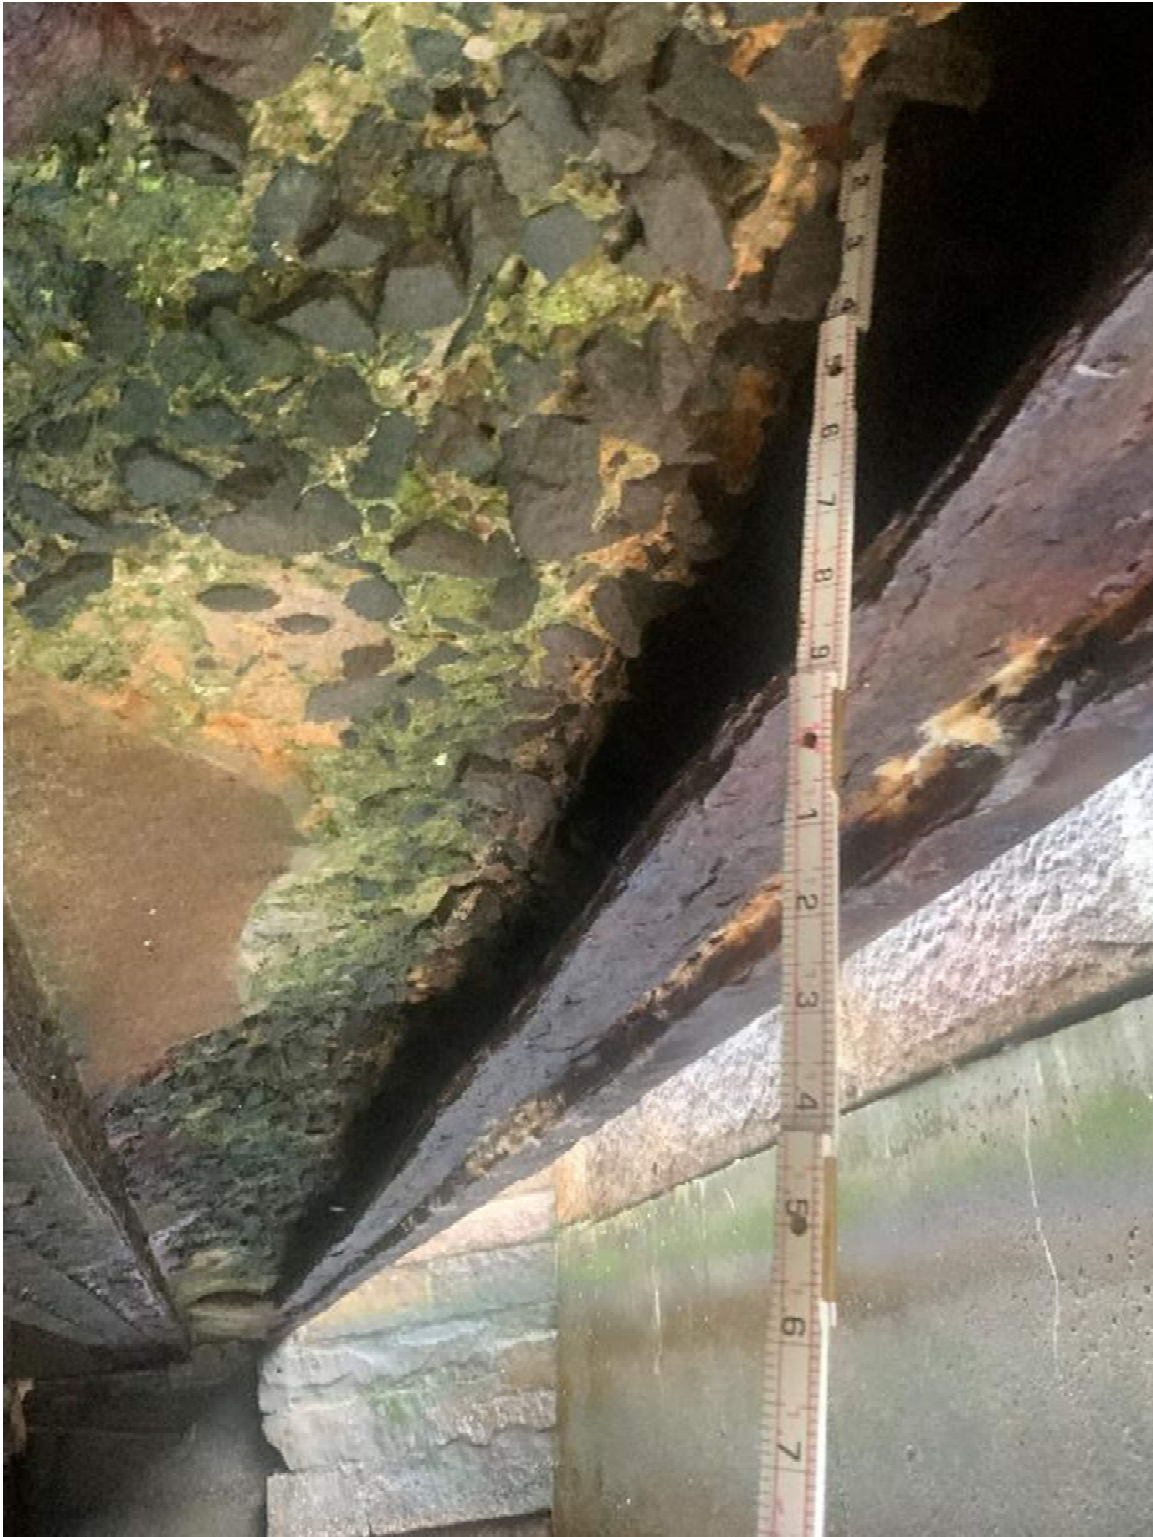
**Photograph 67. Span-1,#1, G6, Edge Beam Concrete Spalling**

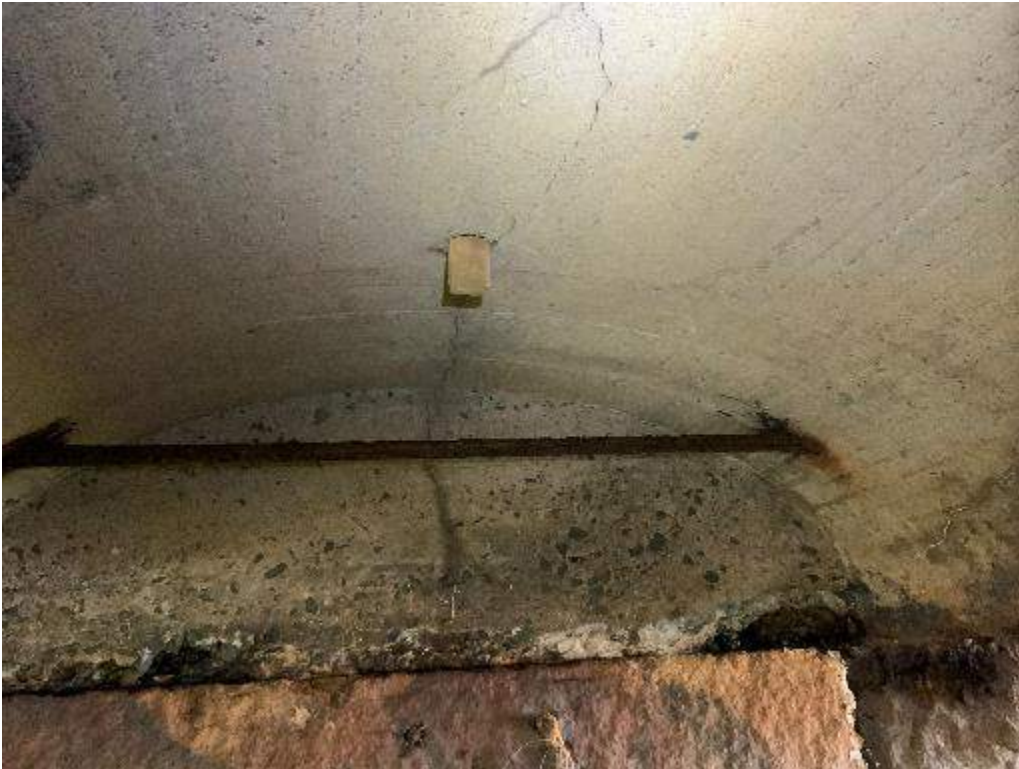
**Photograph 68. Span-1,#11, Arch Transverse wall Concrete Spalling on Pier-1@Bay(5)**

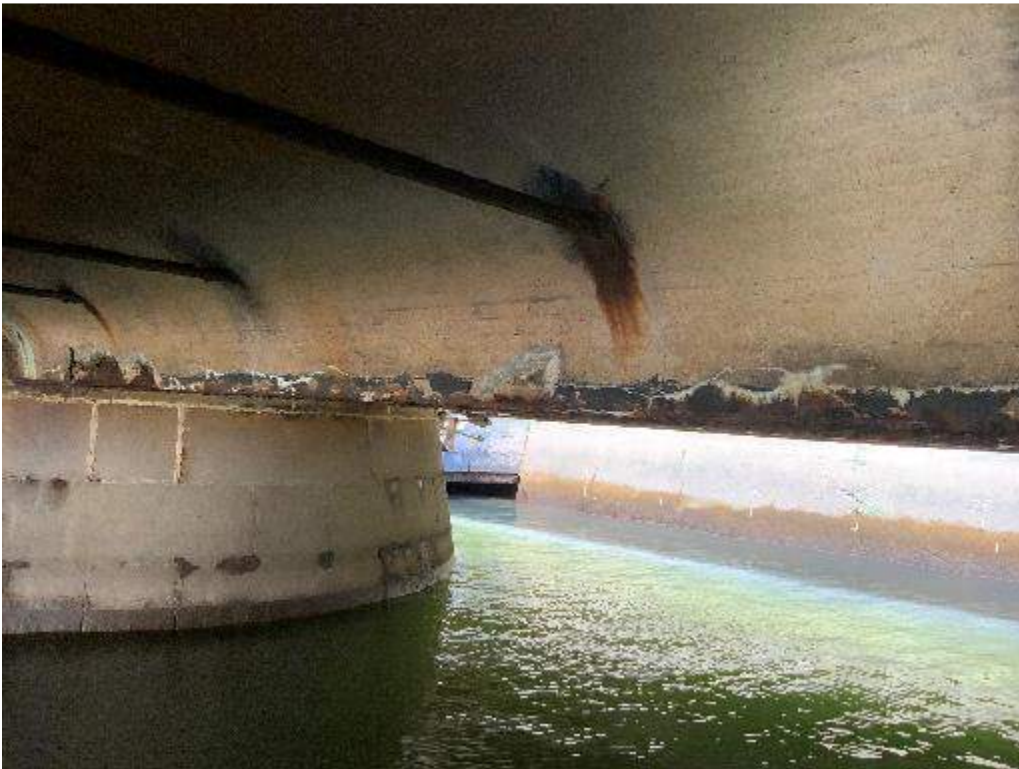
**Photograph 69. Span-1,#17, G3 Bottom of the Iron Flange Efflorescence**

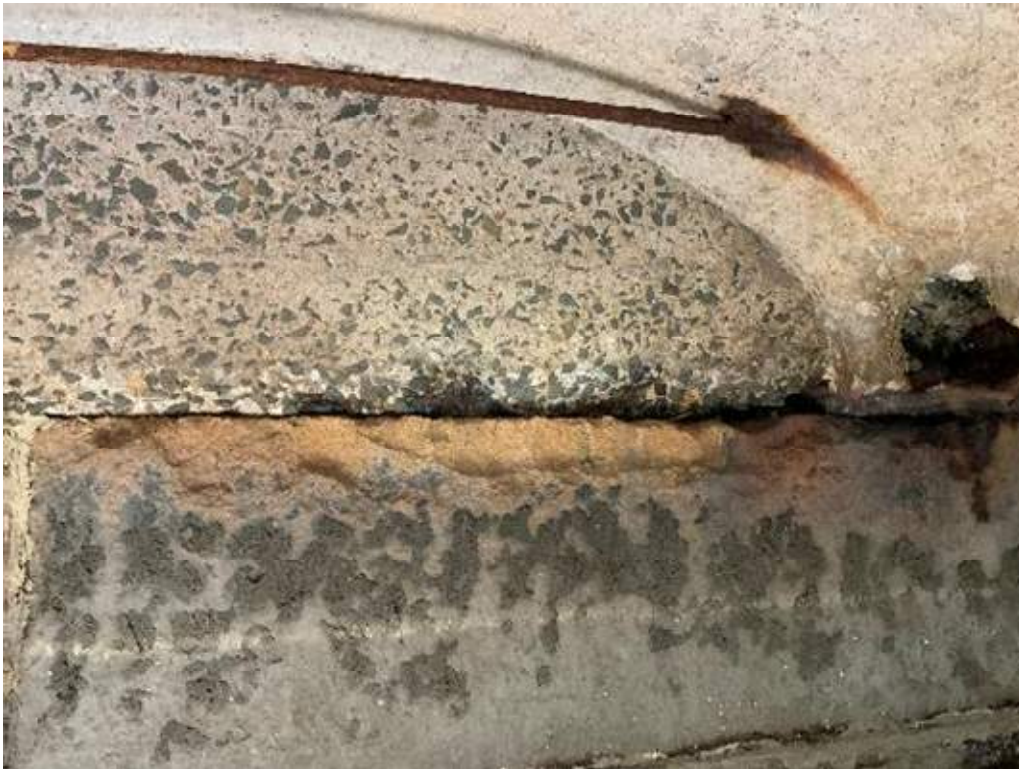
**Photograph 70. Span-1,#18, Concrete Spalling at Bay (2) on Pier-1**

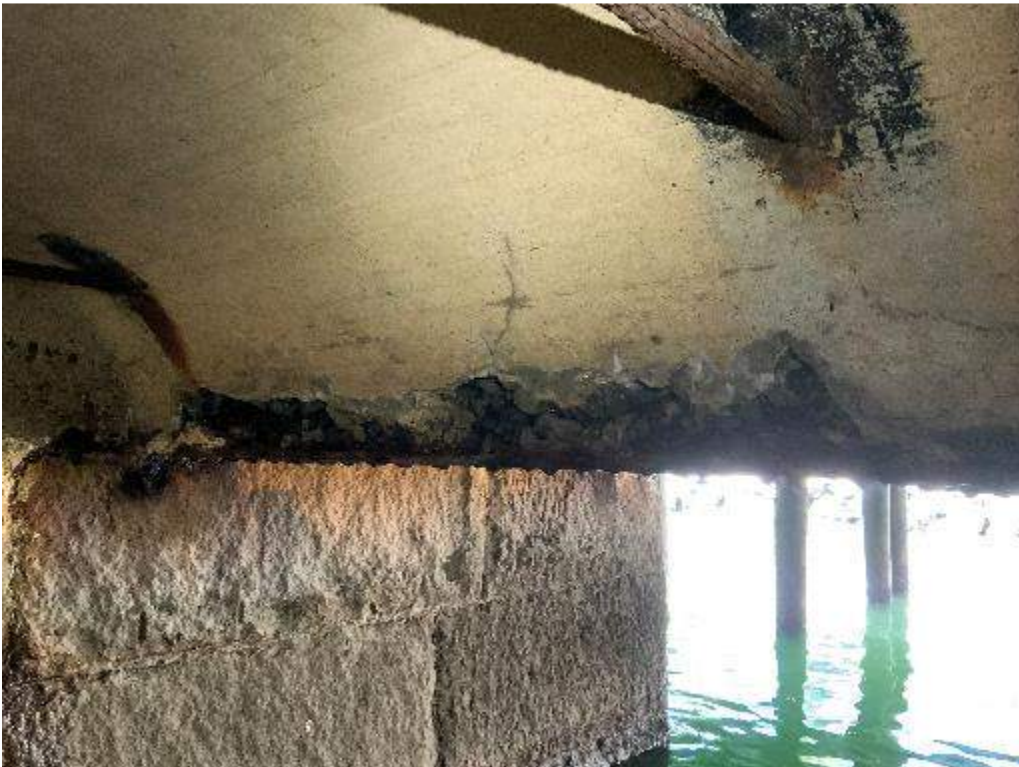
The bottom of iron girders are in poor condition, exhibiting advanced corrosion. The bottom flange rivets have 30% in section loss without bearing loss of rivet head. The web and top flange of the girders are covered by the concrete jack arches and were not inspected.

**Photograph 71. Span-1,#21, Deteriorated Iron Beam & adjacent Concrete Spalling @ G2**

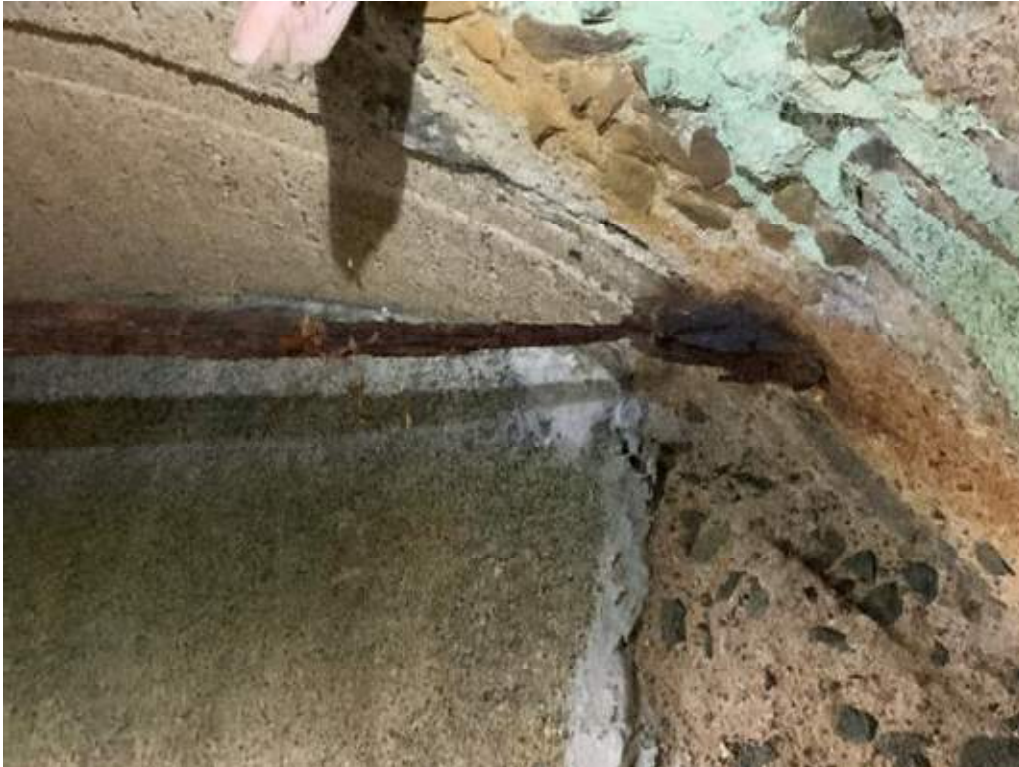
**Photograph 72. Span-1,#23, Deteriorated Tie Rod**

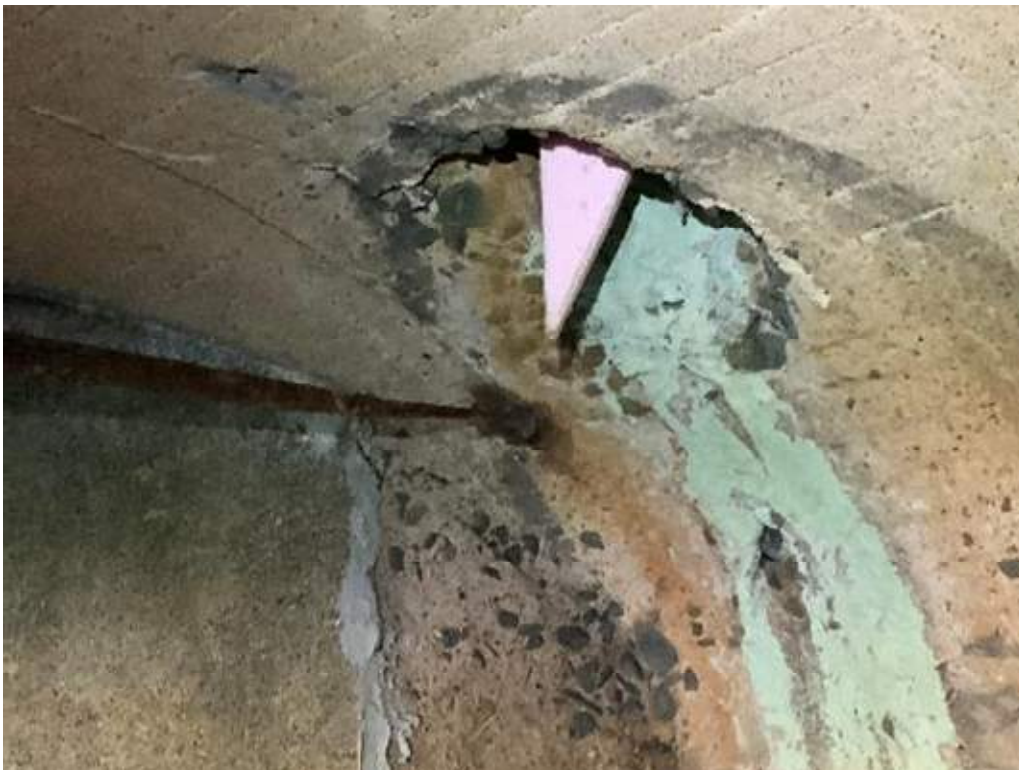
**Photograph 73. Span-1,#24, Arch concrete partially opening**

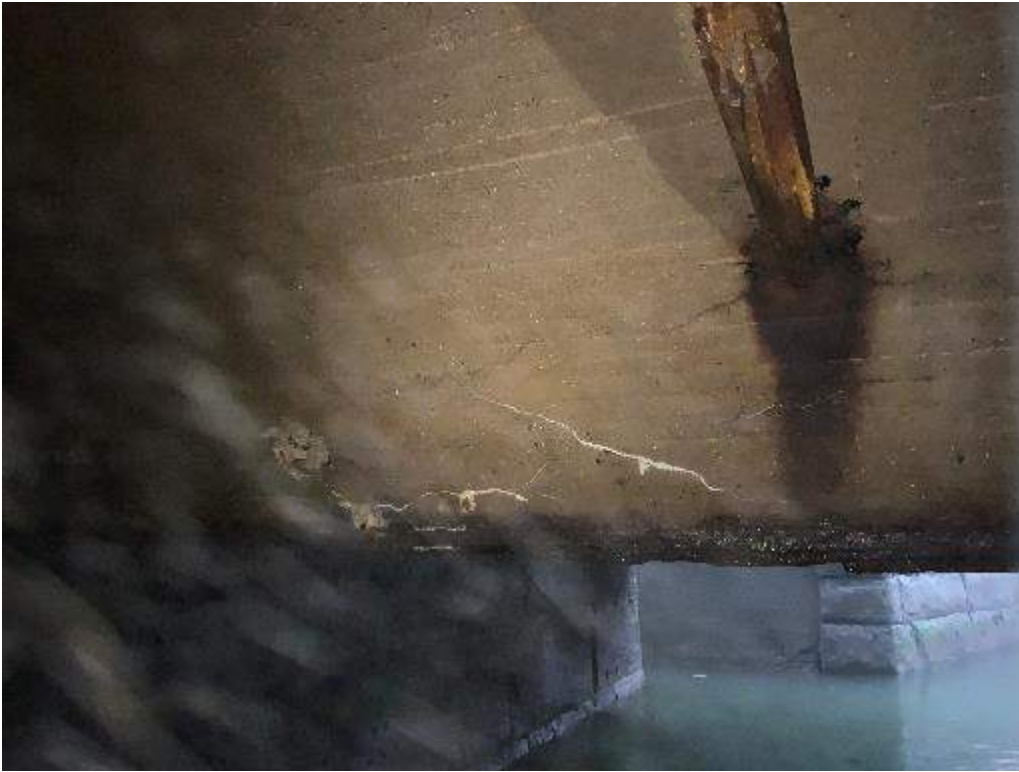
**Photograph 74. Span-3,#10, Concrete Cracking along the Iron Beam Bottom @ G5 Bay (5)**

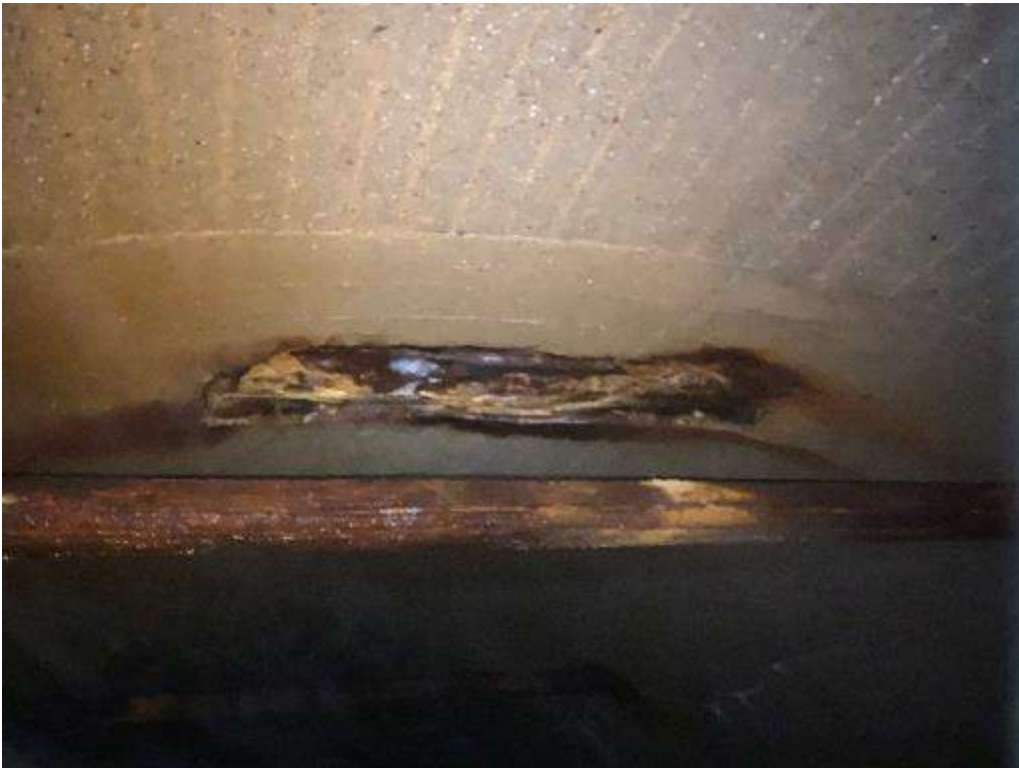
**Photograph 75. Span-3,#19, Exposing Deteriorated reinforcement from Concrete arch**

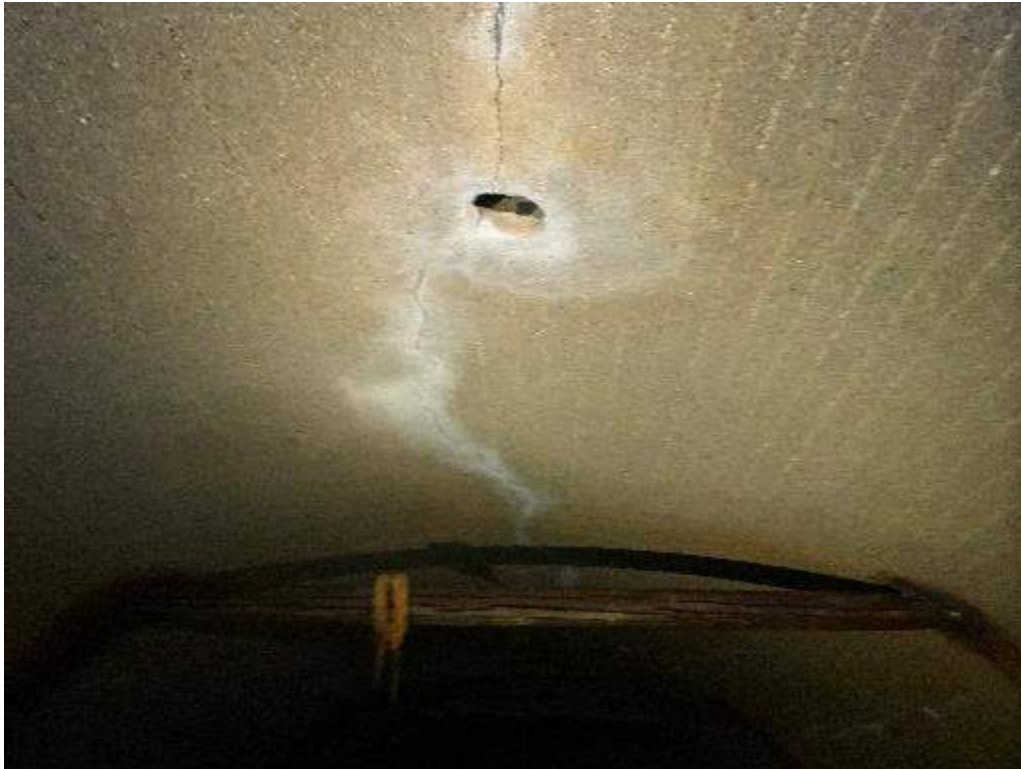
**Photograph 76. Span-3,#28, Longitudinal Crack line at Bay (2)**

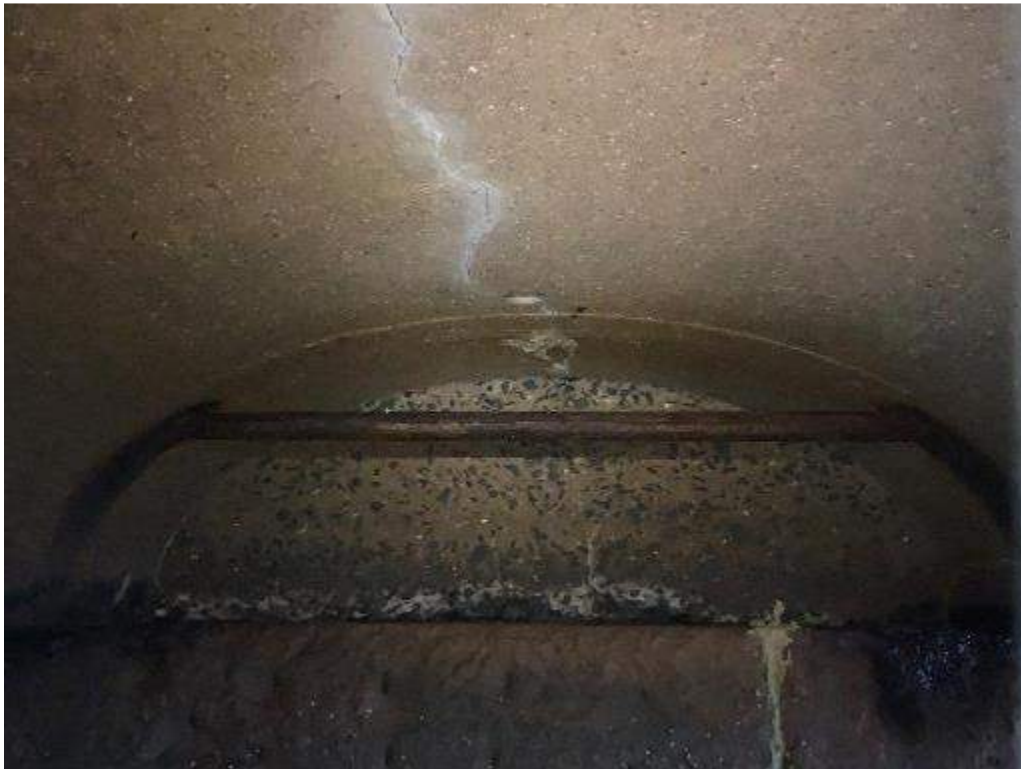
**Photograph 77. Span-4,#9, Longitudinal Crack line at Bay (4)**

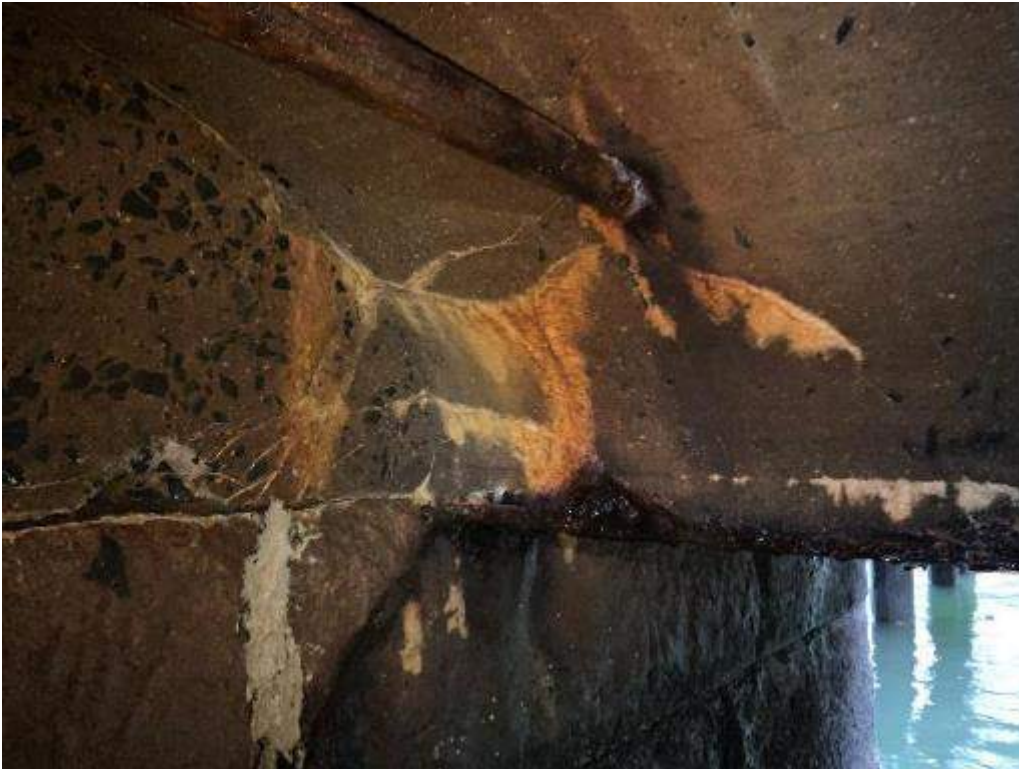
**Photograph 78. Span-4, Concrete Cracks & Iron Beam Bottom flange Deterioration**

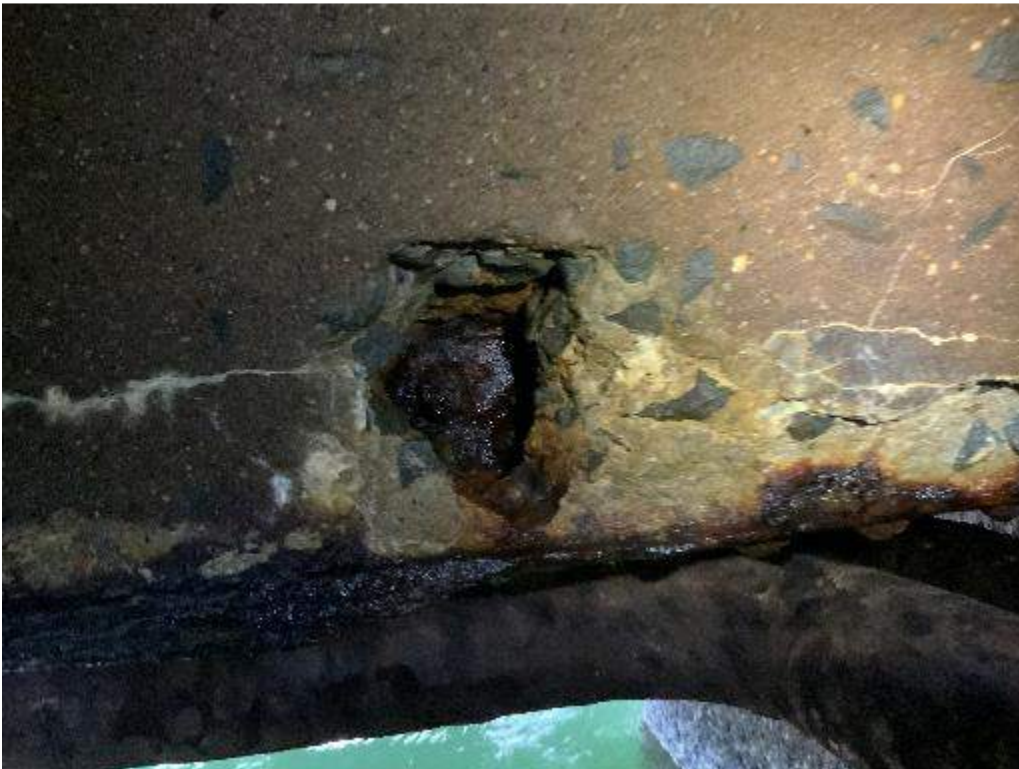
**Photograph 79. Span-6, #27 Concrete Spalling from Iron Beam Web (G2) and Deterioration**

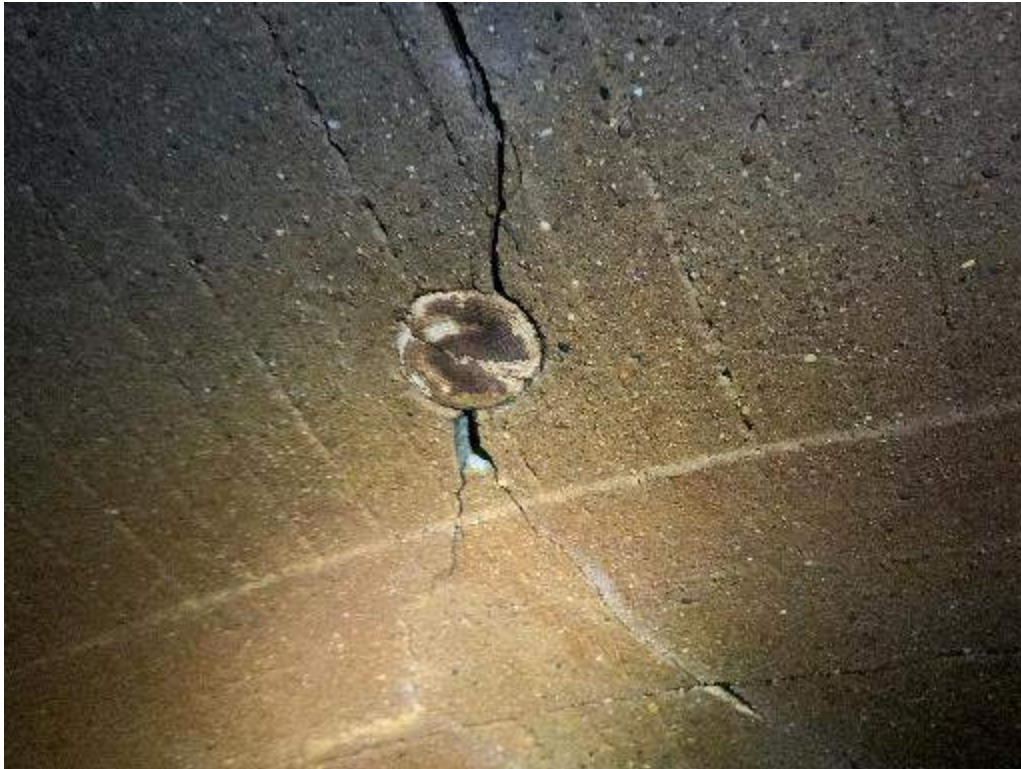
**Photograph 80. Span-6, #10 Repaired Wooden Plug of Hole, expanded cracks surrounded**

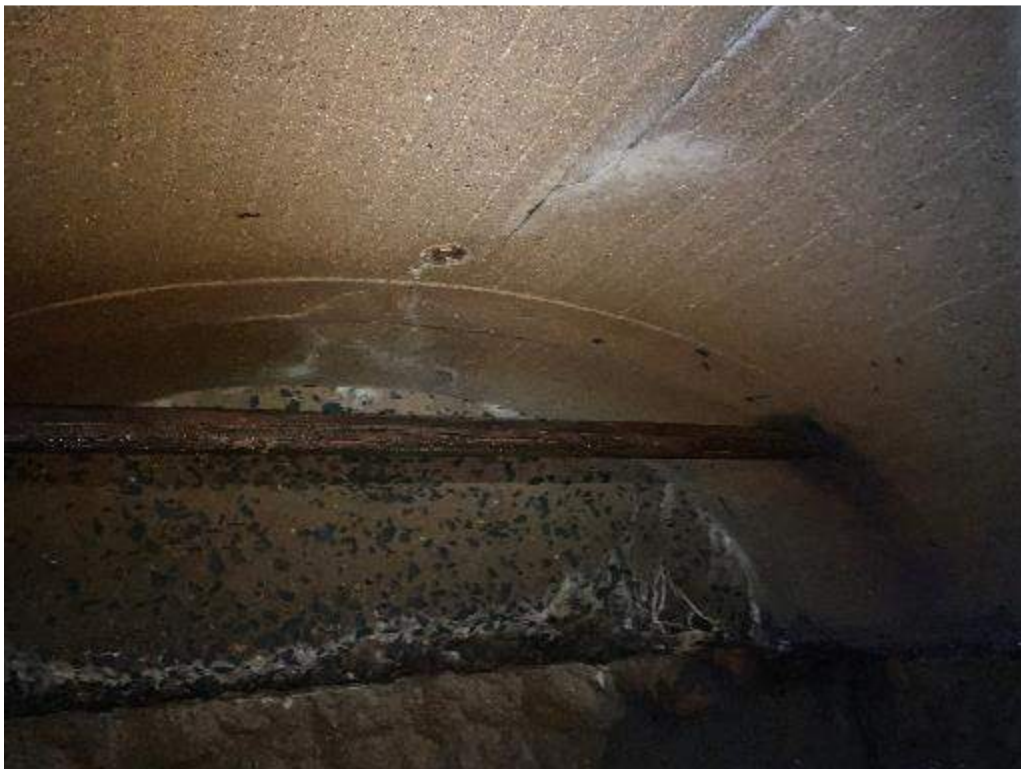
**Photograph 81. Span-6, #30 Longitudinal Crack line at Bay (5)**

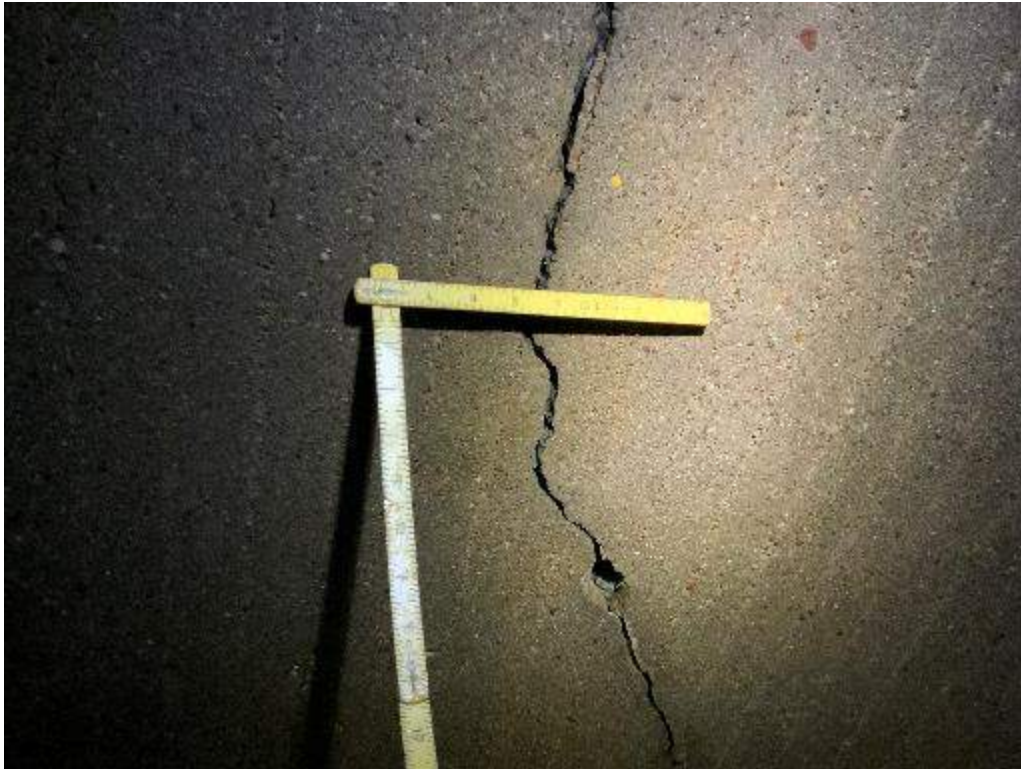
Photograph 82. Span-6, #9 \_ Arch Crown Crack width 4/16" in 10/22/2020 at Bay (4)

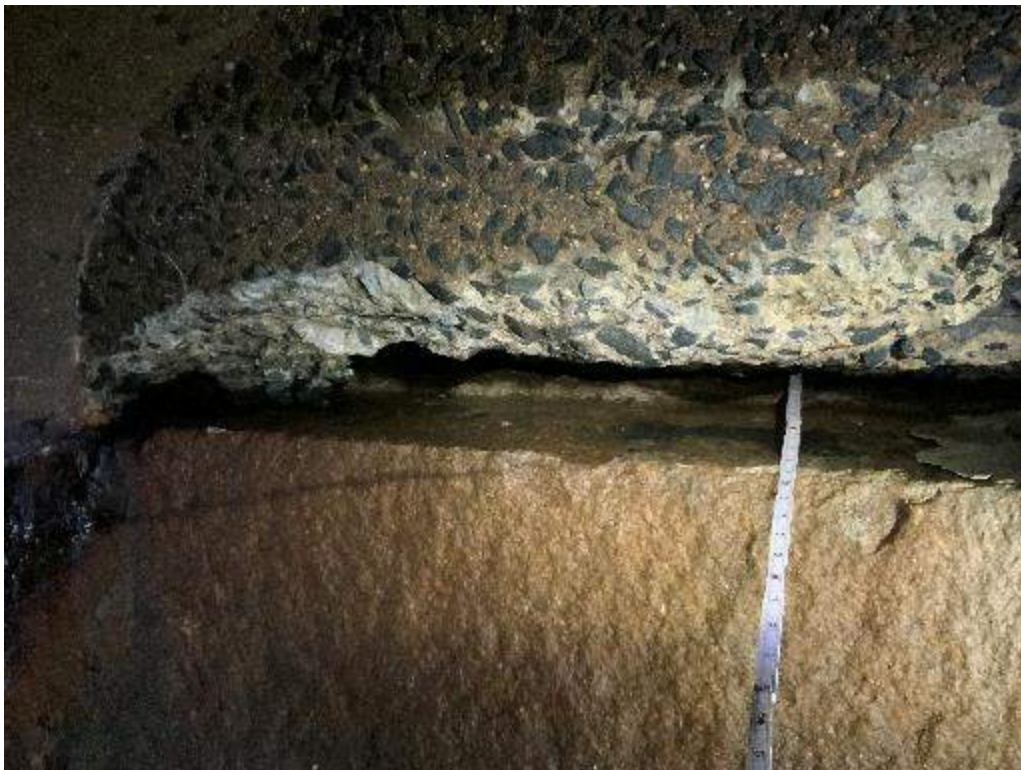
Photograph 83. Span-7, #2 \_ End Diaphragm Wall Bearing loss Pier-6 at Bay (4)
