**Project: Pier A Structural Repairs Project – Phase II  
General Contractor Services –  
Request for Proposals (“RFP”)**

**Addendum #4  
# of Pages: 112**

## **Pier A Underwater Inspection for Phase 2 to 5 Supportive Maintenances**

**PIER A & ADJACENT BULKHEAD,  
BREAKWATER AND LOW-LEVEL  
PLATFORMS  
ROUTINE CONDITION INSPECTION**

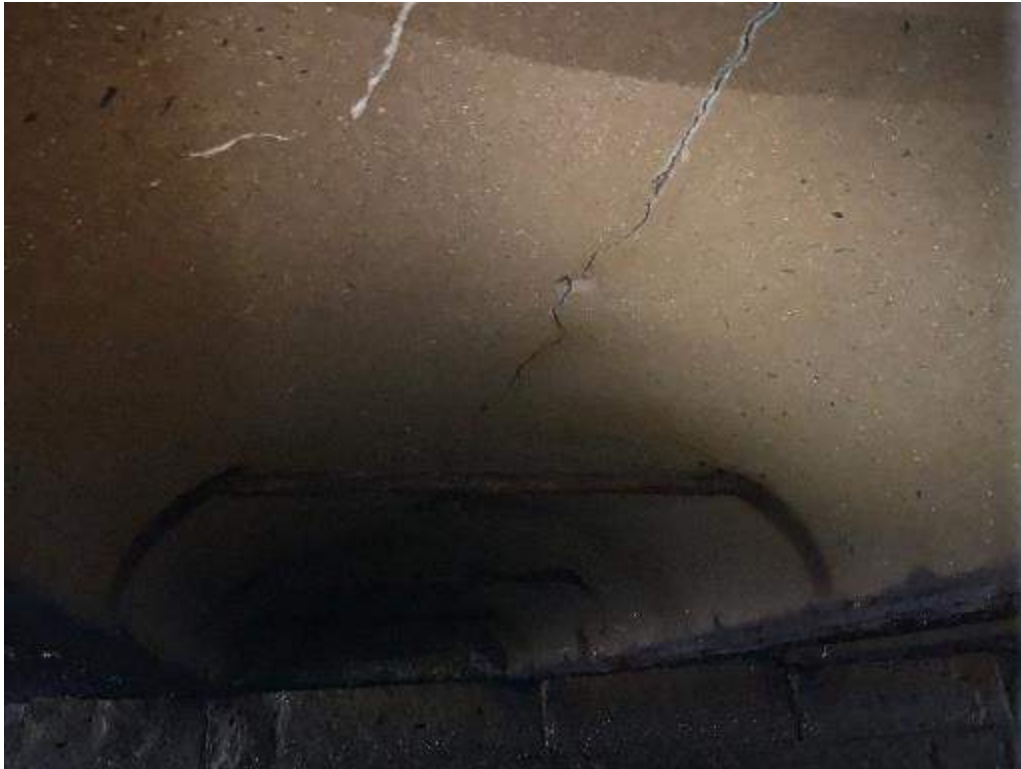
Photograph 84. Span-7, #11 \_ Arch Crown Longitudinal Crack at Bay (4)
