**Appendix F.3c**  
**Hazardous Materials Investigation and Findings**  
**Reports**  
**(February 2022)**

LIMITED HAZARDOUS MATERIALS INVESTIGATION REPORT  
NORTH/WEST BATTERY PARK CITY RESILIENCY PROJECT  
NEW YORK, NEW YORK

Matrix New World Engineering, Land Surveying,  
and Landscape Architecture, P.C.  
26 Columbia Turnpike  
Florham Park, New Jersey 07932

February 23, 2022

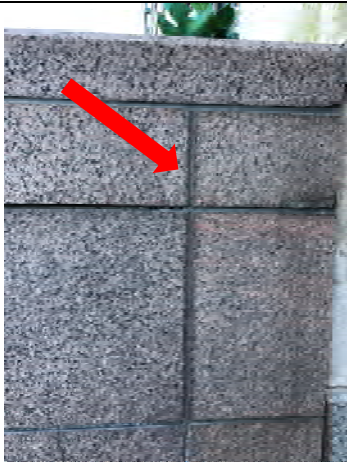
**MATERIAL:** Building Retention Wall Mortar

**SAMPLE ID:** HA-01

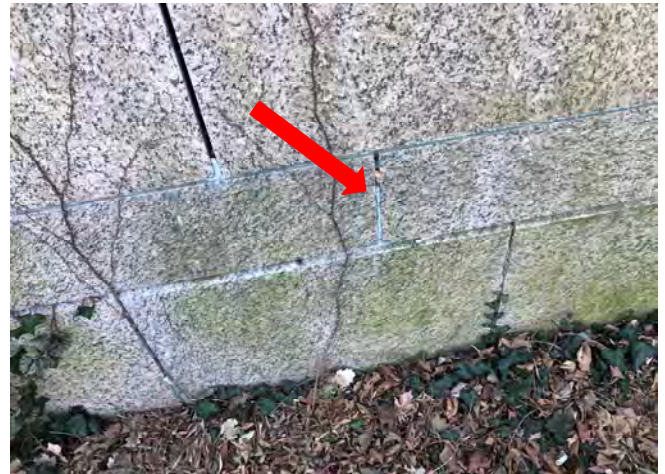
**PHOTO 2**

**LOCATION:** South Cove Park North of Museum of Jewish Heritage

**MATERIAL:** Building Retention Wall Caulk

**SAMPLE ID:** HA-02

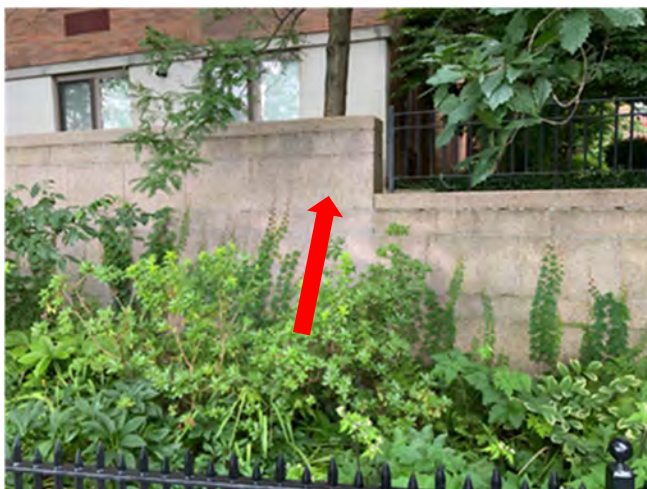
**PHOTO 3**

**LOCATION:** South Cove Park Between 2<sup>nd</sup> and 3<sup>rd</sup>

**MATERIAL:** Retention Wall Mortar

**SAMPLE ID:** HA-04

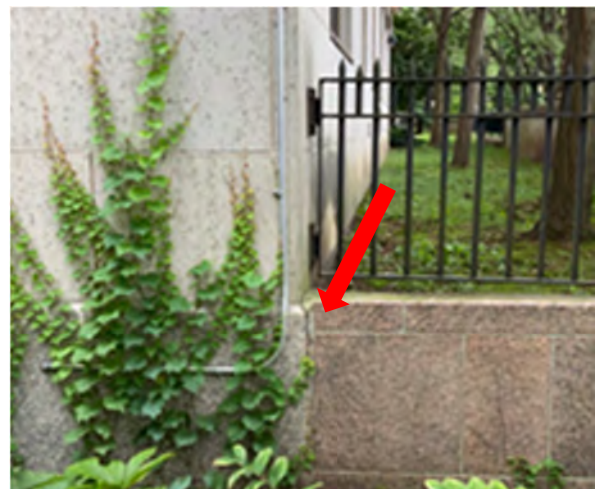
**PHOTO 4**

**LOCATION:** South Cove Park Between 2<sup>nd</sup> and 3<sup>rd</sup>

**MATERIAL:** Building/Retention Wall Joint

**SAMPLE ID:** HA-05

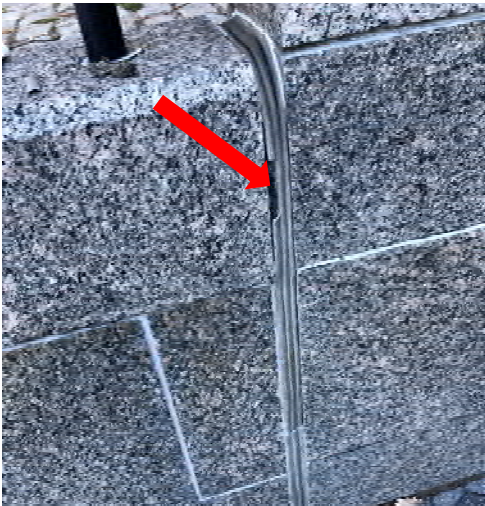
**MATERIAL:** Fibrous Expansion Joint

**SAMPLE ID:** HA-06

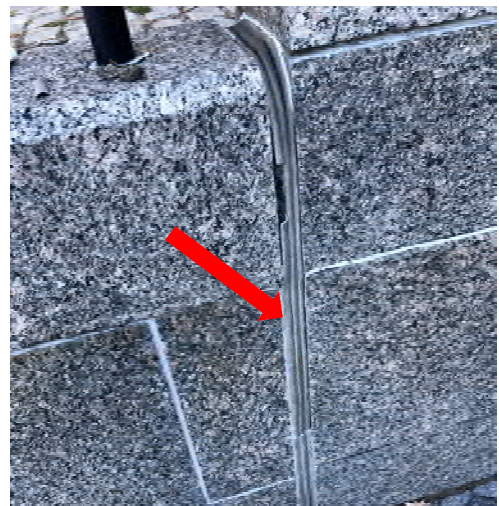
**PHOTO 6**

**LOCATION:** South Cove Park Between 2<sup>nd</sup> and 3<sup>rd</sup>

**MATERIAL:** Caulk to Retention Wall

**SAMPLE ID:** HA-07

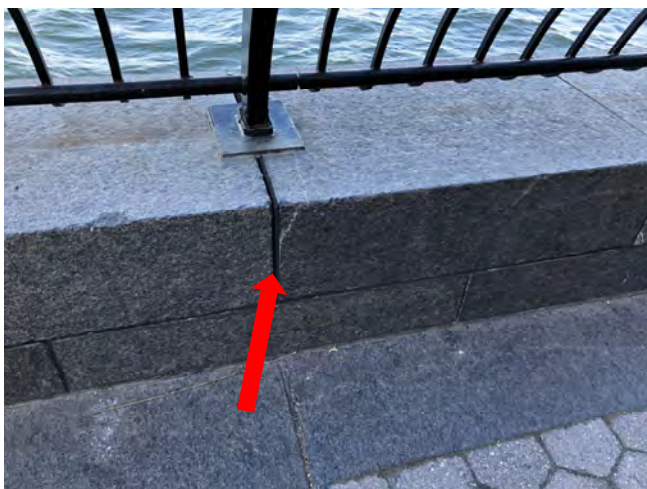
**PHOTO 7**

**LOCATION:** South Cove Park Lower Wall by 3<sup>rd</sup> PI

**MATERIAL:** Caulk to Lower Retention Wall

**SAMPLE ID:** HA-08

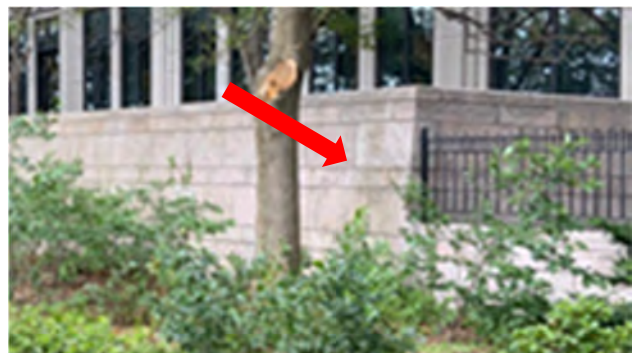
**PHOTO 8**

**LOCATION:** South Cove Park Esplanade Plaza  
Adjacent to Thames Street

**MATERIAL:** Retention Wall Caulk

**SAMPLE ID:** HA-09

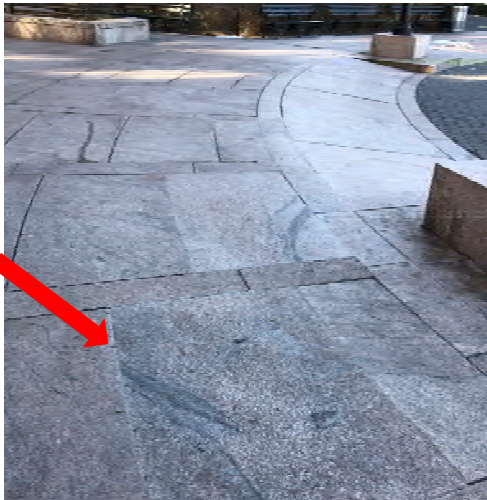
**MATERIAL:** Caulk to Plaza

**SAMPLE ID:** HA-10

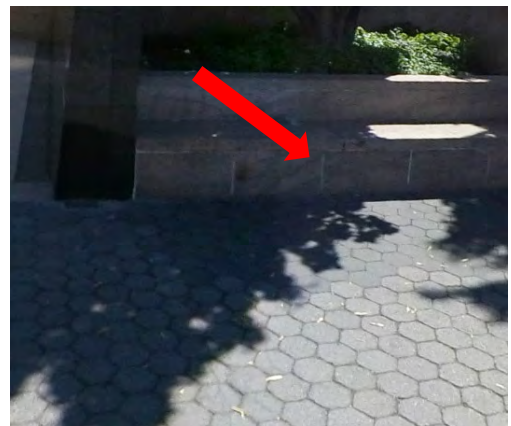
**PHOTO 10**

**LOCATION:** South Cove Park Esplanade Plaza  
South of Marina

**MATERIAL:** Retention Wall Caulk

**SAMPLE ID:** HA-12

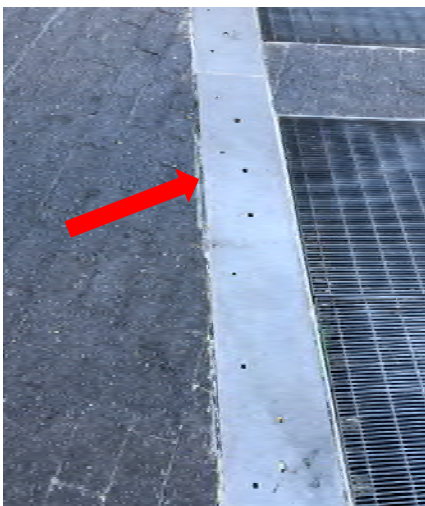
**PHOTO 11**

| Matrix Sample No. | Material Description | Lab ID No. | PCB Concentration by Weight (mg/Kg) |
|---|---|---|---|
| PCB-HA-13 | Caulk to Outfall Frame - Outfall #NCM-832 | 012200767-0006 | <0.89 mg/Kg |

**LOCATION:** Outfall #NCM-832

**MATERIAL:** Caulk to Outfall Frame

**SAMPLE ID:** HA-13

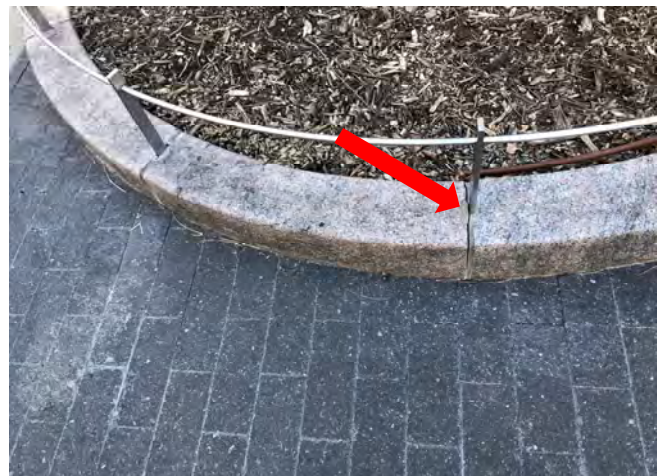
**PHOTO 12**

**LOCATION:** By Outfall #NCM-832 and Liberty  
Street

**MATERIAL:** Mortar to Planter

**SAMPLE ID:** HA-14

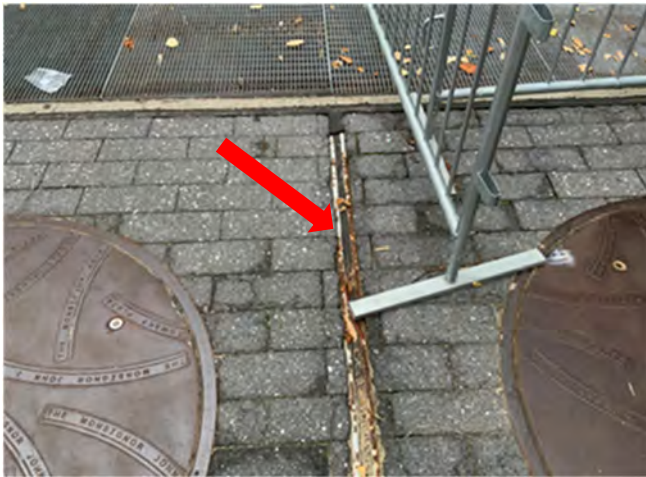
**MATERIAL:** Expansion Joint to Outfall Frame

**SAMPLE ID:** HA-15

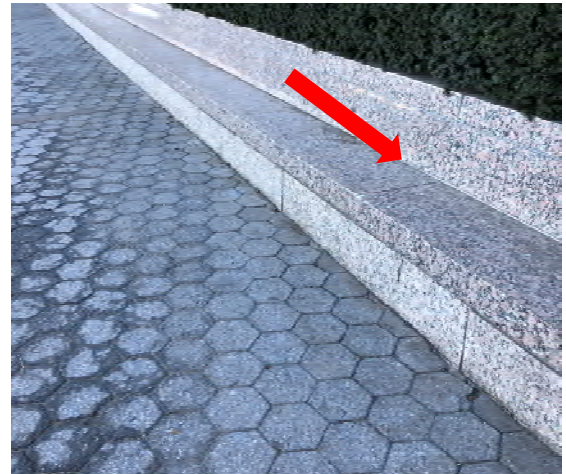
**PHOTO 14**

**LOCATION:** Battery Park Esplanade Adjacent to Liberty Street

**MATERIAL:** Caulk to Bench

**SAMPLE ID:** HA-17

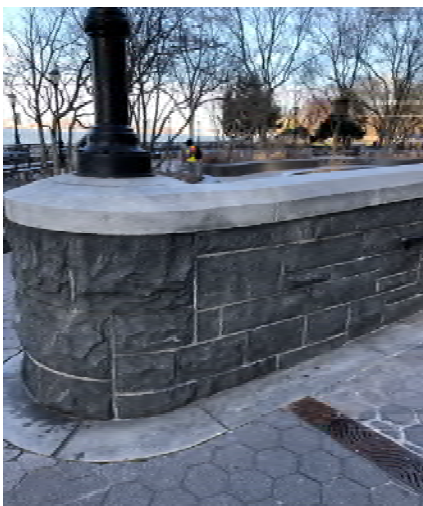
**PHOTO 15**

**LOCATION:** Rockefeller Park

**MATERIAL:** Mortar to Stone Wall

**SAMPLE ID:** HA-18

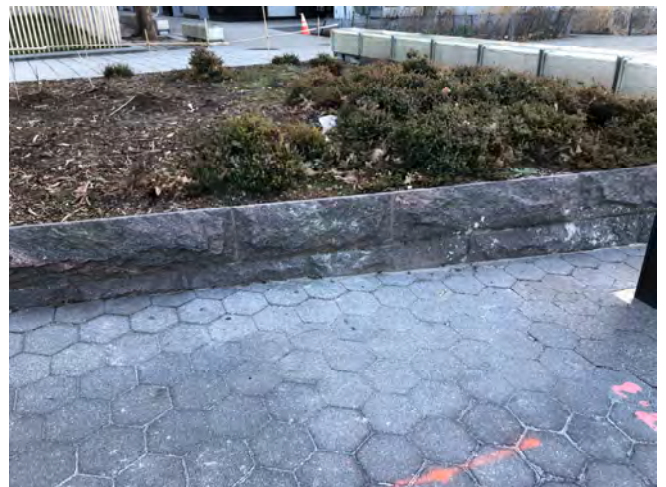
**PHOTO 16**

**LOCATION:** Rockefeller Park Along River Terrace

**MATERIAL:** Mortar to Stone Wall Short Wall

**SAMPLE ID:** HA-19

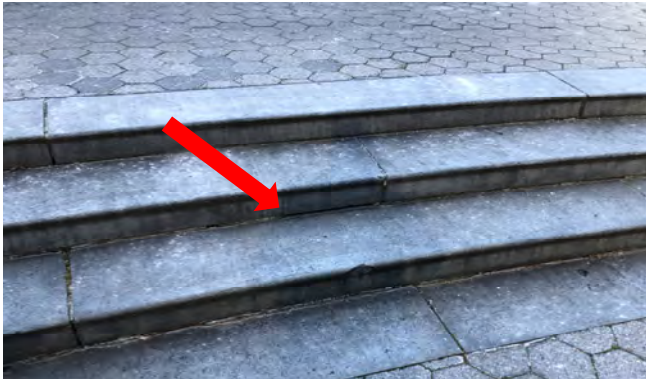
**MATERIAL: Caulk to Stairs**

**SAMPLE ID: HA-20**

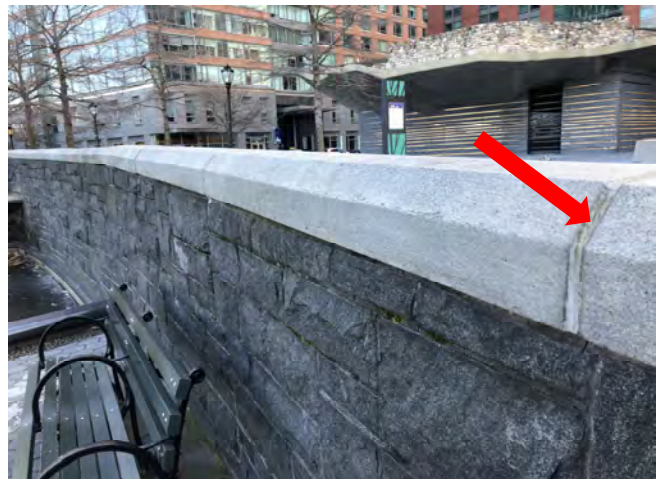
**PHOTO 18**

**LOCATION: Rockefeller Park Adjacent to Murray Street**

**MATERIAL: Coping Stone Seam Caulk to Wall**

**SAMPLE ID: HA-21**

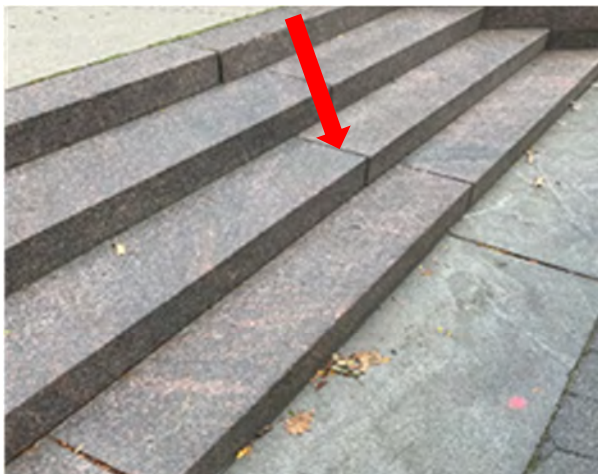
**PHOTO 19**

**LOCATION: Rockefeller Park Adjacent to Vesey Street**

**MATERIAL: Mortar to Stairs**

**SAMPLE ID: HA-22**

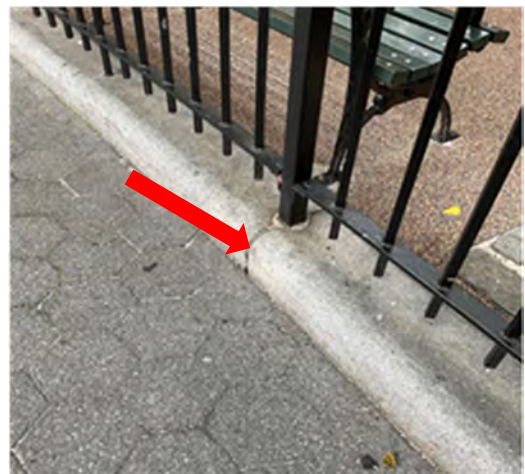
**PHOTO 20**

**LOCATION: Rockefeller Park Adjacent to Lilly Pond**

**MATERIAL: Mortar to Curb**

**SAMPLE ID: HA-23**

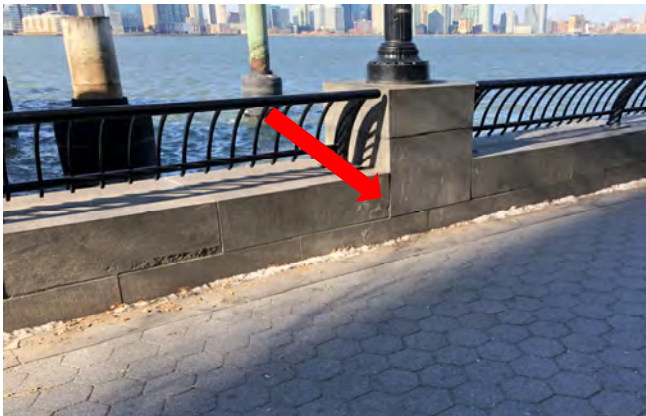
**MATERIAL: Caulk to Wall**

**SAMPLE ID: HA-24**
