MONTHLY INDEPENDENT COMMUNITY AIR MONITORING REPORT

AUGUST 2026

NORTH/WEST BATTERY PARK CITY
RESILIENCY PROJECT

NORTH/WEST BATTERY PARK CITY RESILIENCY PROJECT
INDEPENDENT ENVIRONMENTAL MONITORING MONTHLY REPORT NO. 5

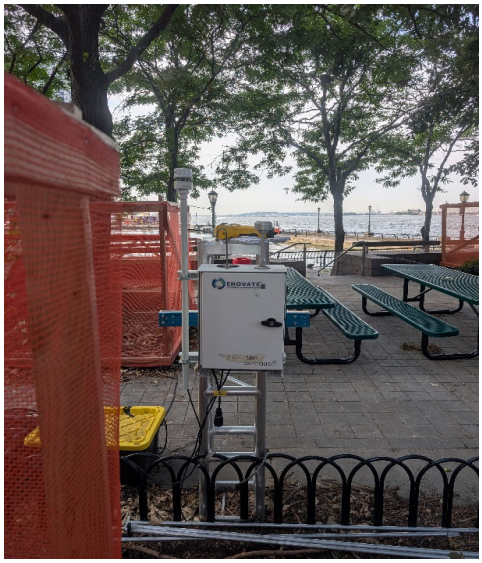
Photo No.: 4

Description: AM unit at the perimeter of the Reach 5 work area.

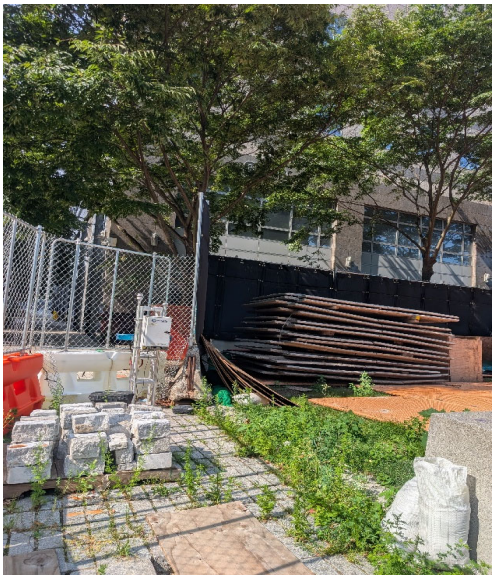
Photo No.: 5

0954-1003 hrs: Reach 4- Work had not started in this Reach at the time of the inspection. See Photo No. 5 that shows the work area, noise blankets on fencing, and an AM unit already installed but no work started or in progress. There was no visible dust observed and a maximum PM 10 dust reading of 23.9 ug/m^3, which is below any level of concern and consistent with background. There were no VOCs detected with the hand-held PID readings all zero ppm.

Description: View of AM unit located in Reach 4. No work was being conducted at the time of the inspection.

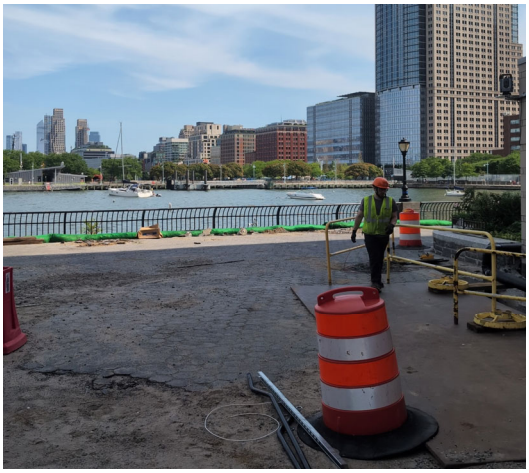
Photo No.: **10**

Description: View of worker preparing the work area adjacent to the school building in Reach 2.

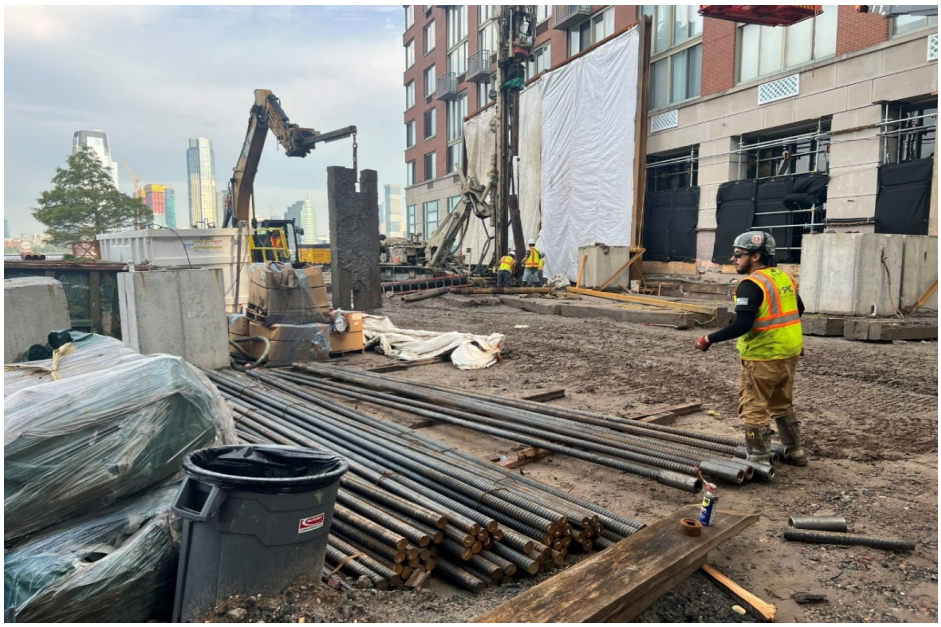
Photo No.:	1
Description:	View of drilling work being conducted at Reach 7. Noise blankets observed on the fencing.

Photo No.:	**2**
Description:	View of utility trench work being conducted at Reach 7. Noise blankets observed on the fencing.

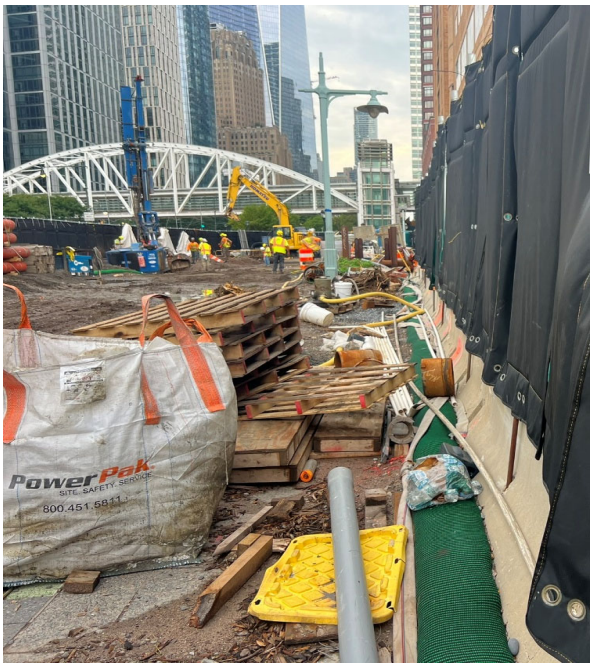
Photo No.: **8**

Description: View of work area at Reach 1. Noise blankets observed on the fencing surrounding the work area.
