**Project: Pier A Structural Repairs Project – Phase II  
General Contractor Services –  
Request for Proposals (“RFP”)**

**Addendum #4  
# of Pages: 112**

## **Pier A Underwater Inspection for Phase 2 to 5 Supportive Maintenances**

**PIER A & ADJACENT BULKHEAD,  
BREAKWATER AND LOW-LEVEL  
PLATFORMS  
ROUTINE CONDITION INSPECTION**

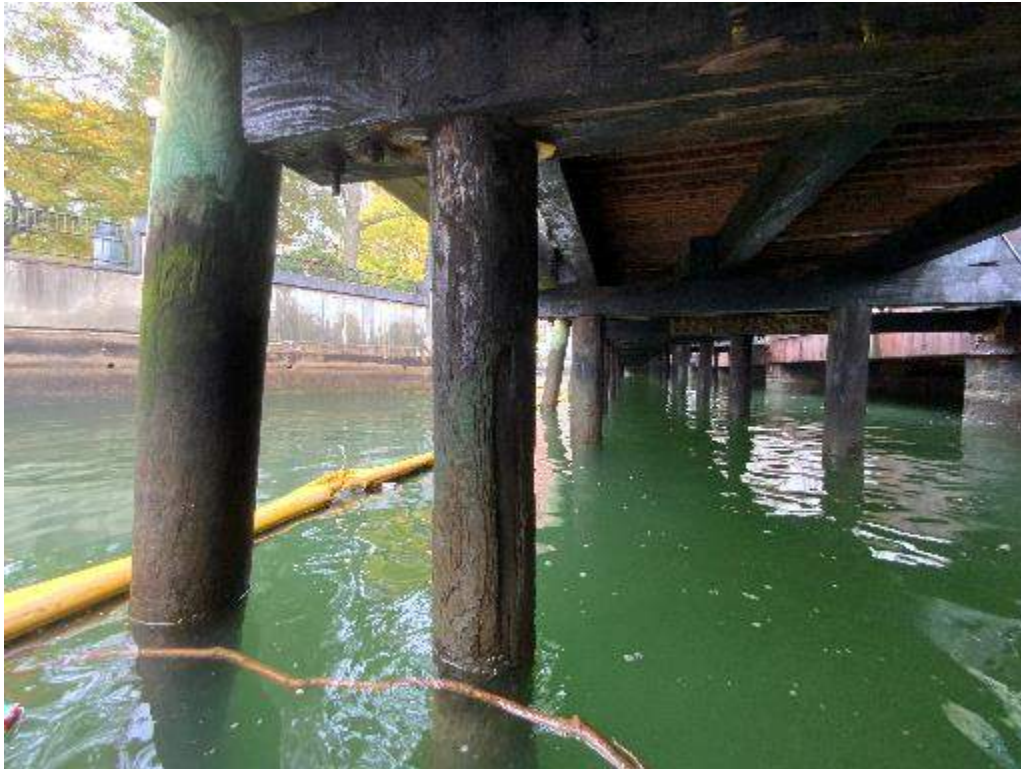
**Photograph 5. Pile peeling off at Grid - 17A**

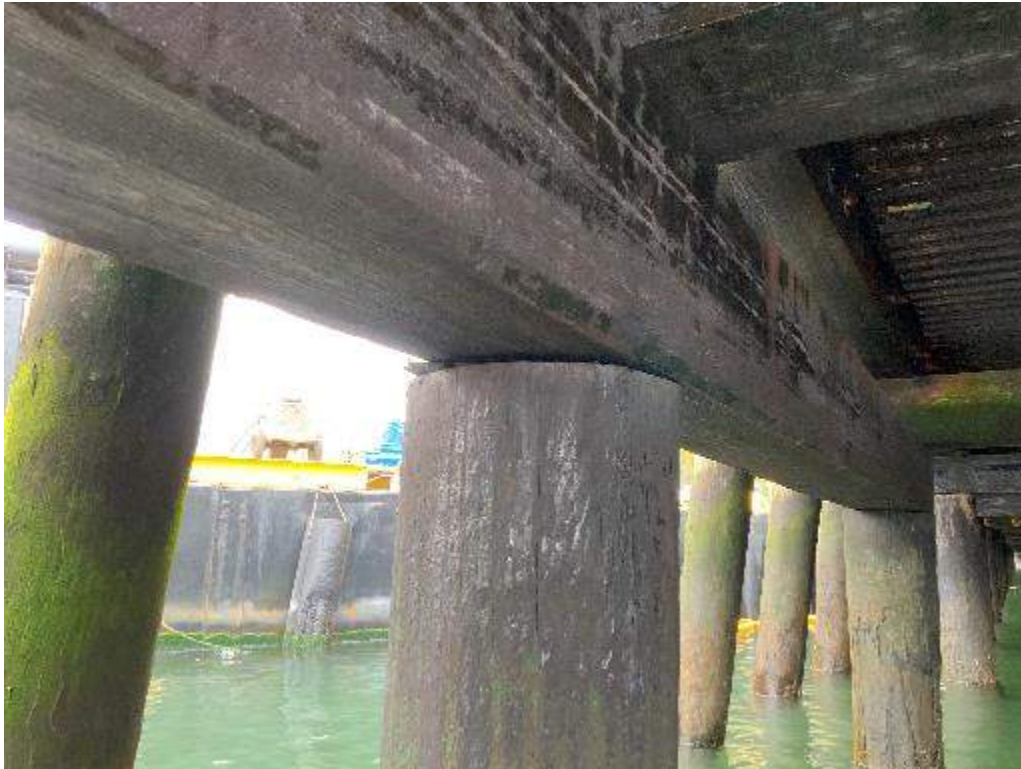
**Photograph 7. Pile Cap Bearing Loss at Grid - 8A**

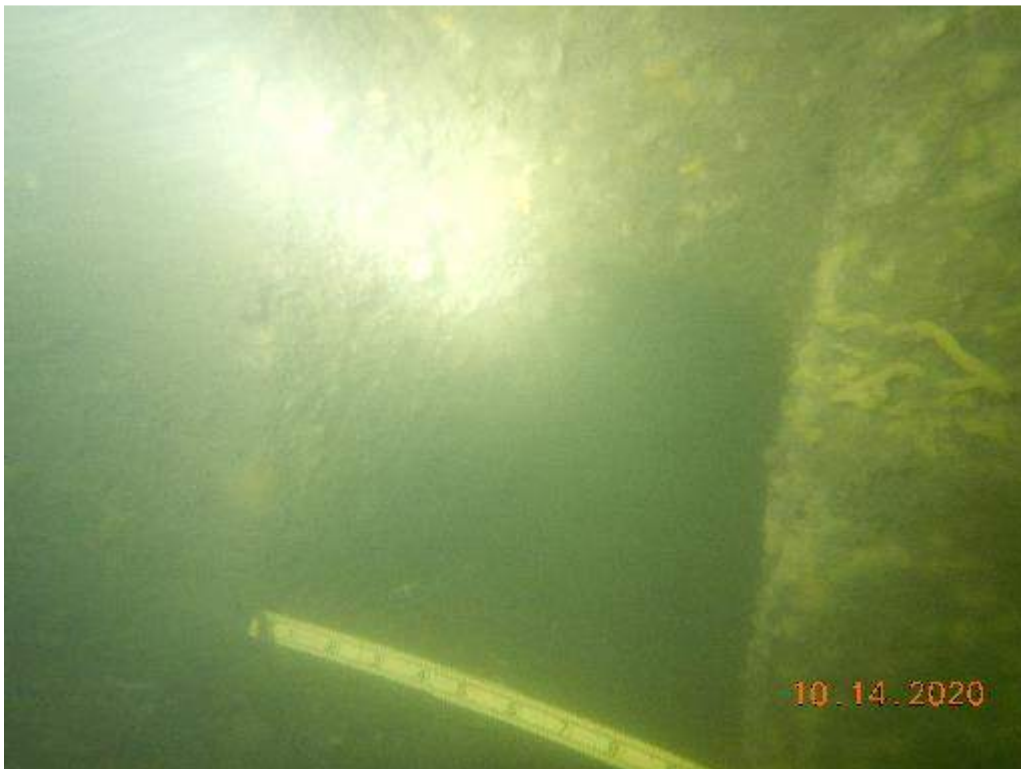
**Photograph 16. Pier-6 Open Cut on Pier Stem**

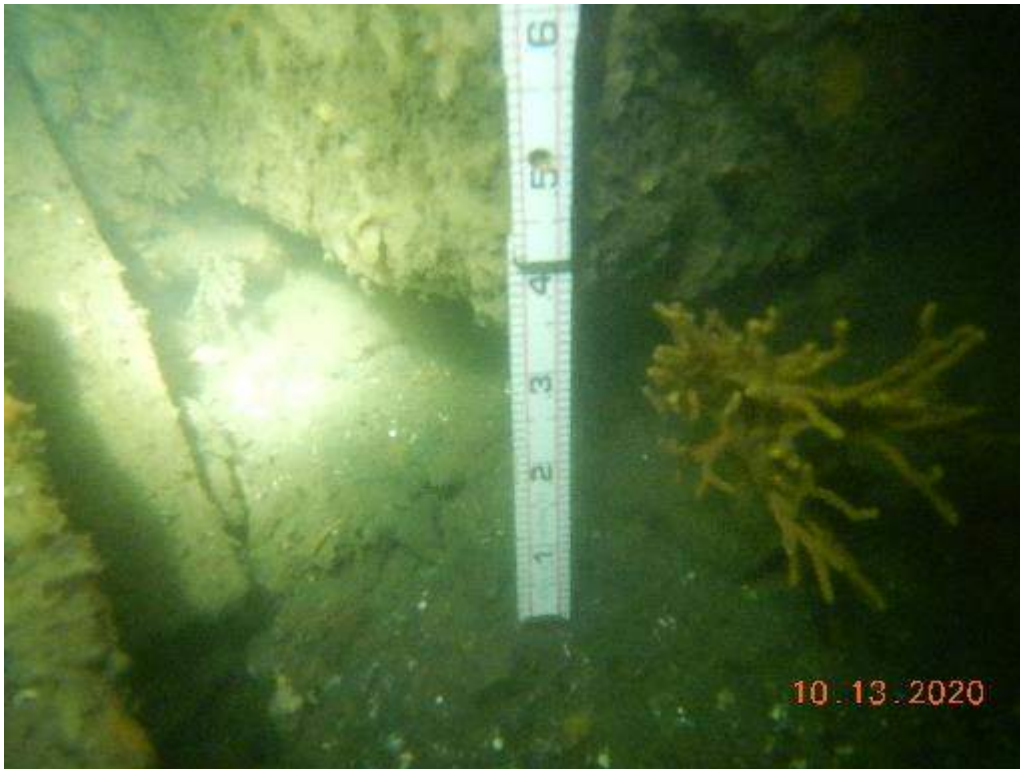
As per the 2016 priority inspection, the piers are satisfactory. Minor chamfer spalls were observed in three locations at Pier-2 and 4. Pier-3 and 7 had small openings, which appear to be original to the structure and are causing no stress or deterioration. The north-west corner of pier-7 was found to be in moderate condition, where there is undermining of the bottom of the concrete block foundation. It is believed that the concrete blocks are supported by piles, but these were not exposed. The 2016 report recommended to monitor this location and place sand bags around the south side of pier-7 for to deter future undermining at this location.

Photograph 19. Pier-7 Undermining NW Corner West Face (1.4'Lx0.3'Hx2.0'D)

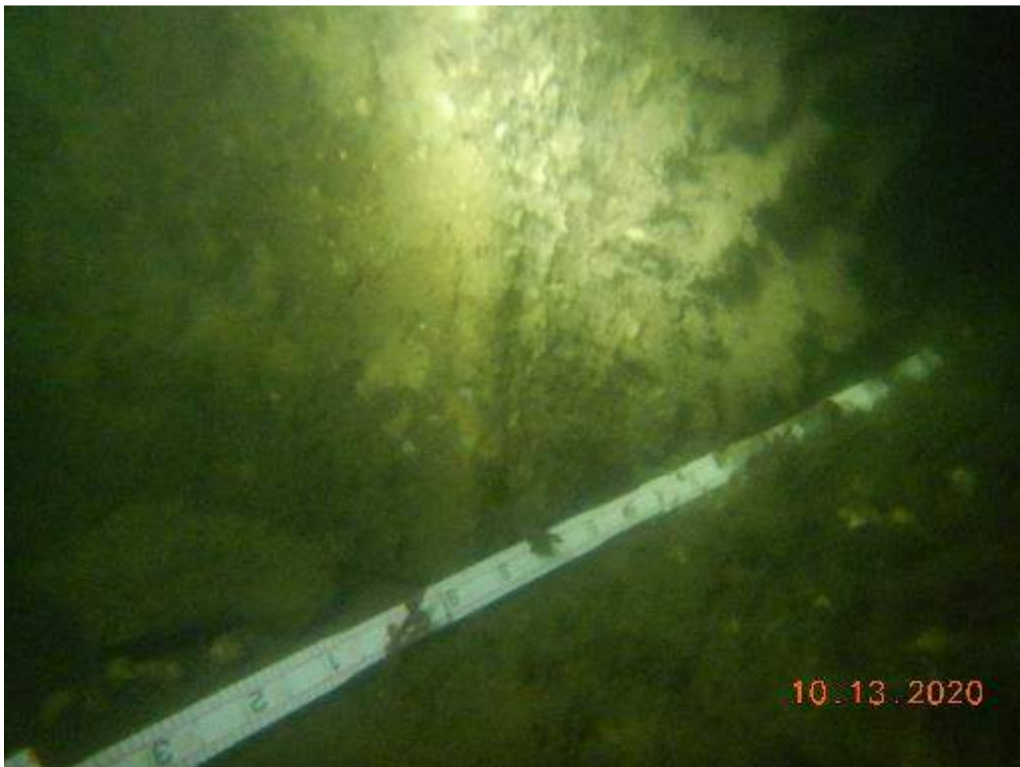
Photograph 20. Pier-7 Undermining NW Corner North Face (0.6'Lx0.2'Hx1.4'D)

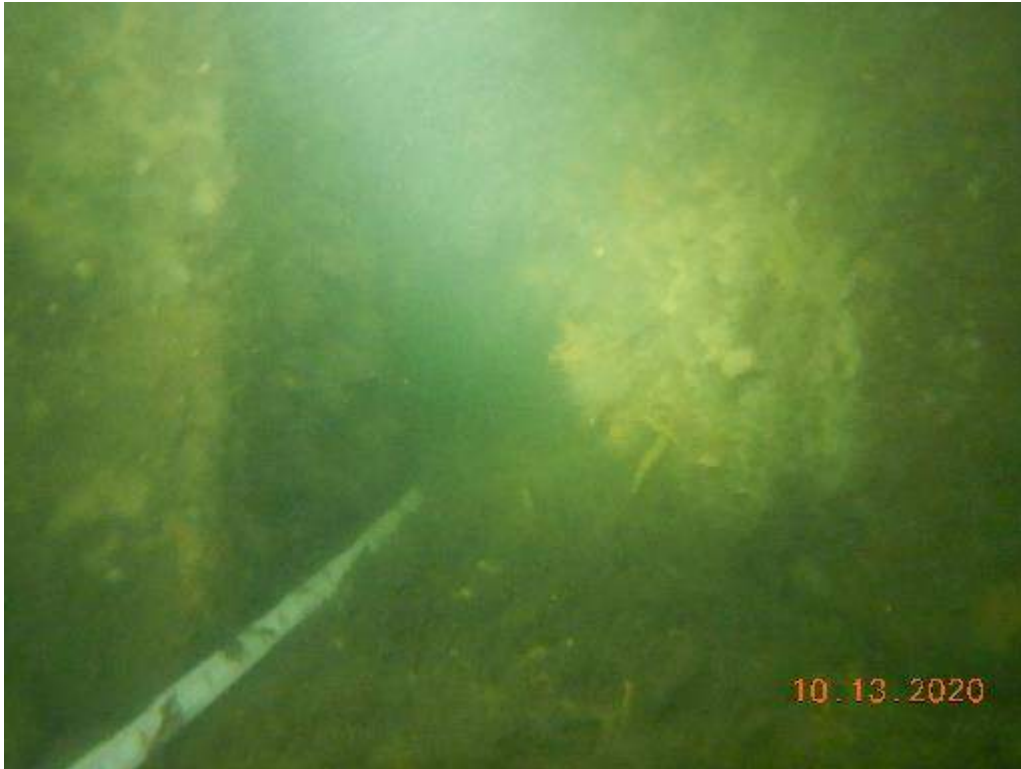
**Photograph 21. Pier-7 Horizontal Passageway (1'W x <1'H)**

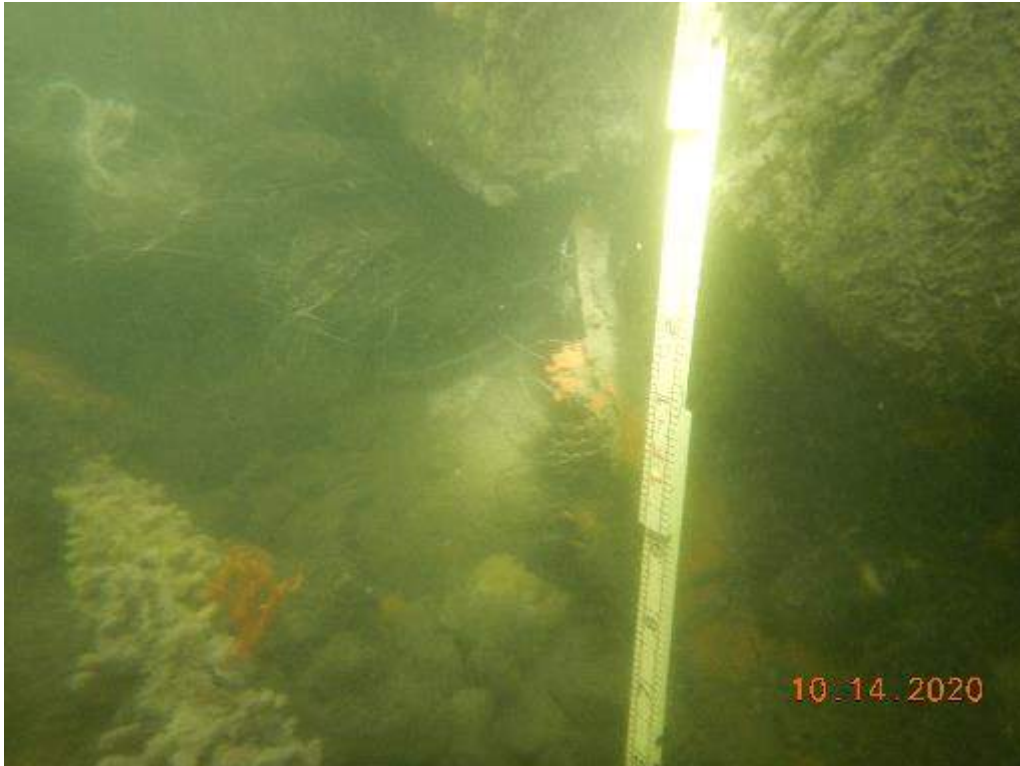
Overall, the northern breakwater structure is in fair condition. Medium and wide transverse cracks are developing on the side surface and on top of the walkway slab along the breakwater. Voids were found on the bottom of north breakwater near the mudline. The maximum size was approximately 1'-0" H x 3'-0" D.

Photograph 31. (30' L x 1.5' W x 2' D) Under Minding at Station 0+56.5, North Breakwater

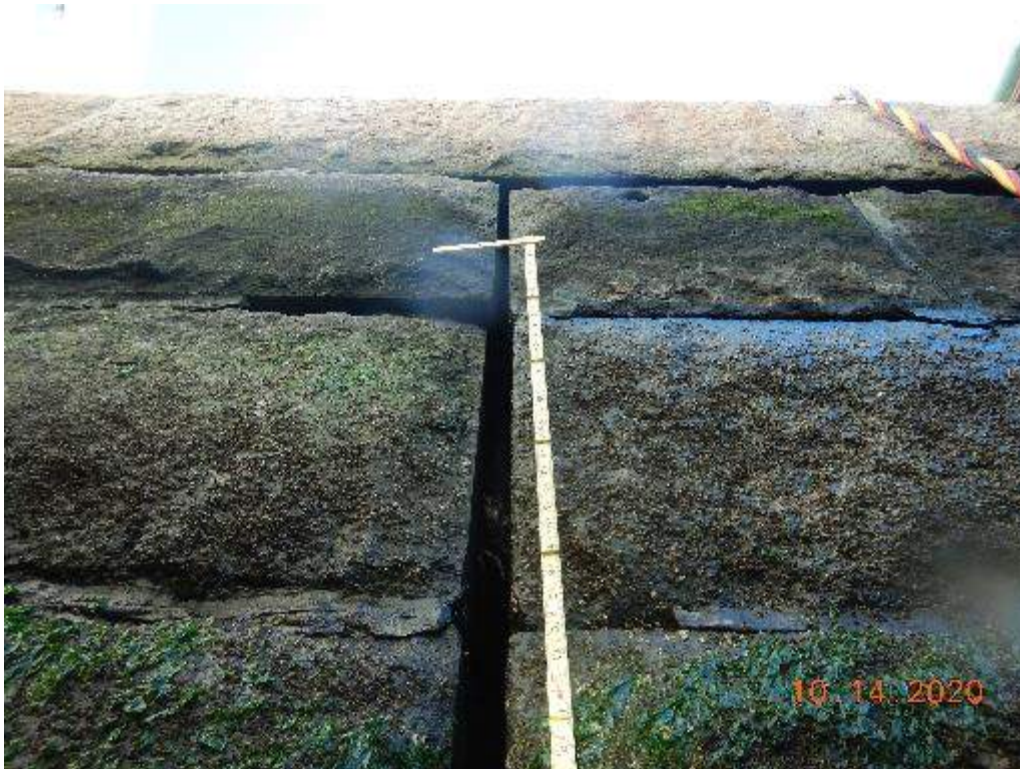
**Photograph 34. Transverse Void above Water Level at Station 0+91, West Breakwater**

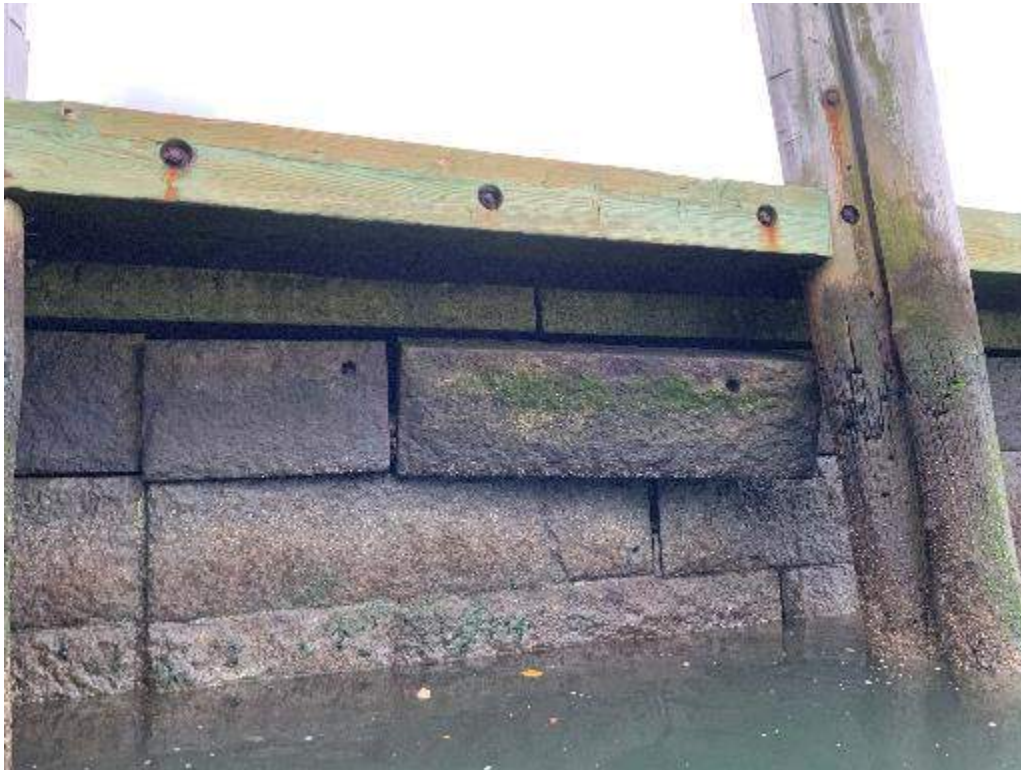
**Photograph 44. Tilted Blocks on West Surface, West Breakwater**

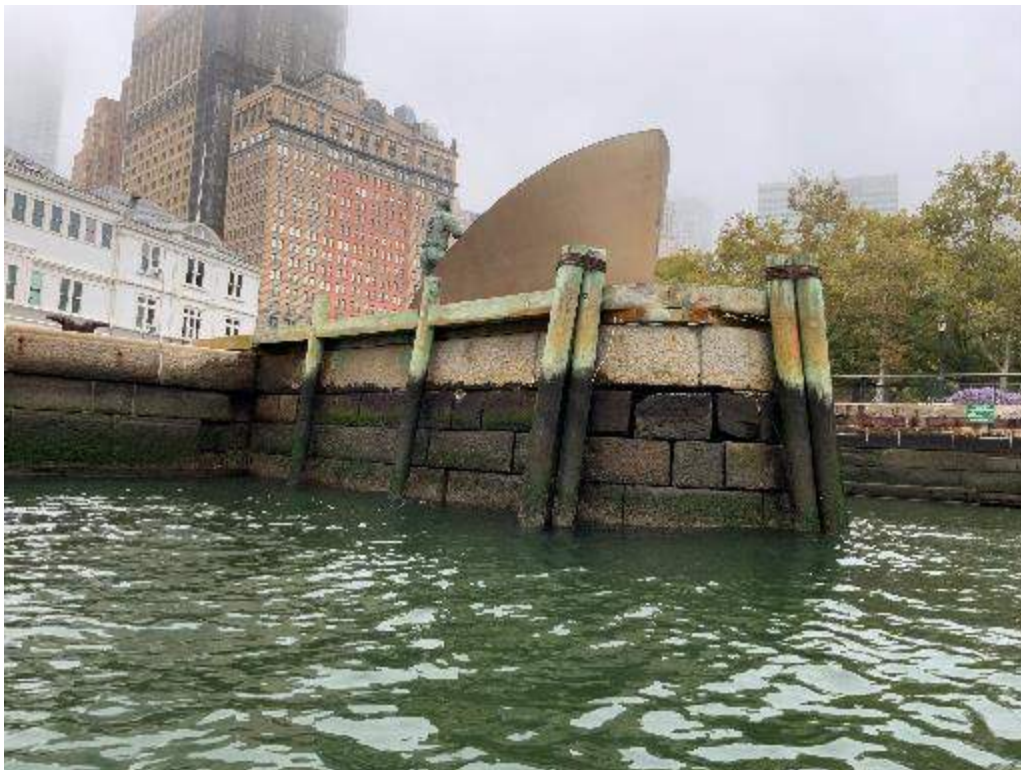
**Photograph 47. Voids between Blocks Wall on South West Surface, Memorial Breakwater**

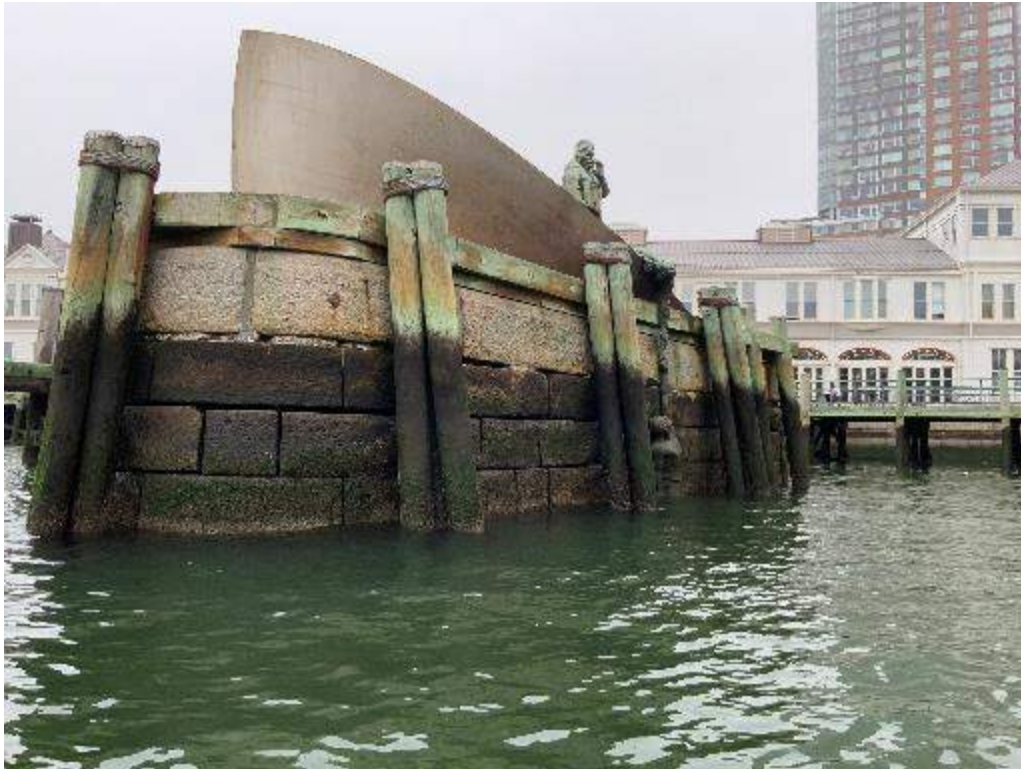
**Photograph 48. Voids between Blocks Wall on South Surface, Memorial Breakwater**

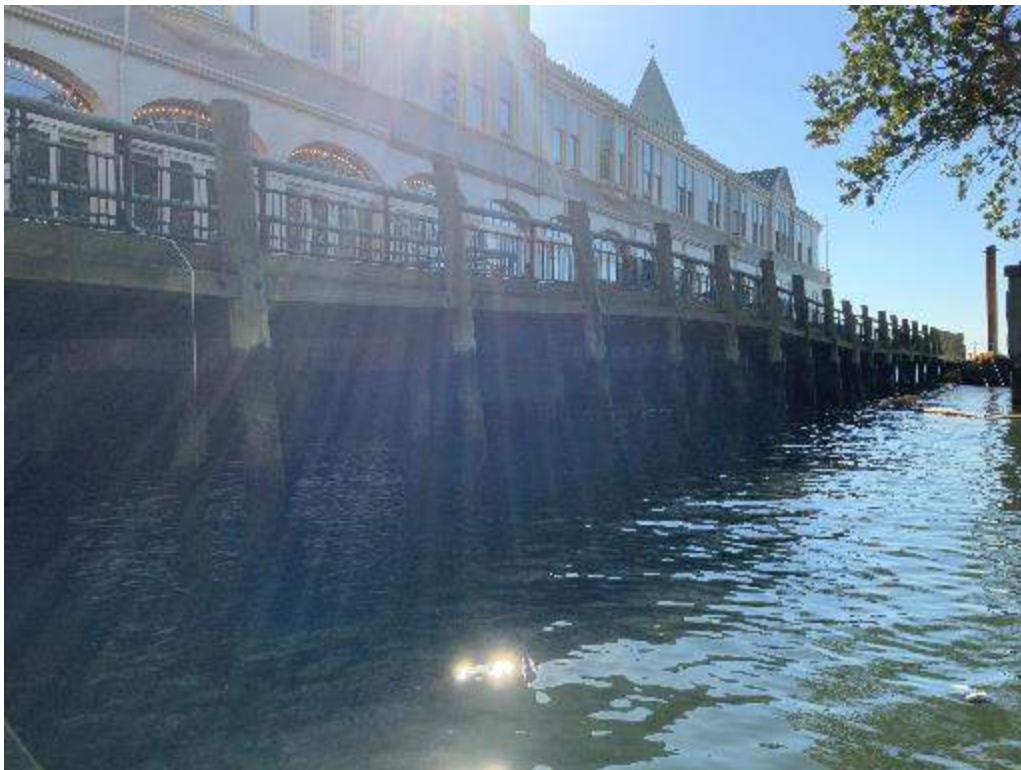
**Photograph 59. Pier-A North Elevation View (Seaside)**

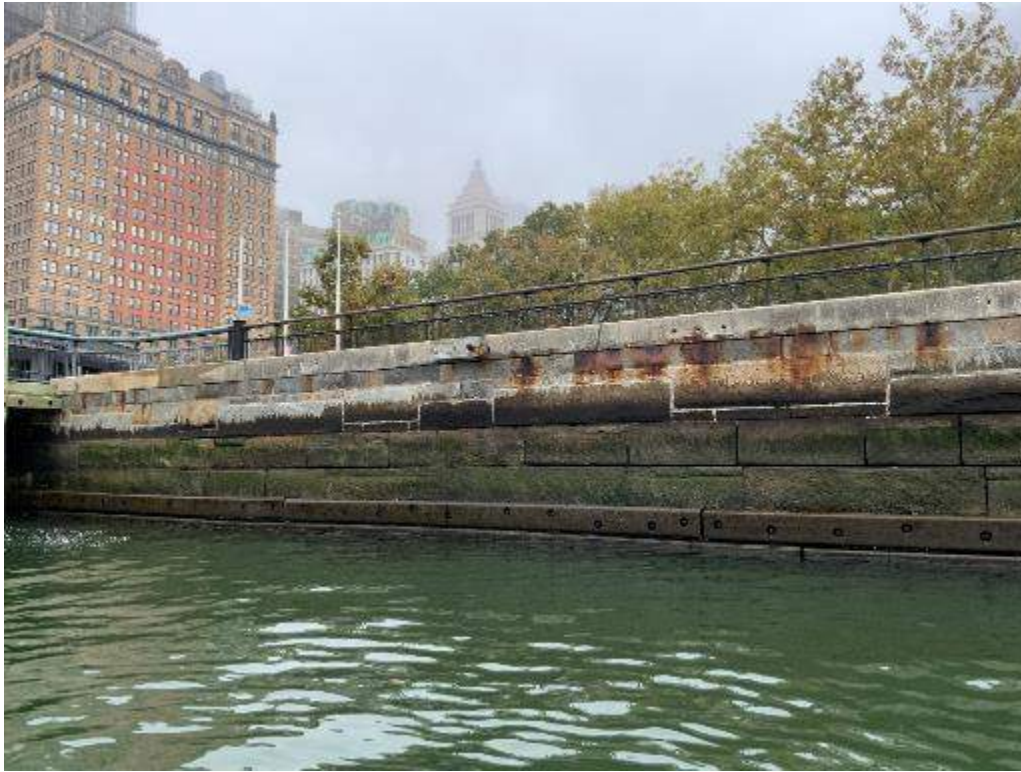
**Photograph 60. Relieving Platform Seawall**

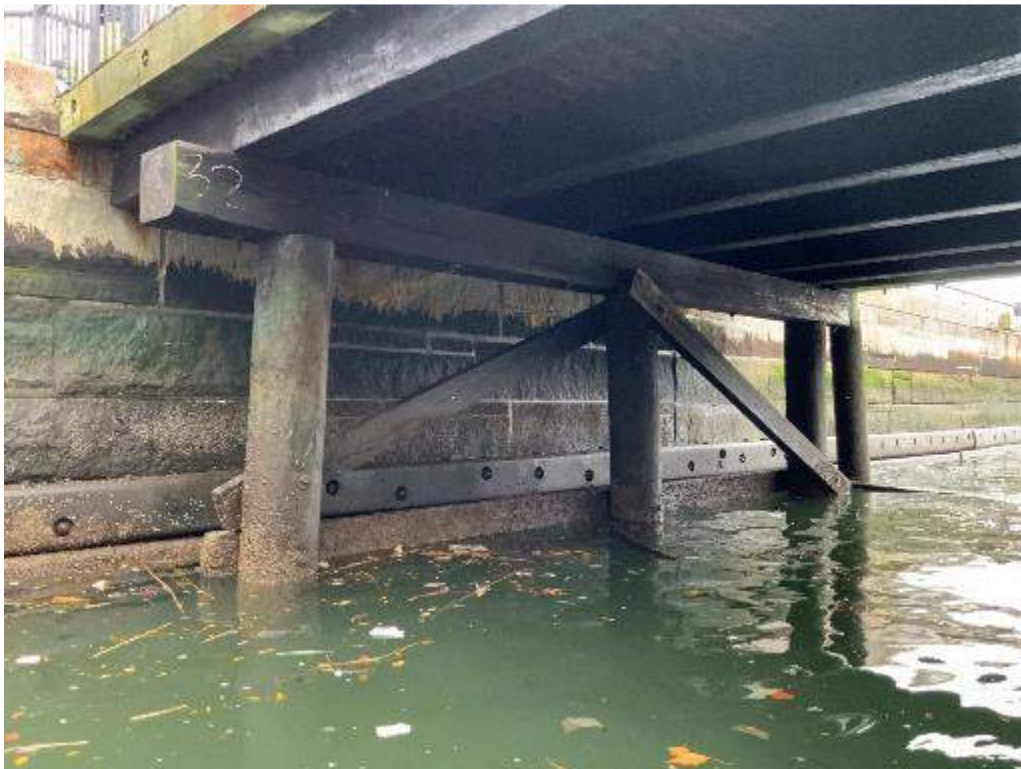
**Photograph 61. Relieving Platform Seawall under Ramp**

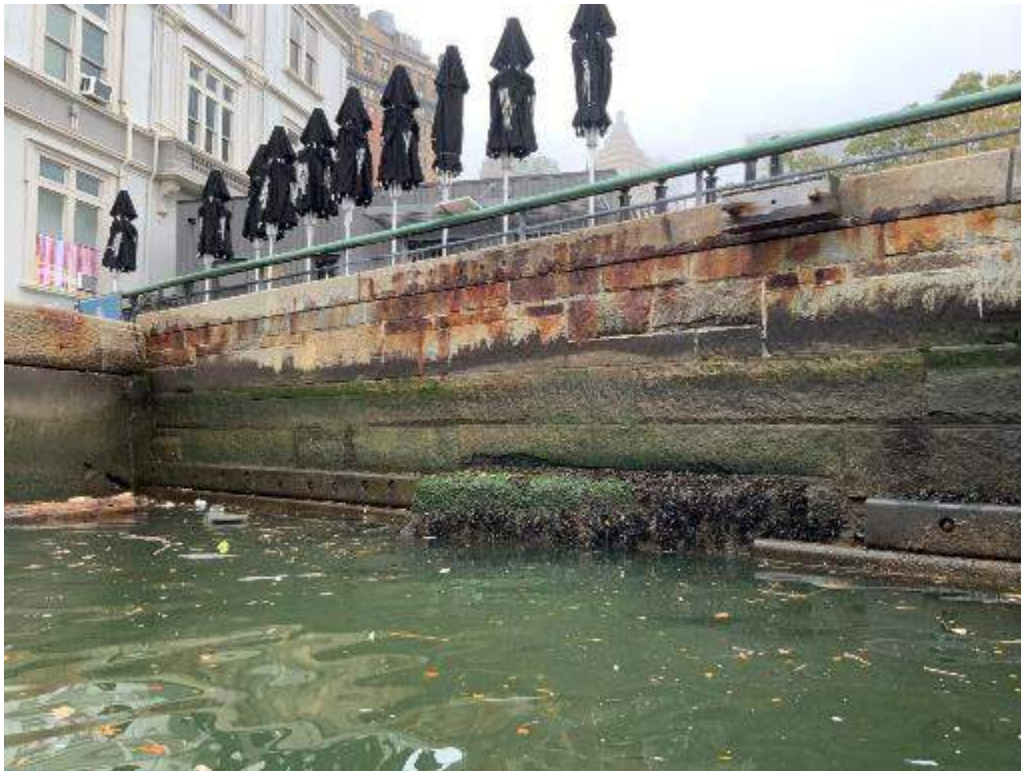
**Photograph 62. Relieving Platform Seawall between Ramp and Breakwater**

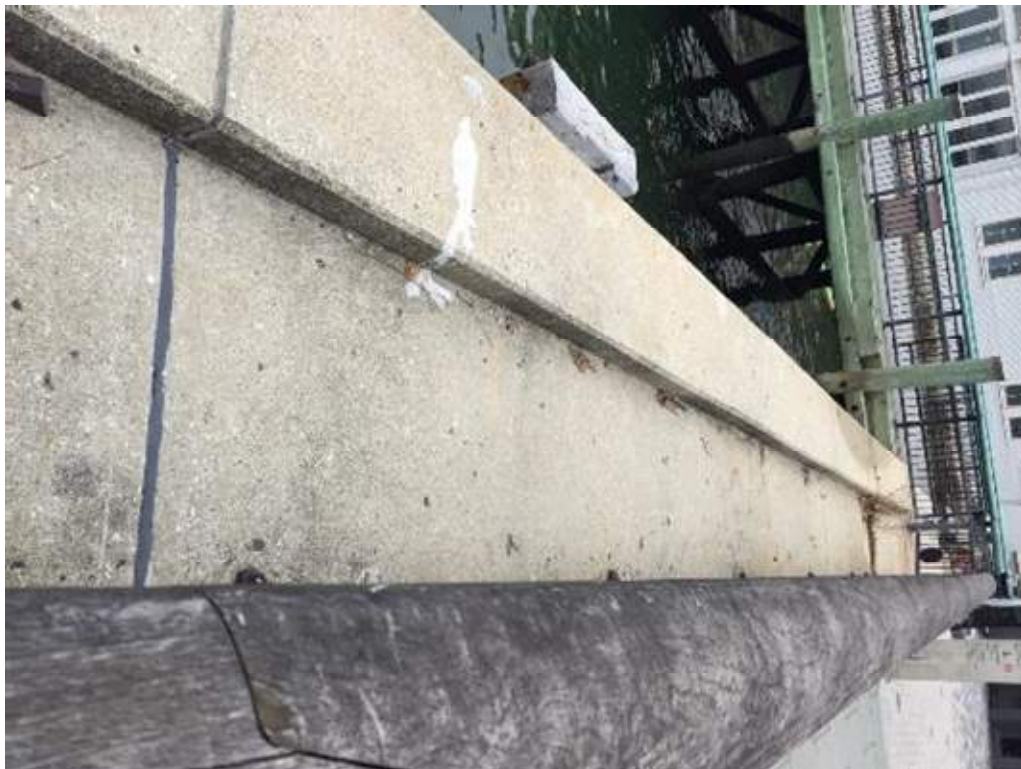
**Photograph 63. Relieving Platform Seawall Concrete Cap Beam**

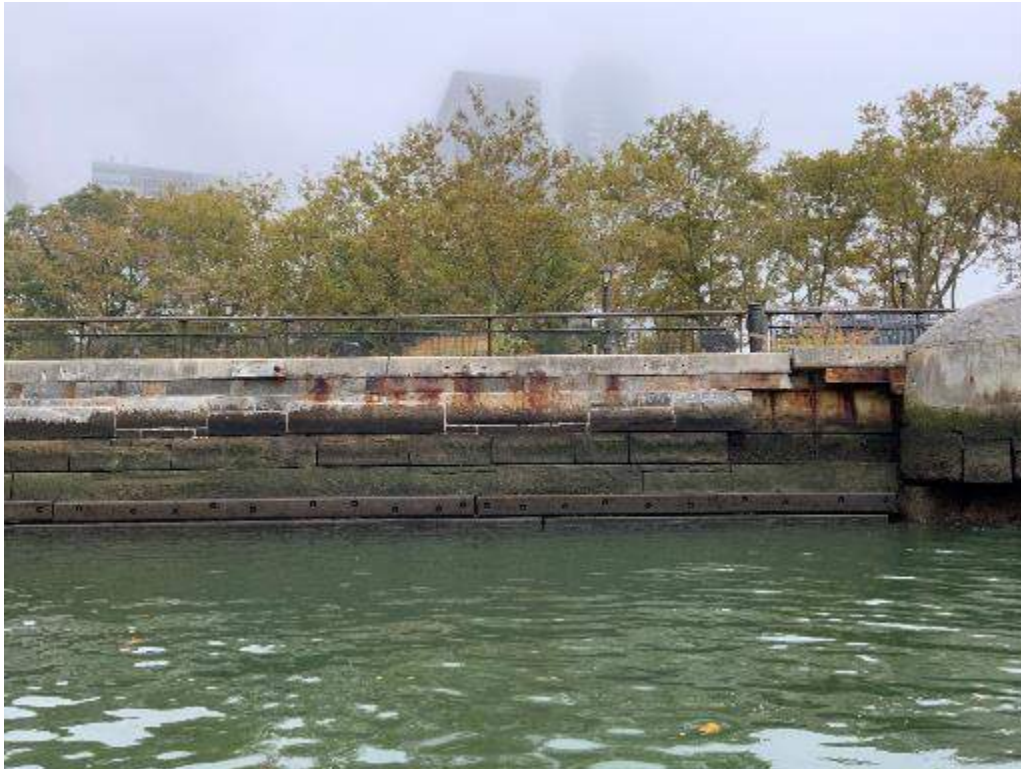
**Photograph 64. Relieving Platform Seawall Outside of Project Limit**

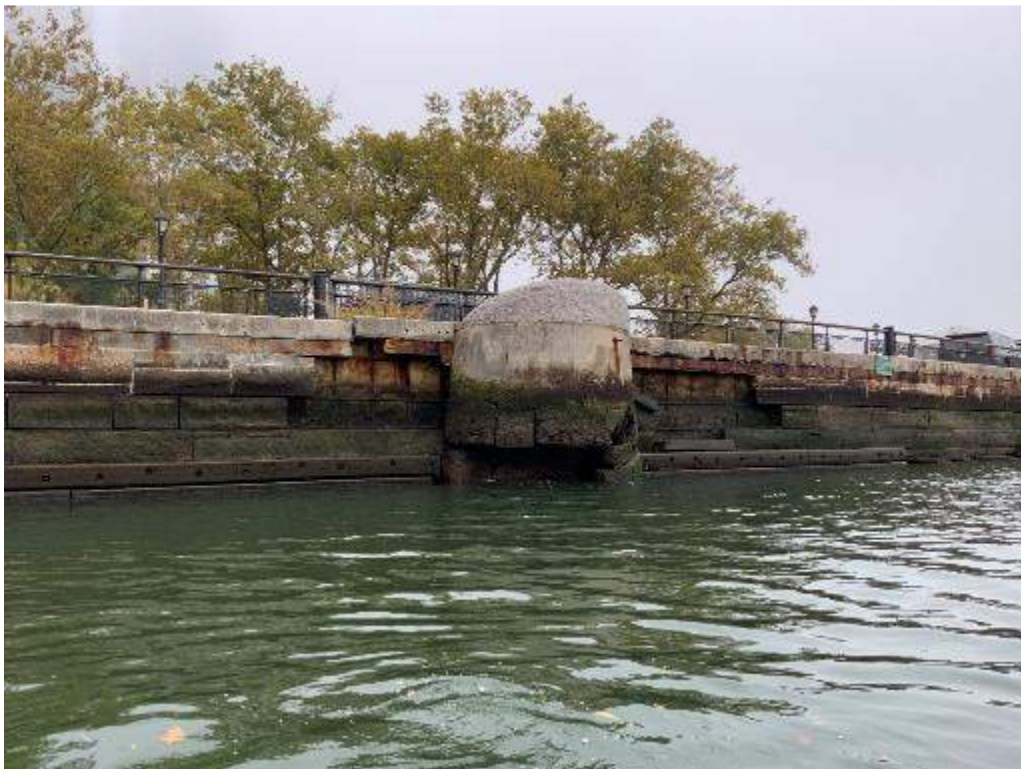
**Photograph 65. Relieving Platform Seawall Outside of project limit**

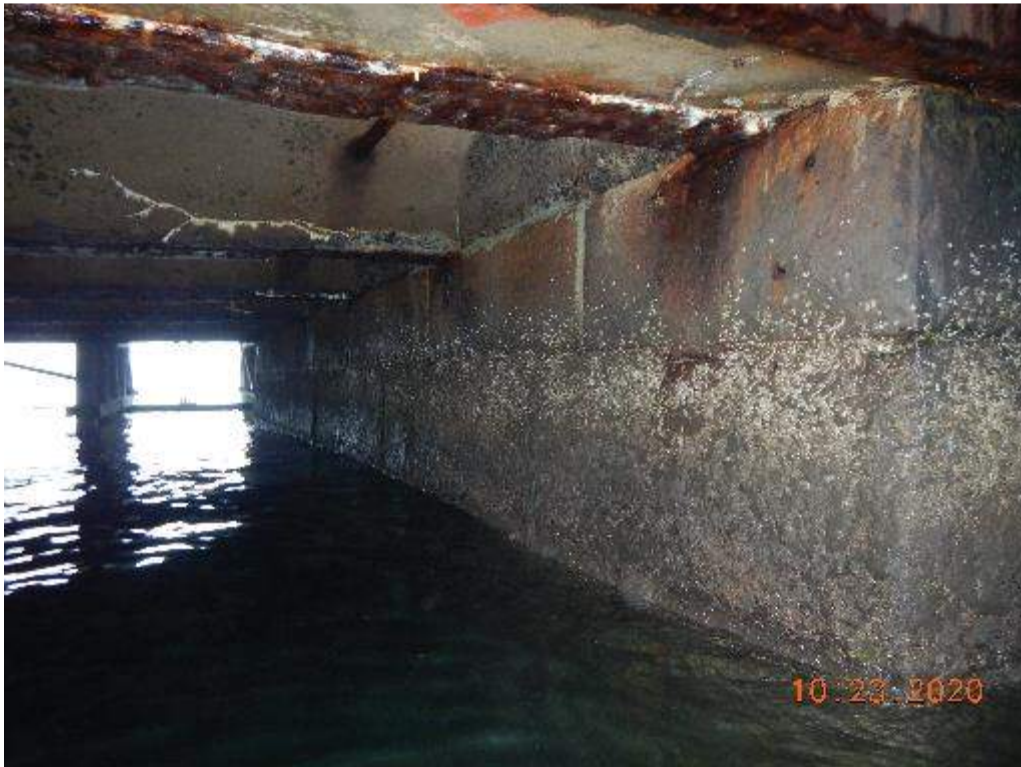
The iron girders consists of built-up plate girders encased in concrete, which is part of the jack arch deck. The bottoms of iron girder flanges are exposed to the air and tidal water and are in poor condition. This corrosion has caused adjacent concrete spalls and cracks. The corresponding top girder flanges are encased in concrete and can not be inspected. The inner girders, G3 & G4 have additional plates on the bottom of the flange. Please see the below sketches extracted from 2008 deck evaluation report. Our recommendation for maintenance of the iron girder bottom flanges is to remove the corrosion and rusted surfaces with sandblasting and then painting with an appropriate marine coating. Please see appendix E2 for detail of defected area photographs - 85 to 90.

Photograph 85. Span-7, View from G-1 , Pier-7

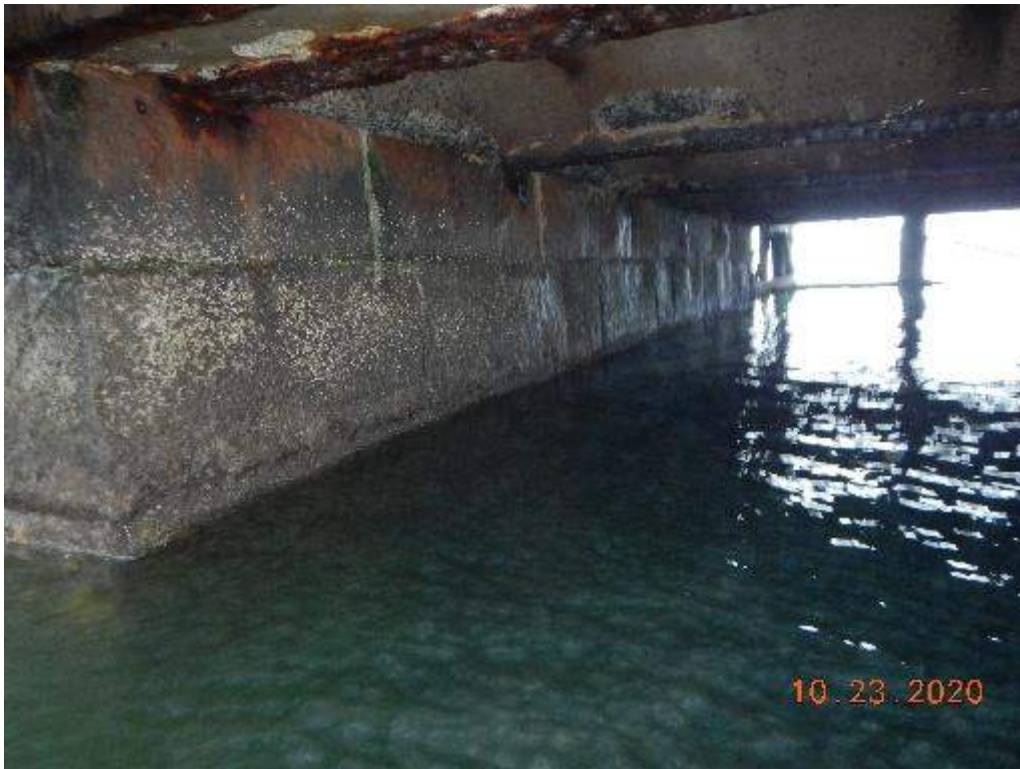
Photograph 86. Span-7, View from G1, Pier-6

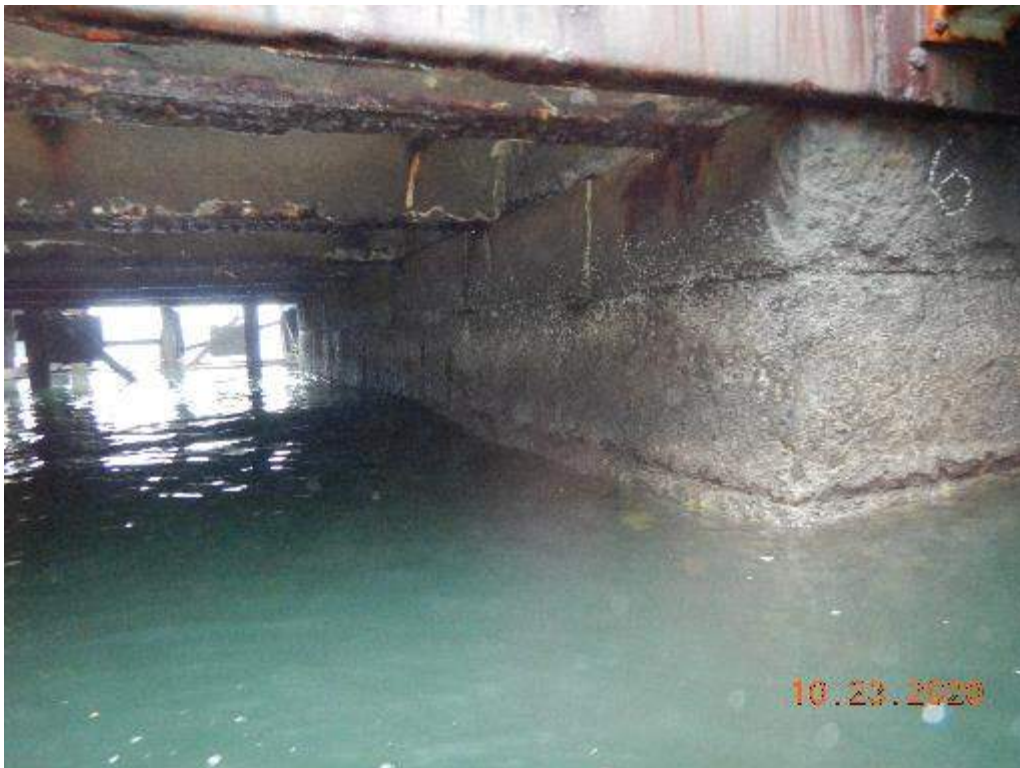
Photograph 87. Span-6, View from G1, Pier-6

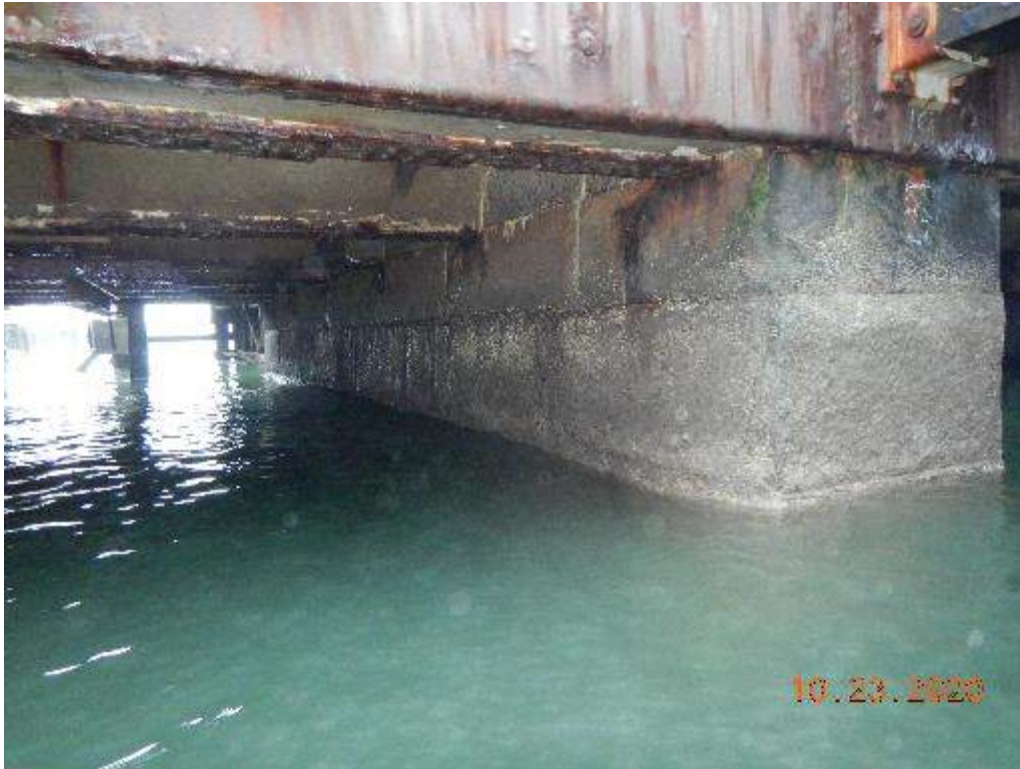
**Photograph 88. Span-5, View from G1, Pier-5**

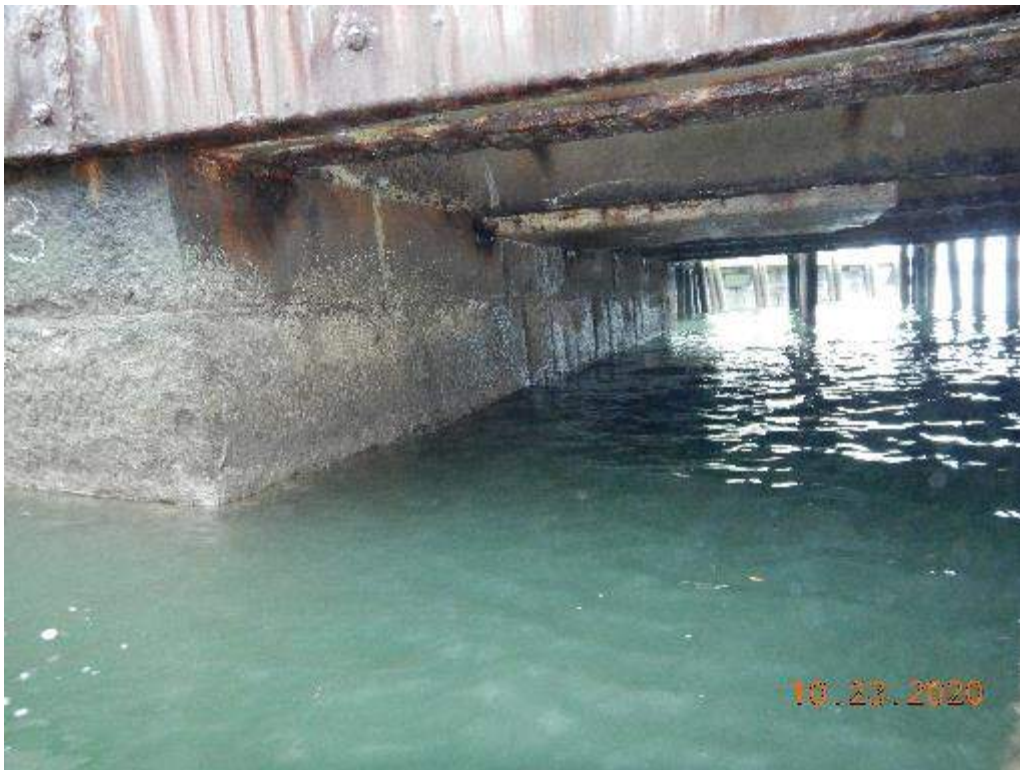
**Photograph 89. Span-4, View from G1, Pier-3**

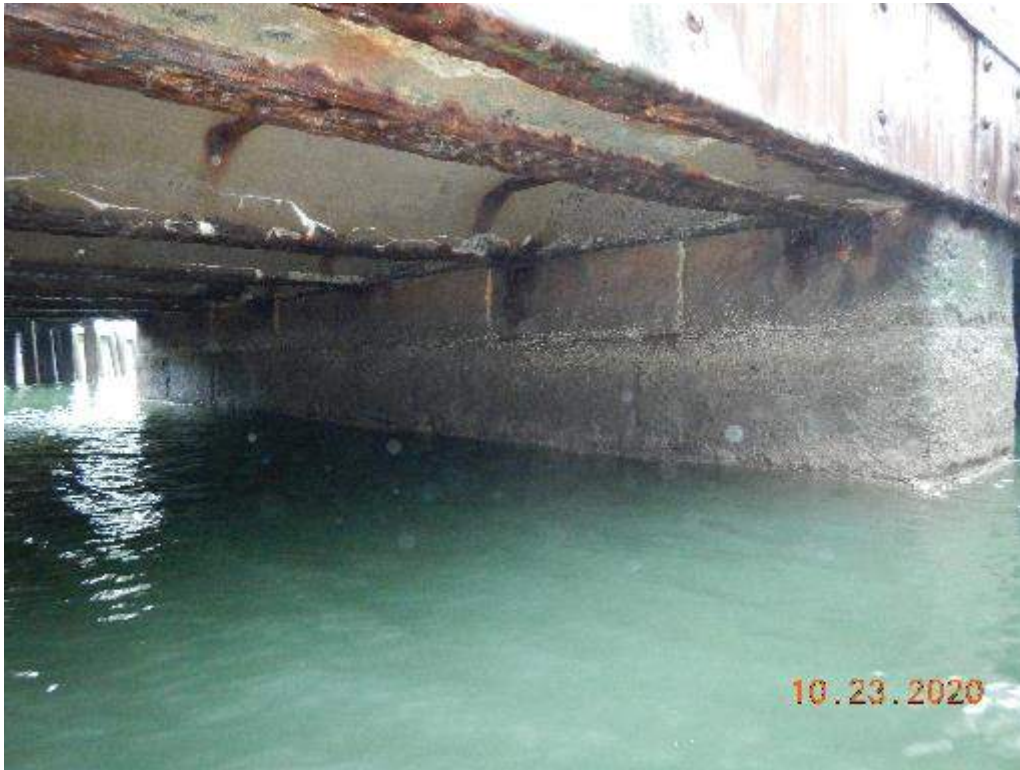
**Photograph 90. Span-3, View from G1, Pier-3**

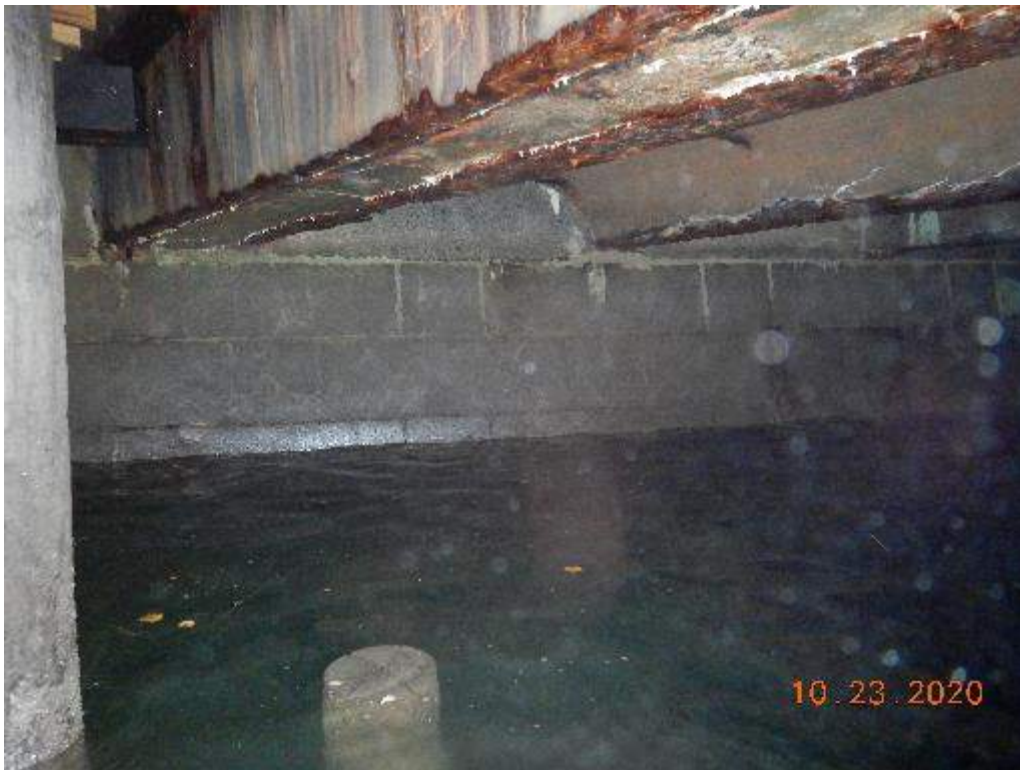
**Photograph 91. Span-1, View from G1 to Bulkhead**
